This is a Factual Investigative Update of a CSB investigation into a multi-fatality incident resulting from the catastrophic failure of a pressure vessel.¹ It provides the facts and findings established by the investigation team to date, which is subject to revision and updates as the investigation proceeds. This document identifies a path forward for a number of potential investigative areas of inquiry that may yield lessons for safety improvements.

Incident Overview

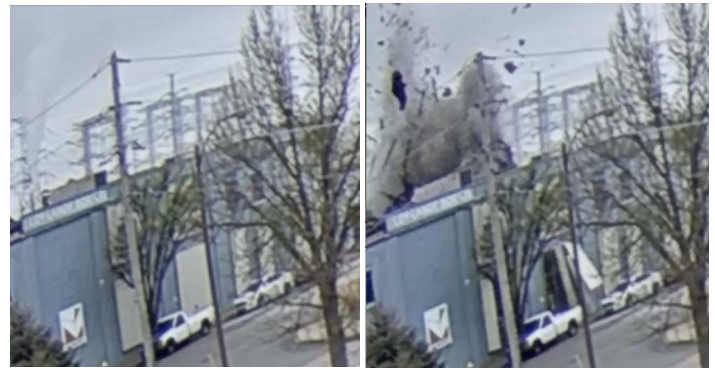
about 350 pounds of TNT.⁸ Some of that energy dissipated when the escaping steam condensed to water, but the surveillance video from a nearby custom work truck shop clearly shows the power of the explosion and the effect on the building (Figure 1), as does the damage evident after the event.

Figure 1. Before and after photos for the explosion - Kranz video

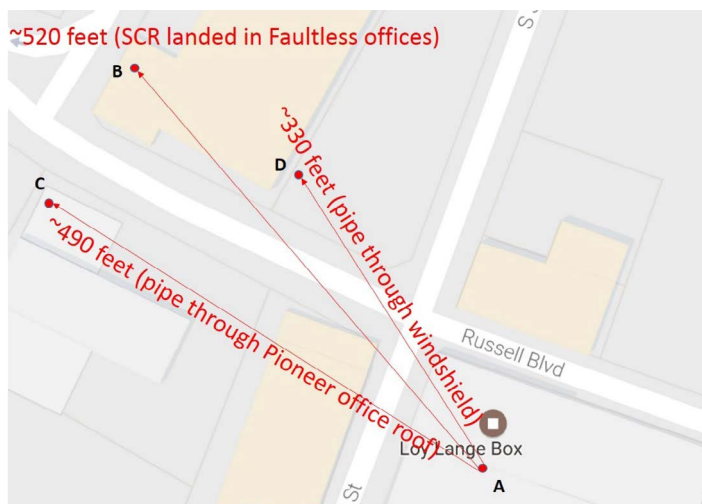
Figure 3. Debris map

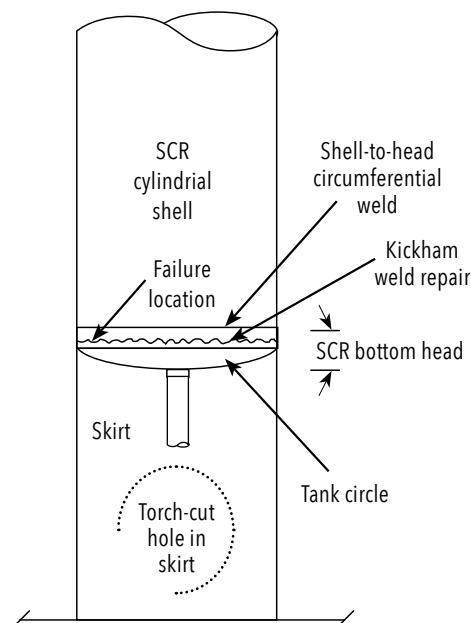
Figure 7. Drawing of various parts of the SCR

Figure 7 is a drawing that illustrates the various parts of the SCR, the failure location, and the pieces depicted in the photographs.

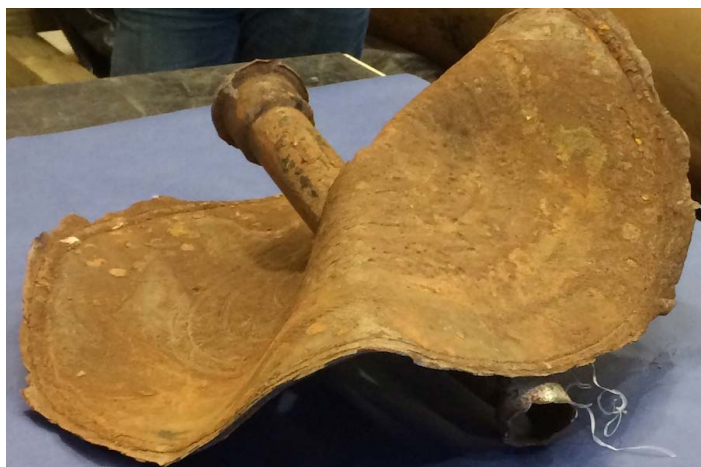
The second piece of evidence supporting the assignment of cause is based on an examination of two metal artifacts found within the upper portion of the SCR lodged at the spargers (Figure 8)²⁹

Figure 8. Close-up of bottom tank circle and portion of bottom piping showing weld seam and, outside of the seam, the thinned original bottom head “ring” material
