July 31, 2008

Commonwealth of Massachusetts
Department of Public Safety
INCIDENT REPORT

Dominion Energy New England - Salem Harbor Station
Salem, MA
Boiler #3 Failure - November 6, 2007

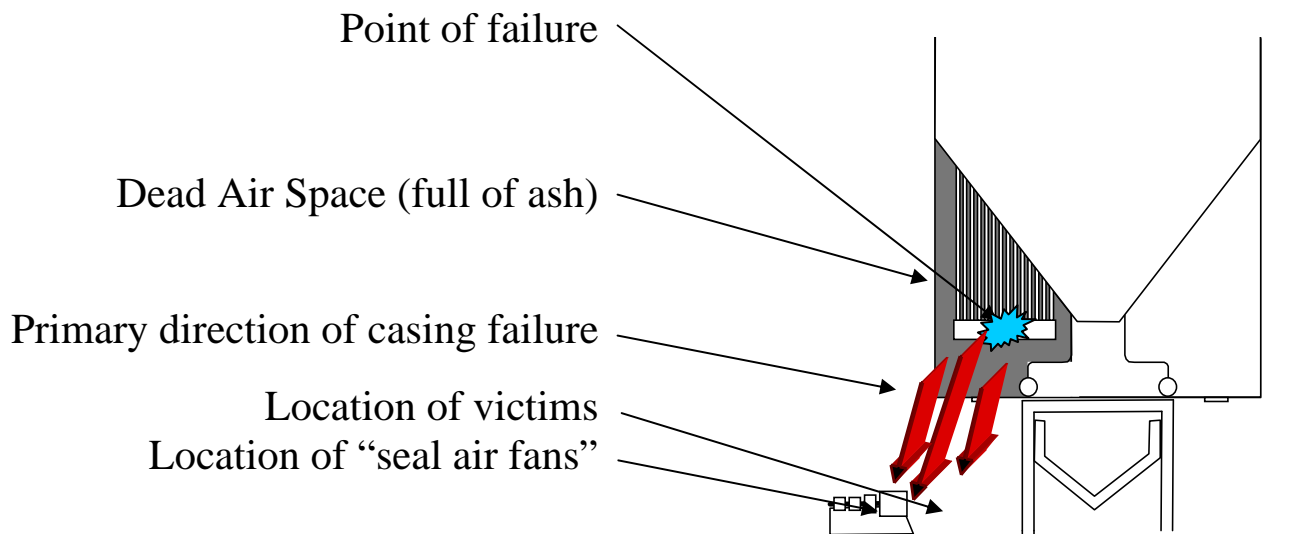
Graphic representation of failure area

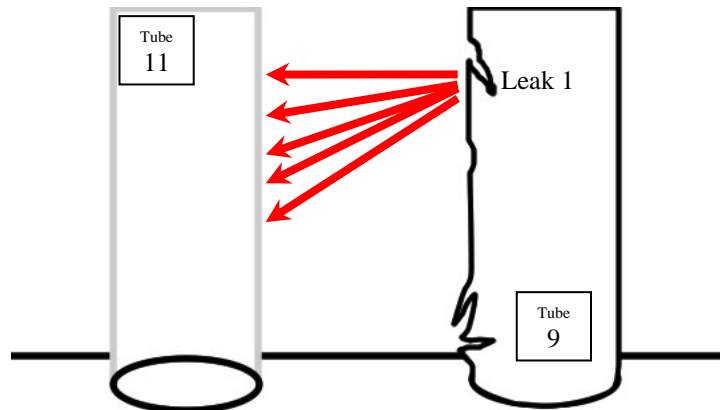
1. Tube 9 begins to leak as a result of a significant welding flaw at the time of manufacture, and external corrosion

a. Leak strikes Tube 10 and 11 causing “collateral damage”

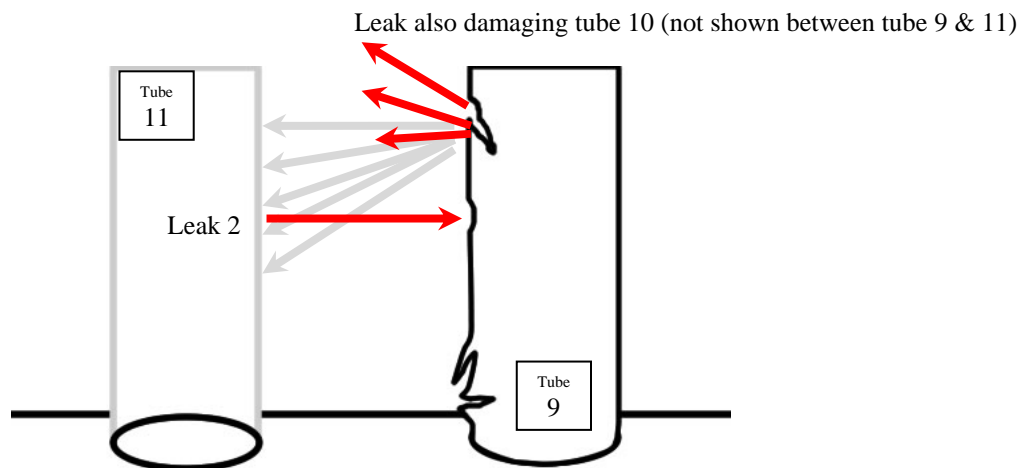
2. Initial leak in Tube 9 continues to damage Tube 10 and 11

a. Tube 11 begins to leak and starts to damage Tube 9

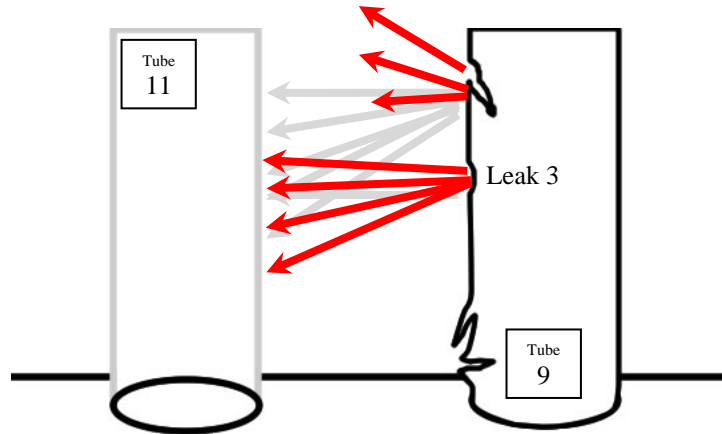
3. All leaks continue to progress.
 - a. Leak from Tube 11 results in a new leak in Tube 9, continues to damage Tube 10

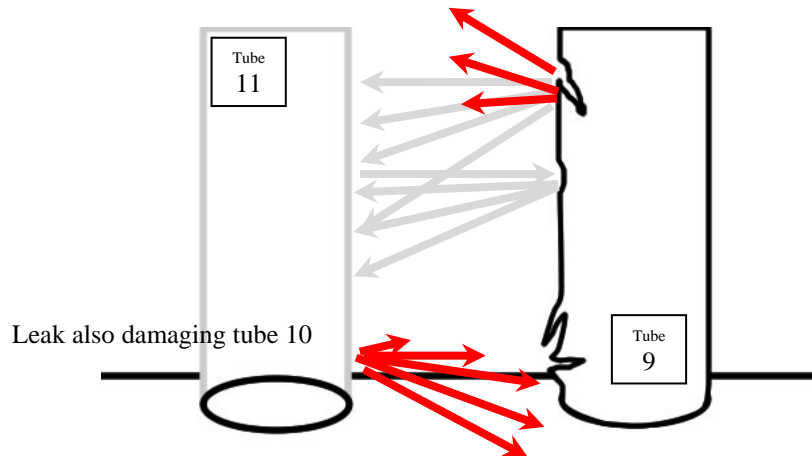
4. All leaks continue to progress and worsen
 - a. New leaks from collateral impingement damage develop

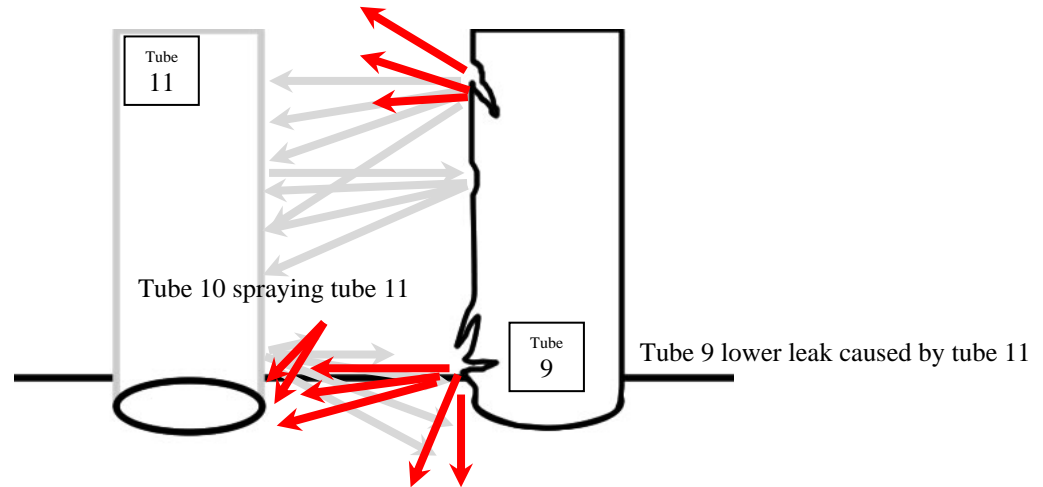
5. All leaks continue to progressively worsen over time
 - a. Tube 10 is thinned along one plane far below minimum wall thickness
 - b. Tube 11 is also thinned considerably below minimum wall thickness
 - c. Tube 10 fails catastrophically forcing steam/hot water in the direction of Tube 11
 - d. The lateral force applied by the failure of Tube 10 toward the weakened Tube 11 causes Tube 11 to separate from the header.

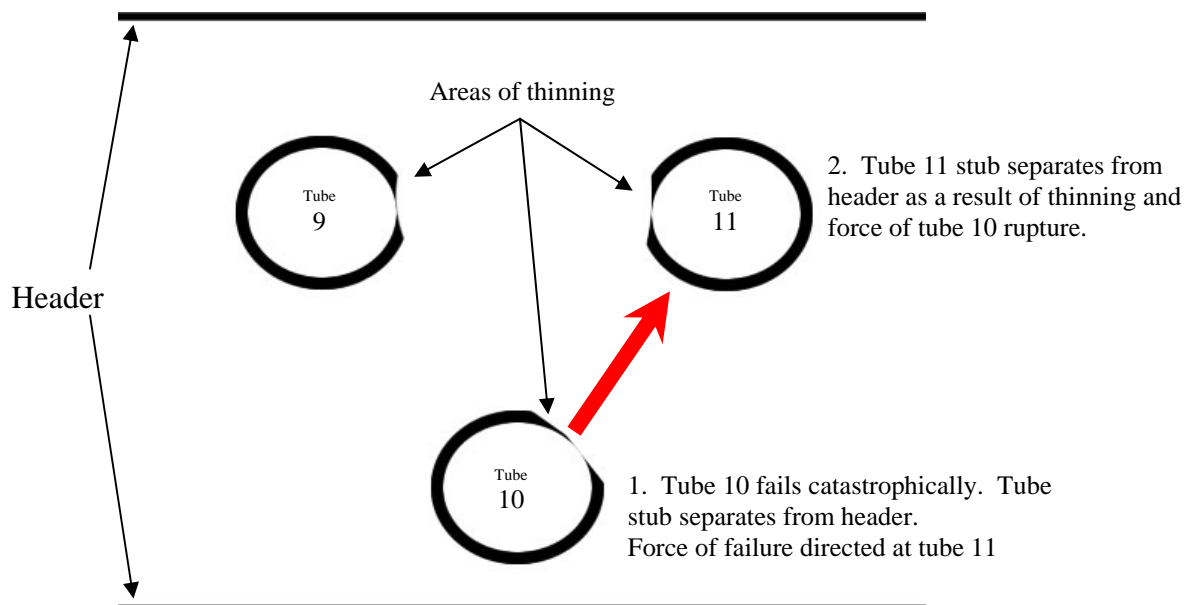
6. View of tube arrangement on header looking down.
 - a. As stated in (5) above, the lateral force applied by the failure of Tube 10 toward Tube 11 caused the already weakened Tube 11 to separate from the header.

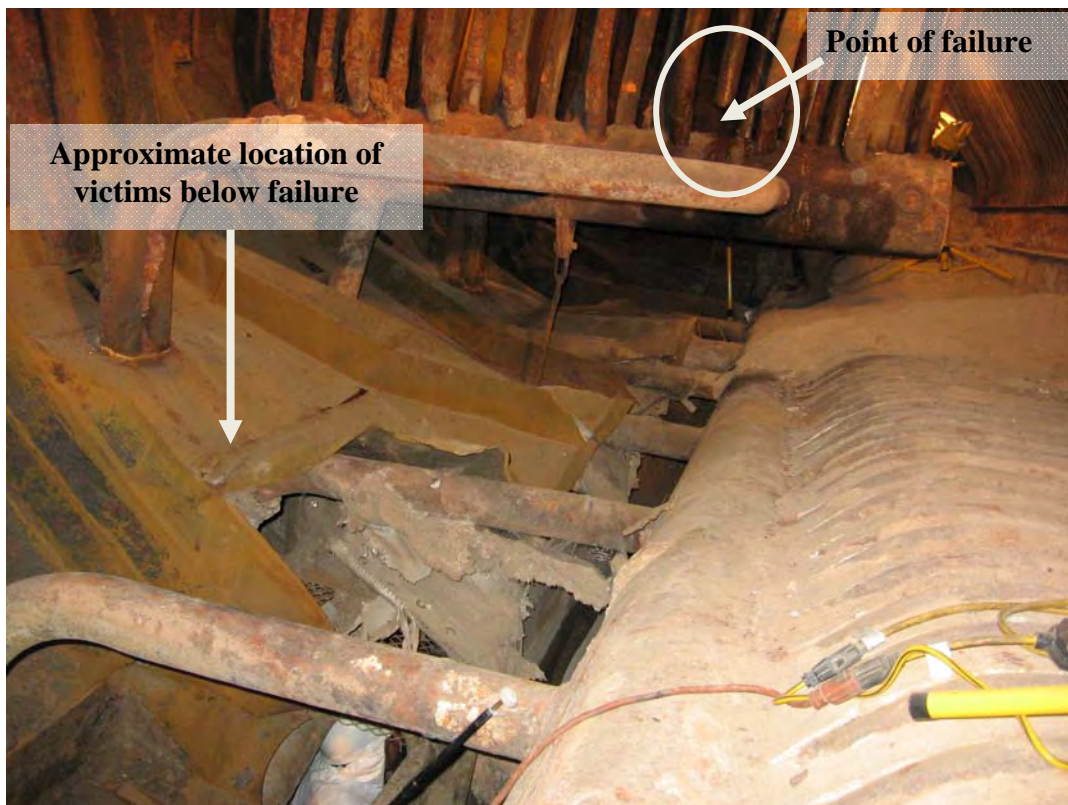
4. Dead air space showing ruptured boiler casing (facing south)

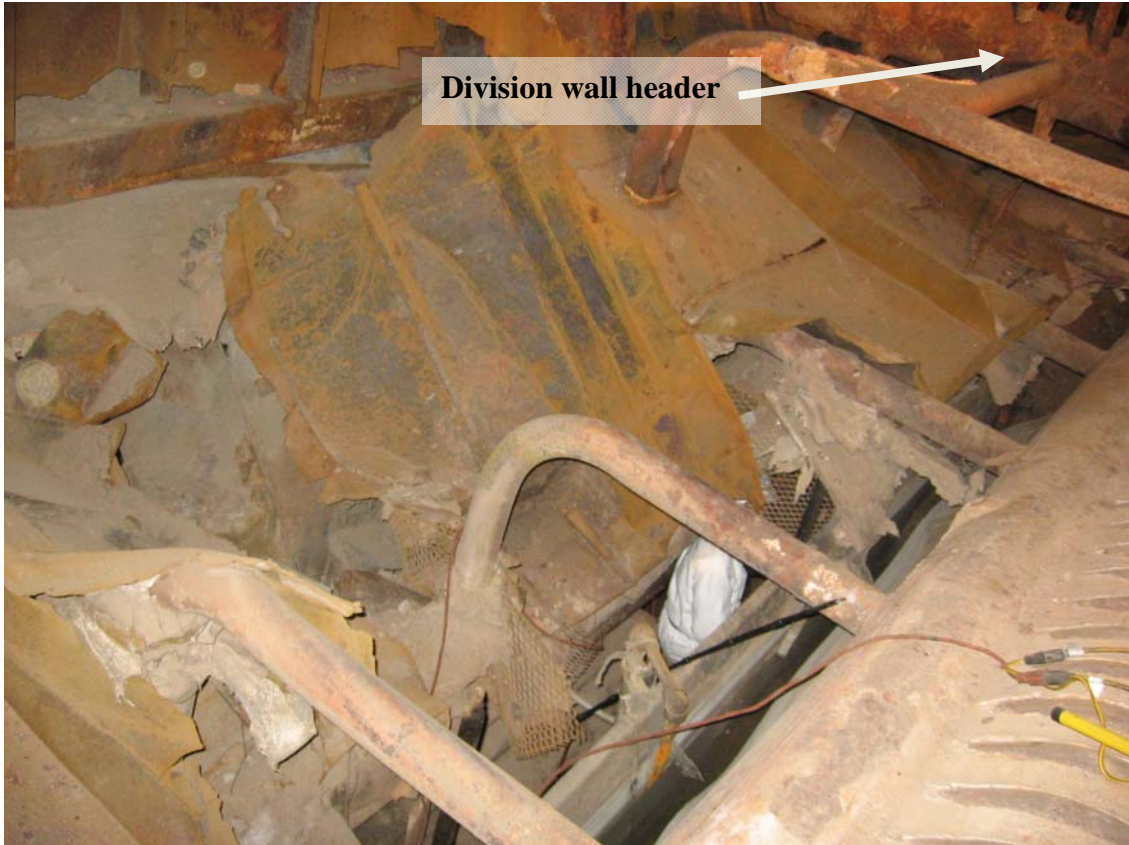
5. Dead air space showing ruptured boiler casing (looking down, facing south)

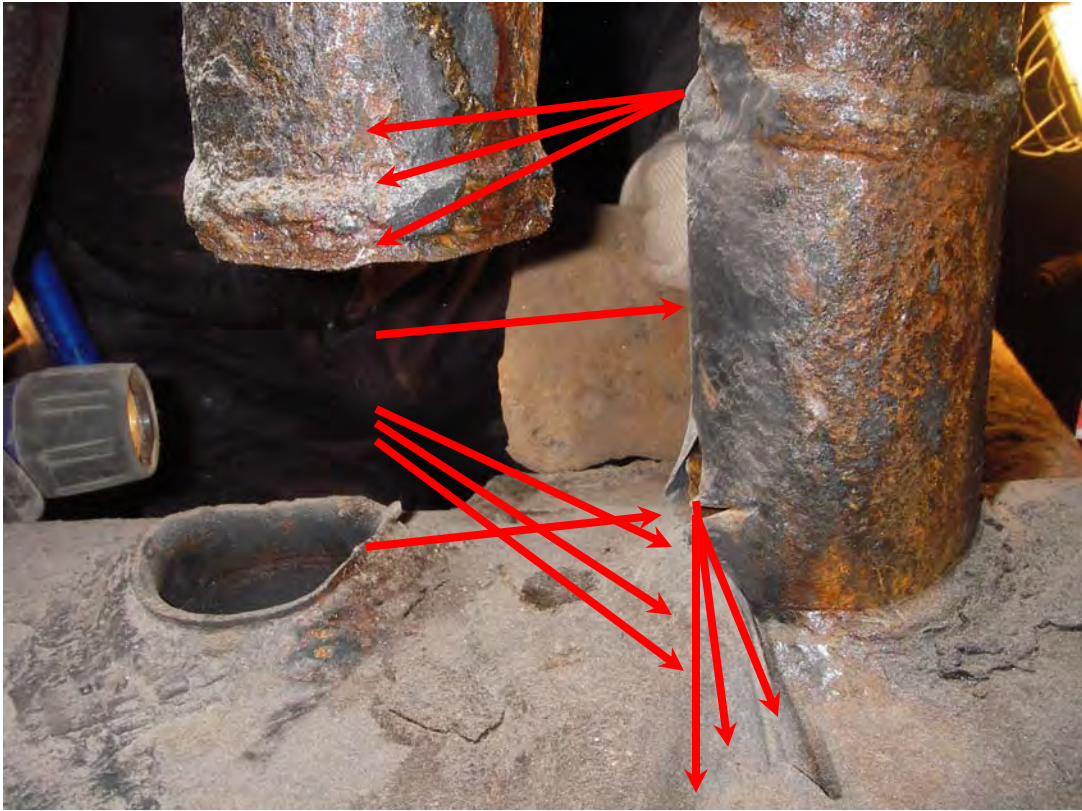
15. Steam impingement indications between tube 9 and 11

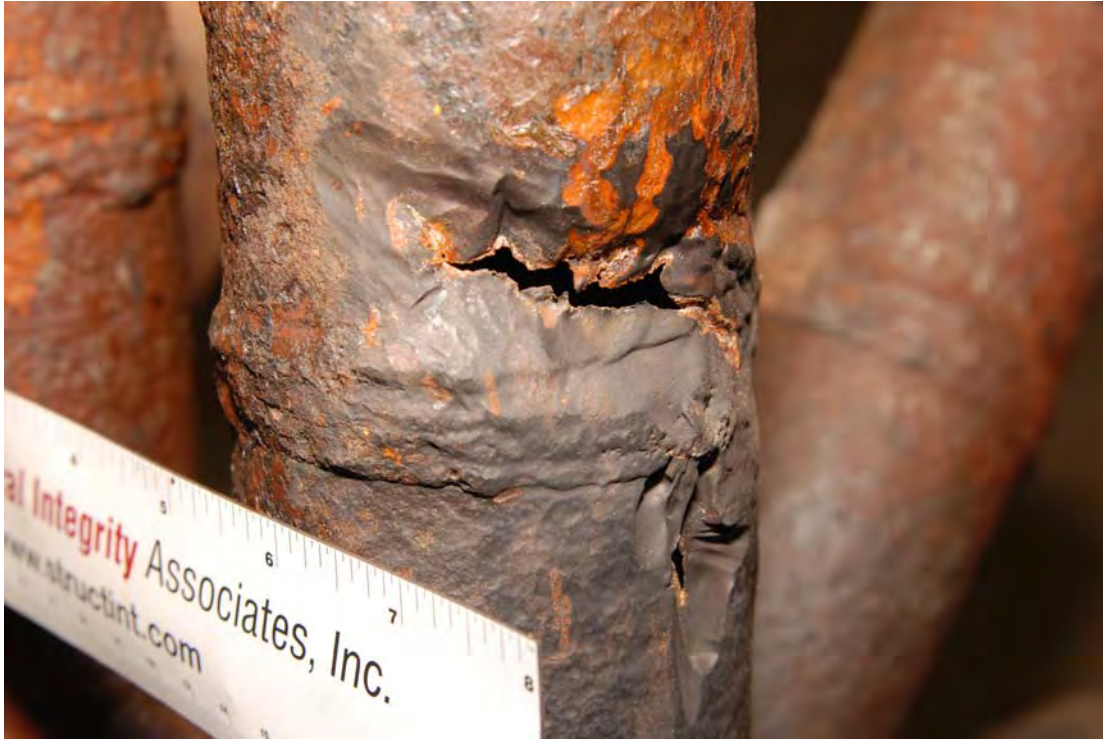
21. Close-up of tube 9 top leak

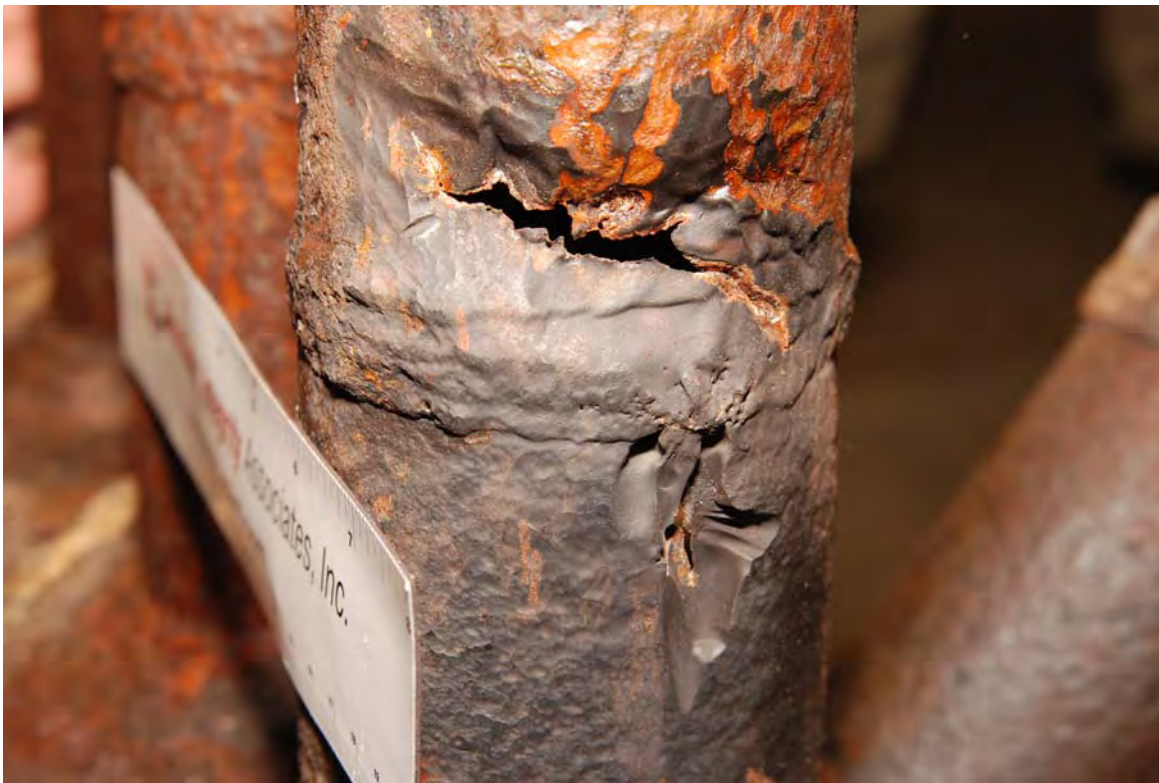
22. Close-up of tube 9 top leaks

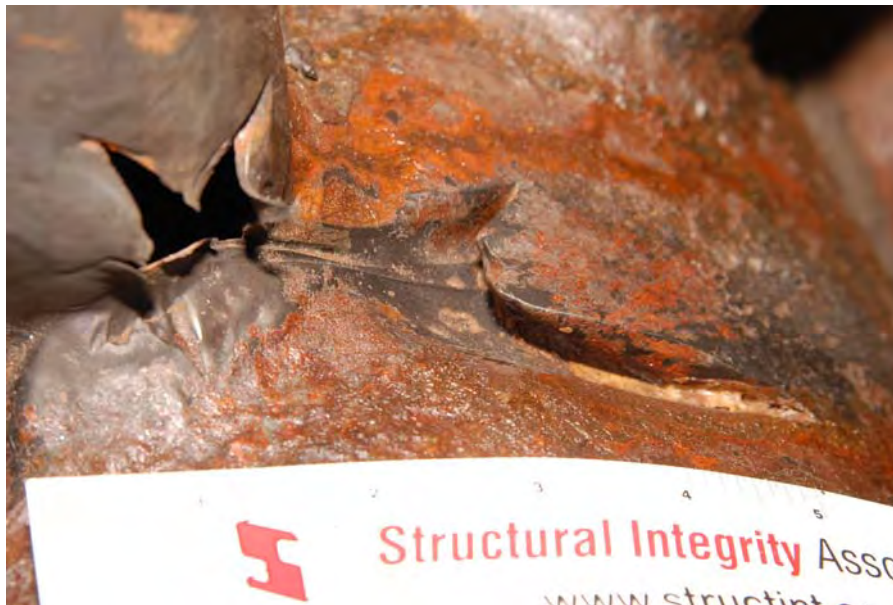
29. Close-up of header damage from steam/water impingement

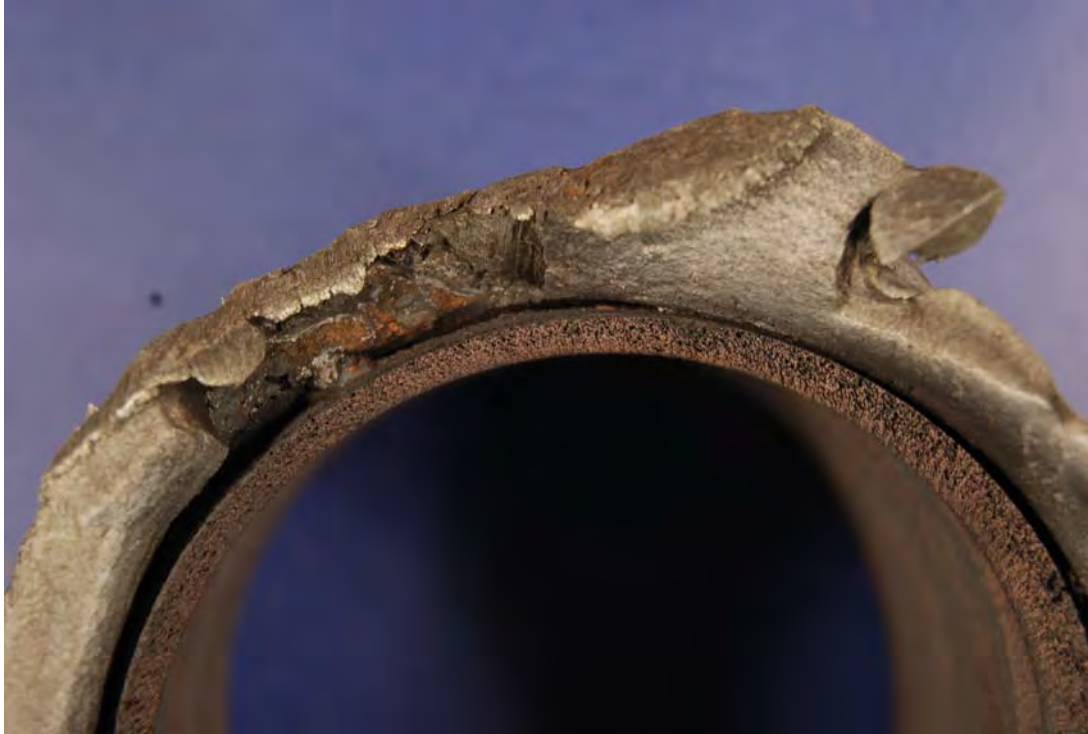
30. Close-up of Tube 10 showing poor weld

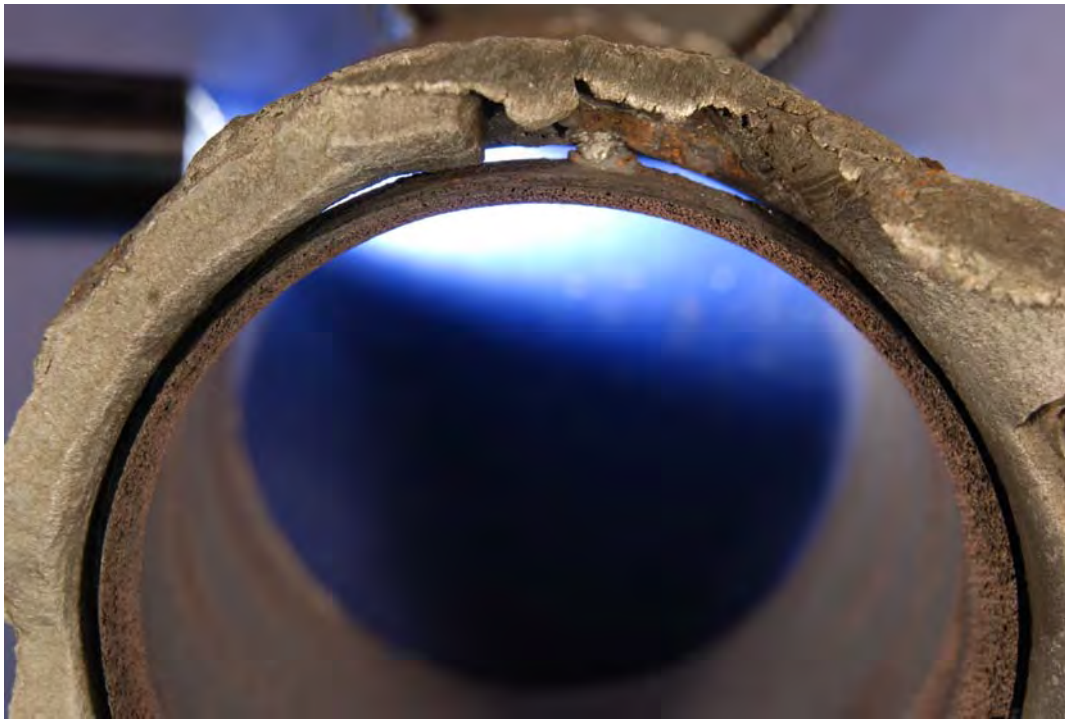
31. Close-up of Tube 10 showing poor weld

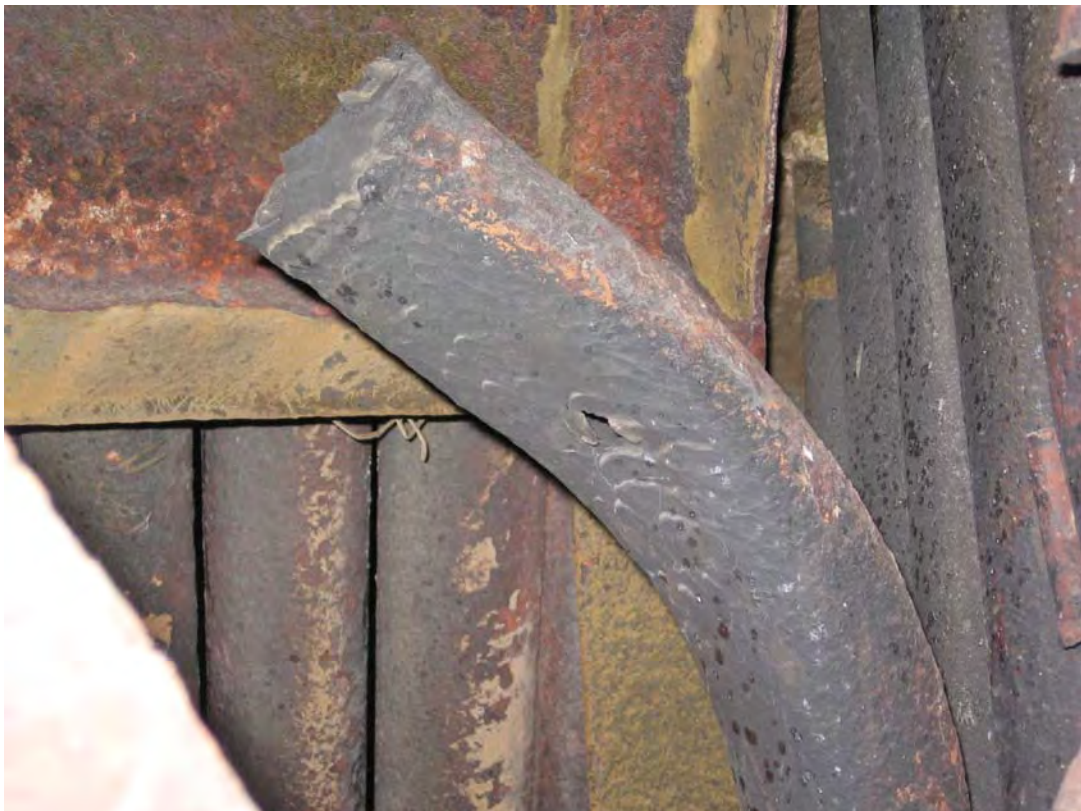
33. Tube 10 showing damage from steam / water impingement

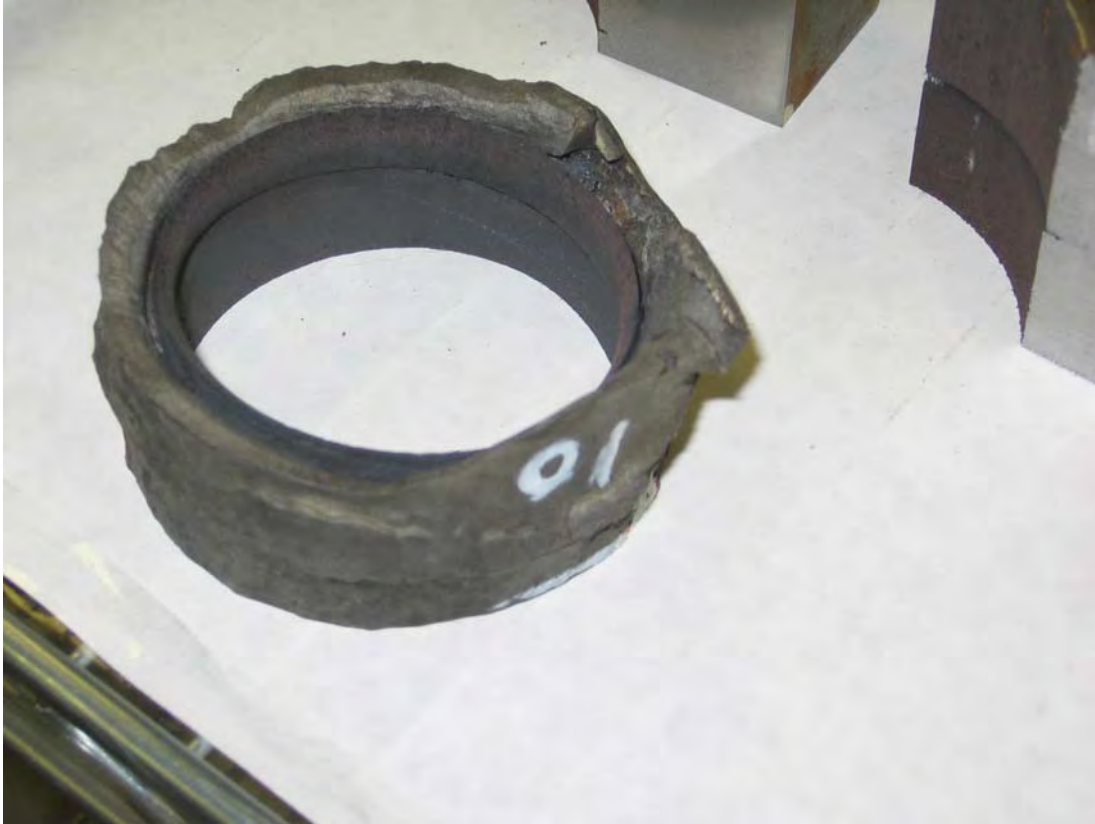
38. Cut away of Tube 10 stub (with bad weld)

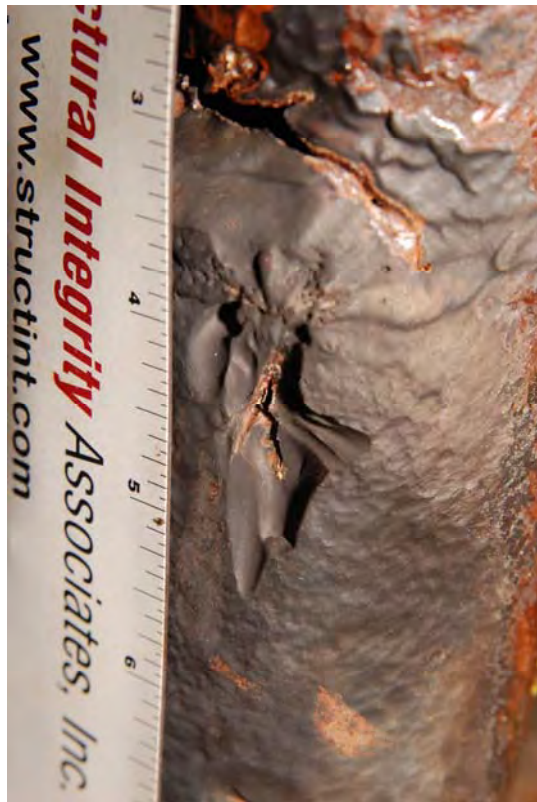
41. Close-up of Tube 9 middle leak

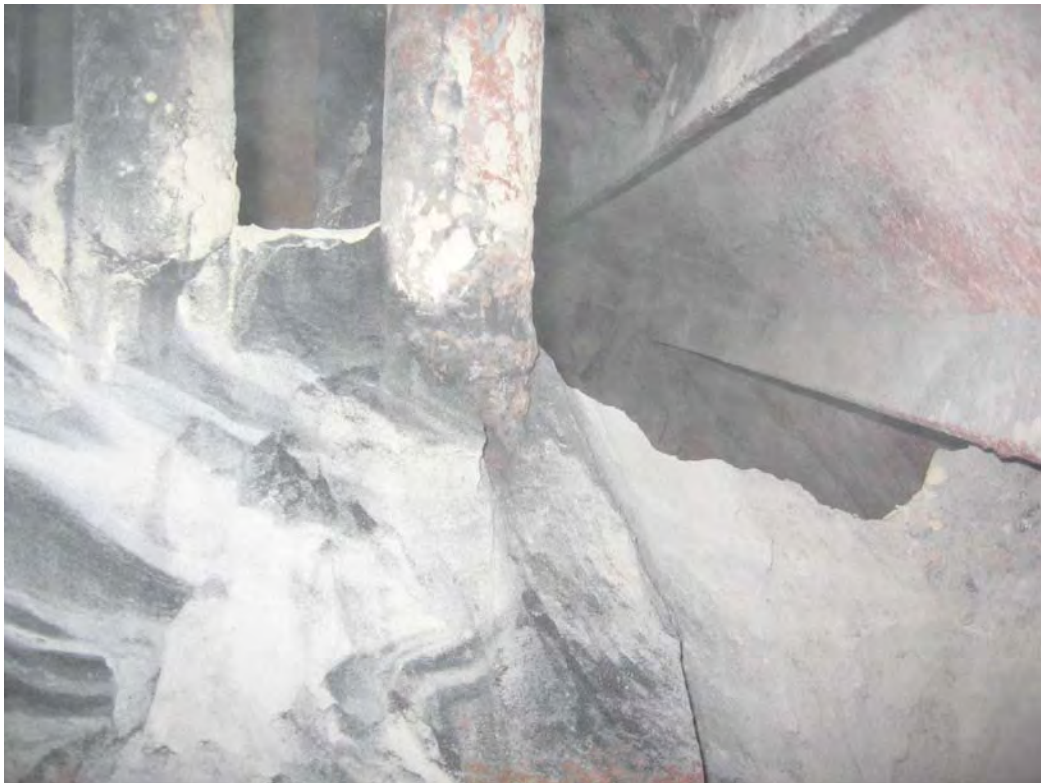
Based on (1) the volume of ash that emptied into the area below the failure, (2) the volume of ash in the west side dead air space, (3) the level of corrosion on the tubes and header in the lower dead air space, and (4) the number of witnesses that confirmed the existence of ash in the lower dead air space, we determined that the lower dead air space was full of ash prior to the failure. To determine the volume of ash that was in the east dead air space in relation to the space, the DPS gained access to the dead air space opposite the space the failure occurred in. This space was virtually a mirror image of the area in which the failure occurred and was under the same operating conditions. This space (west side dead air space) could not be entered because of the heavily packed ash filling the space and blocking the entrance. The DPS ordered a channel in the ash, within the west side dead air space, be dug to gain a better view the current conditions of the space. The ash in the space was a mixture of fine ash and hardened solid rocklike form. The solid ash was broken up with poke rods and shovels and vacuumed out of the space. Mooney observed the space to be nearly full of ash, with the west side division wall header (directly opposite the one that was involved with the failure) completely encased in ash. The header and tubes on the west side had similar corrosion to that found on the east side. (See photos 42 – 53).

**43. West side dead air space before ash is completely removed
Tubes encased in ash going to lower header**

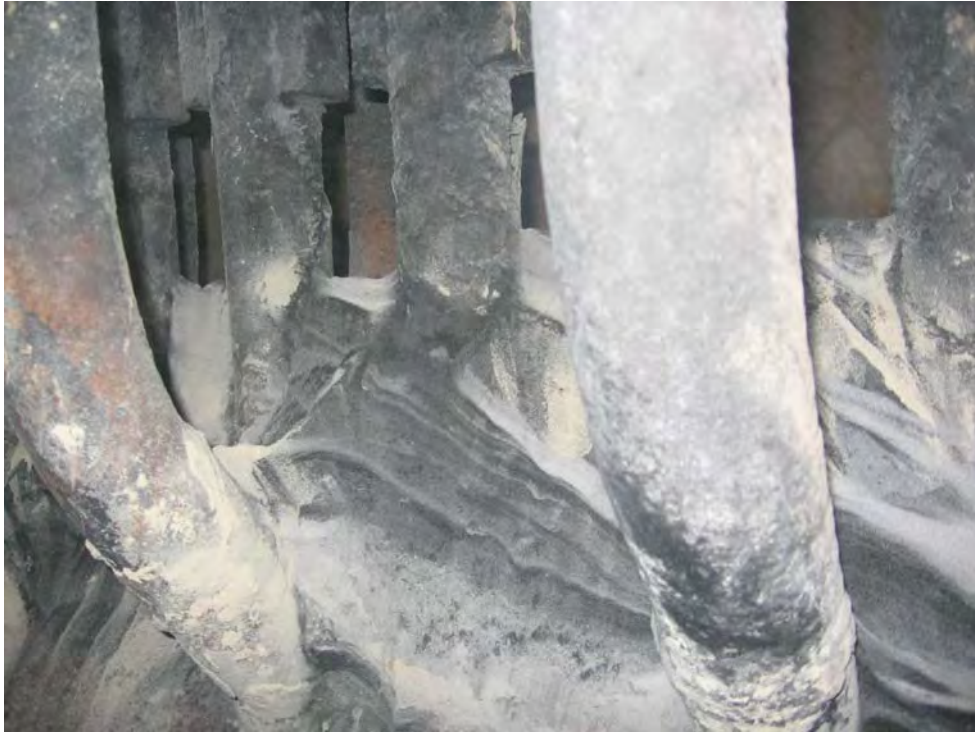
44. West side dead air space. Ash on top of header

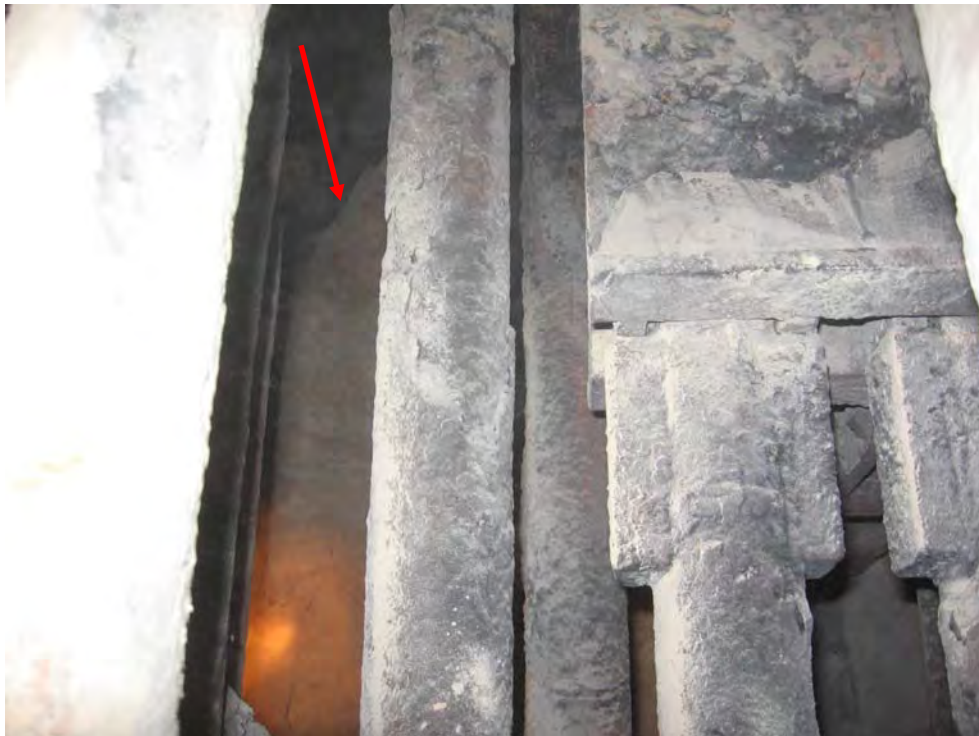
**45. West side dead air space before ash is completely removed
Note level of ash behind tubes.**

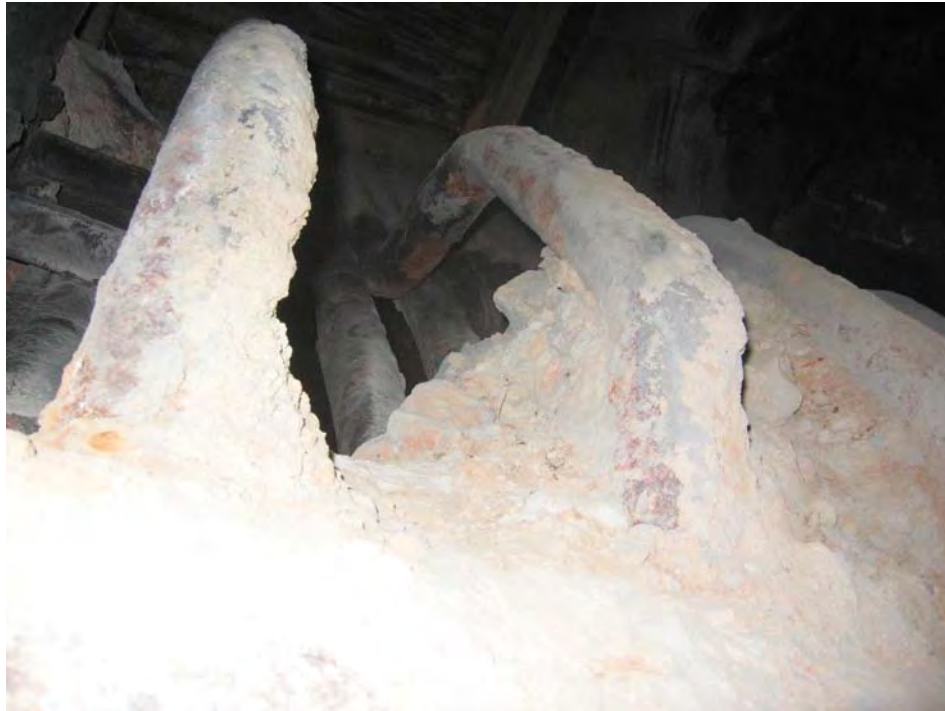
**48. West side dead air space before ash is completely removed
Note impacted ash between tubes above header (buried)**

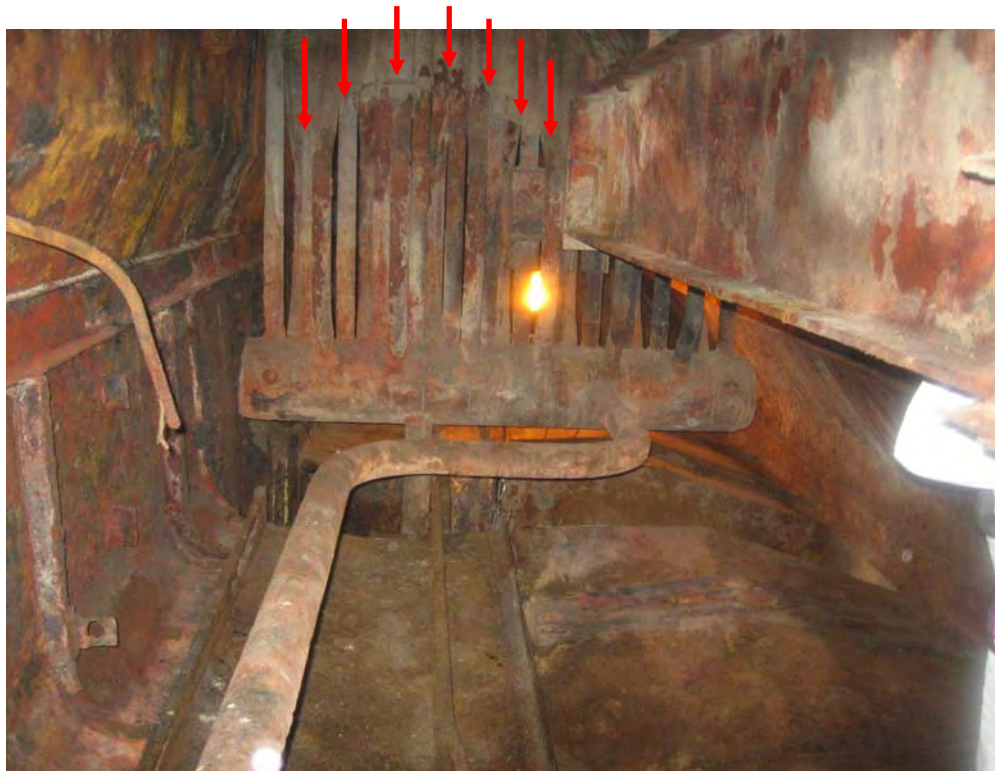
**49. West side dead air space after ash is removed.
Prior level of ash is evident on division wall header**

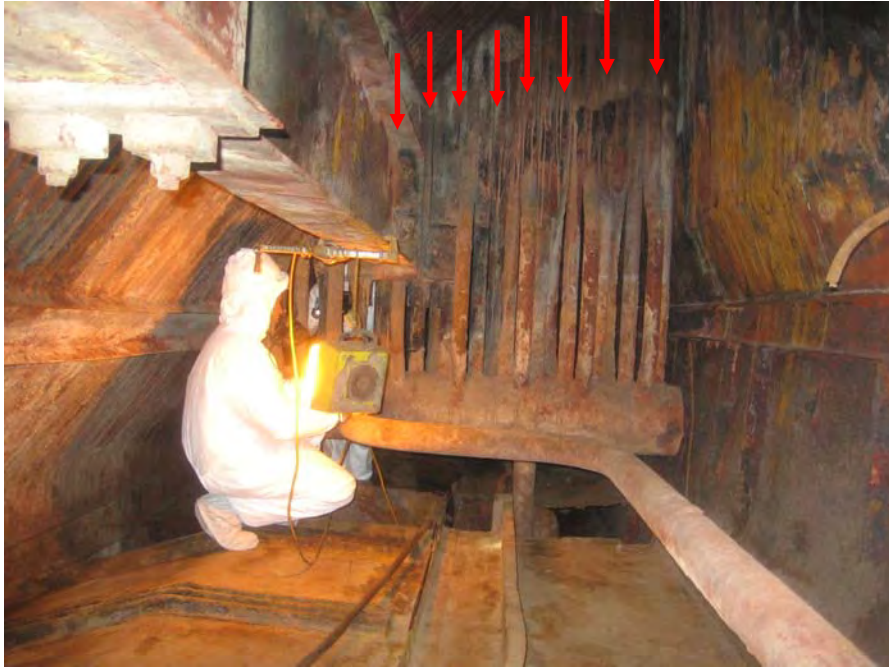
**50. West side dead air space after ash is removed.
Prior level of ash is evident on division wall header**

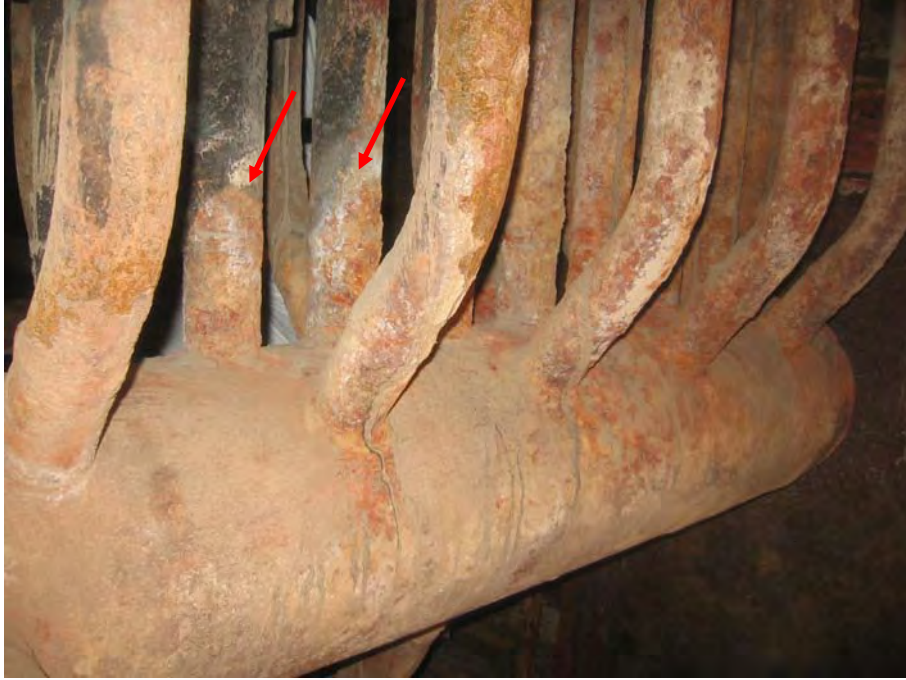
**52. West side dead air space after ash is initially vacuumed out.
Difference in corrosion in tubes closest to header**
