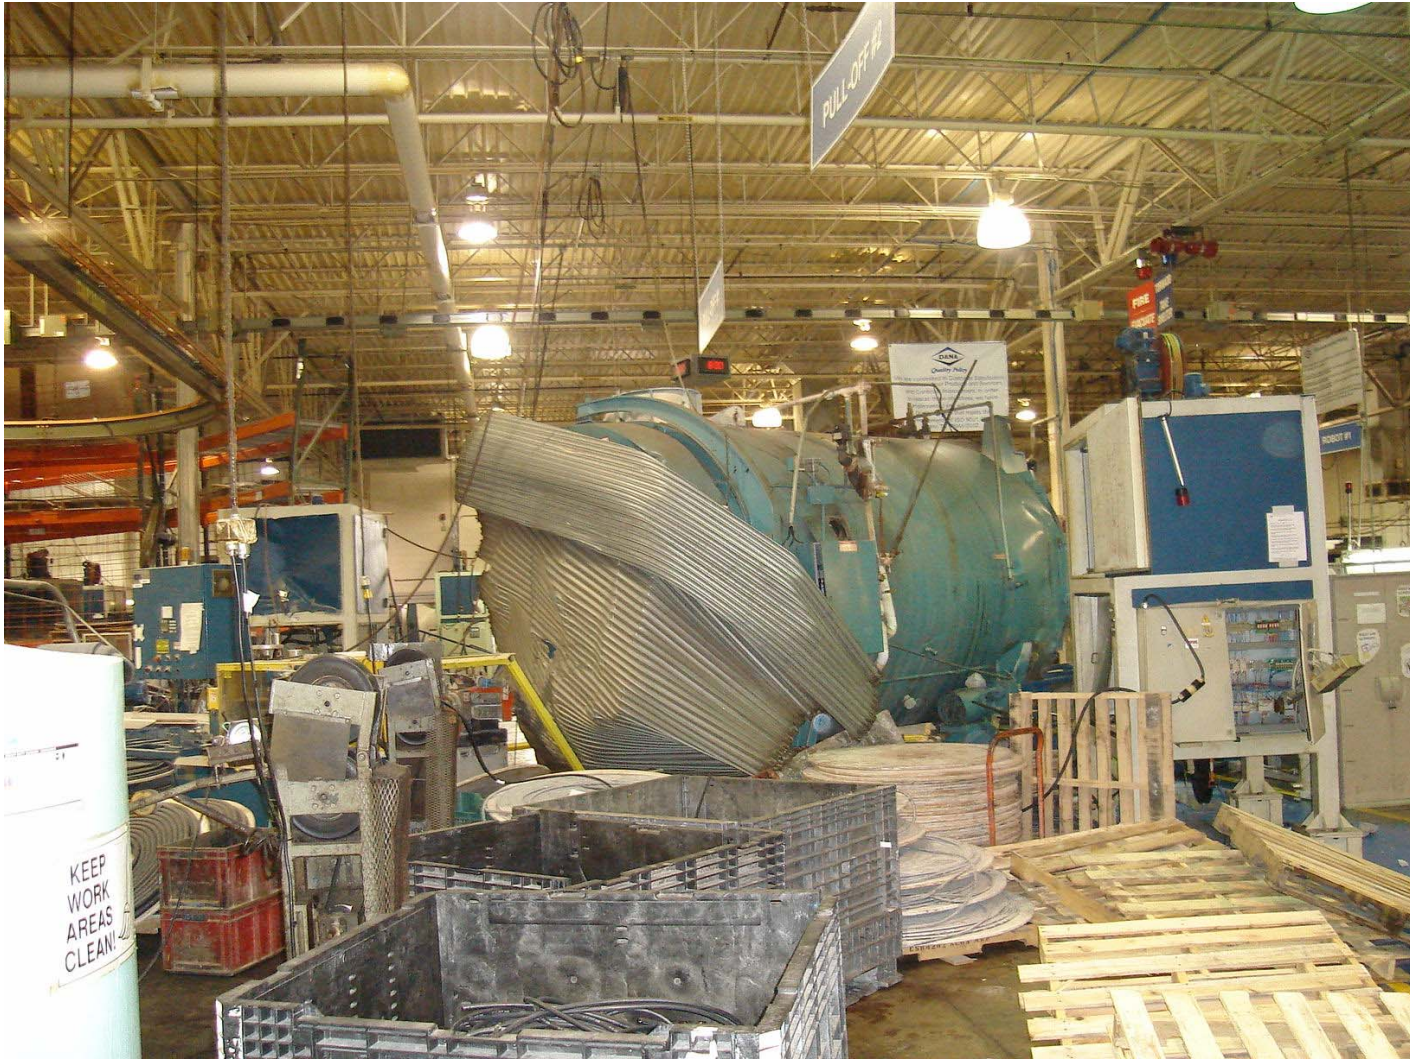
Photo #1 – Final Location of Boiler after Explosion (Roll Up Door on Boiler)

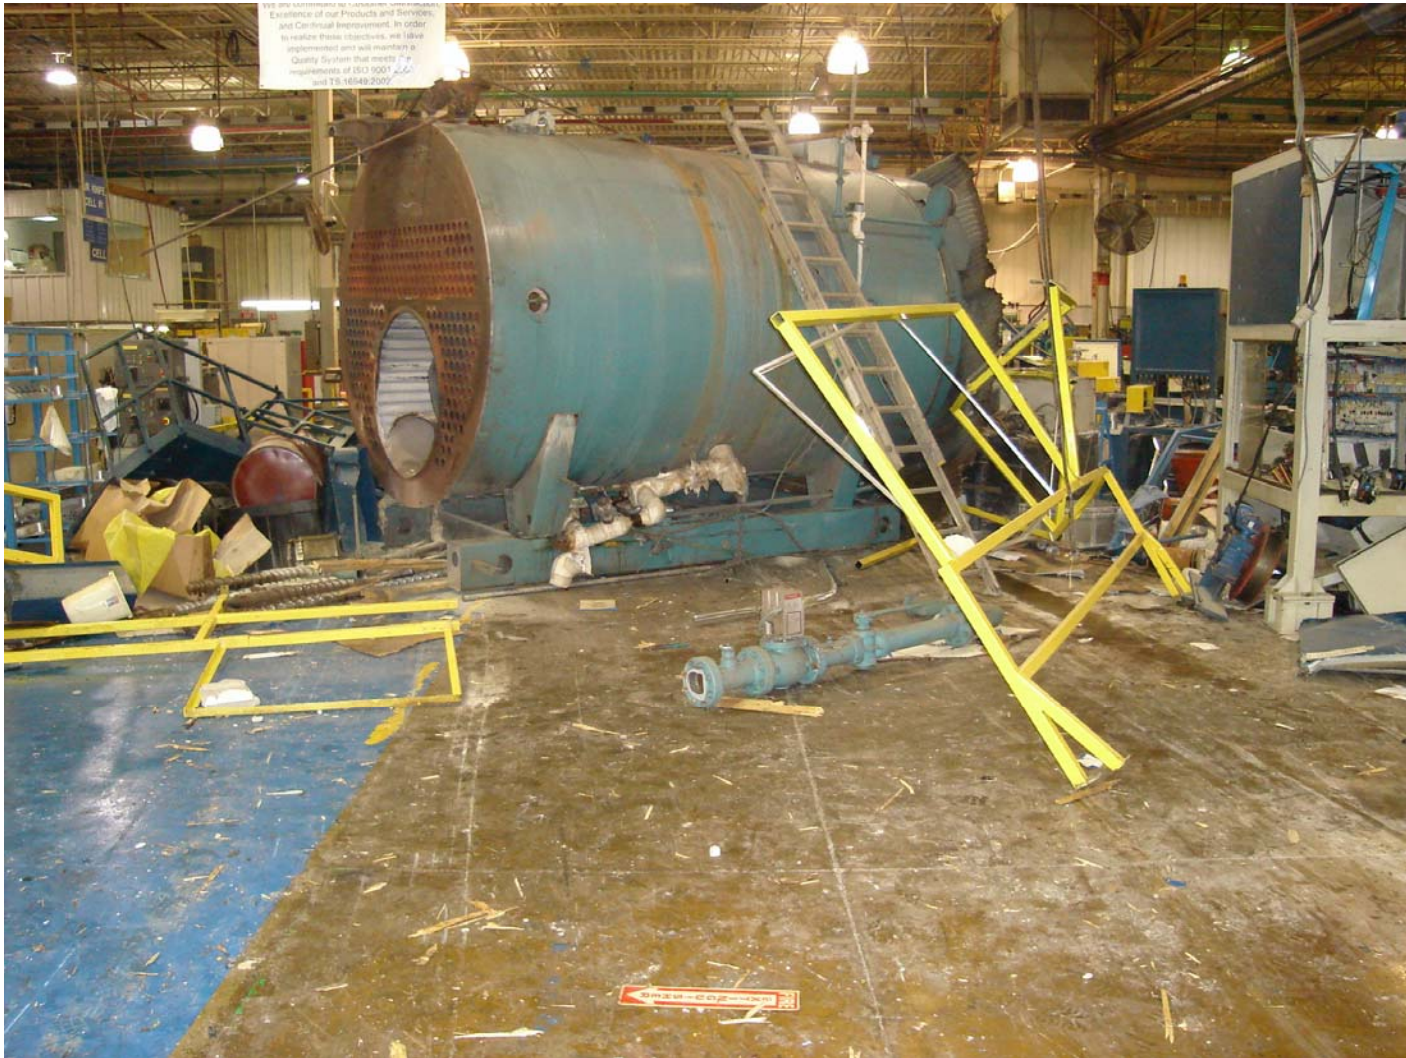
Photo #2 – Final Location of Boiler After Explosion

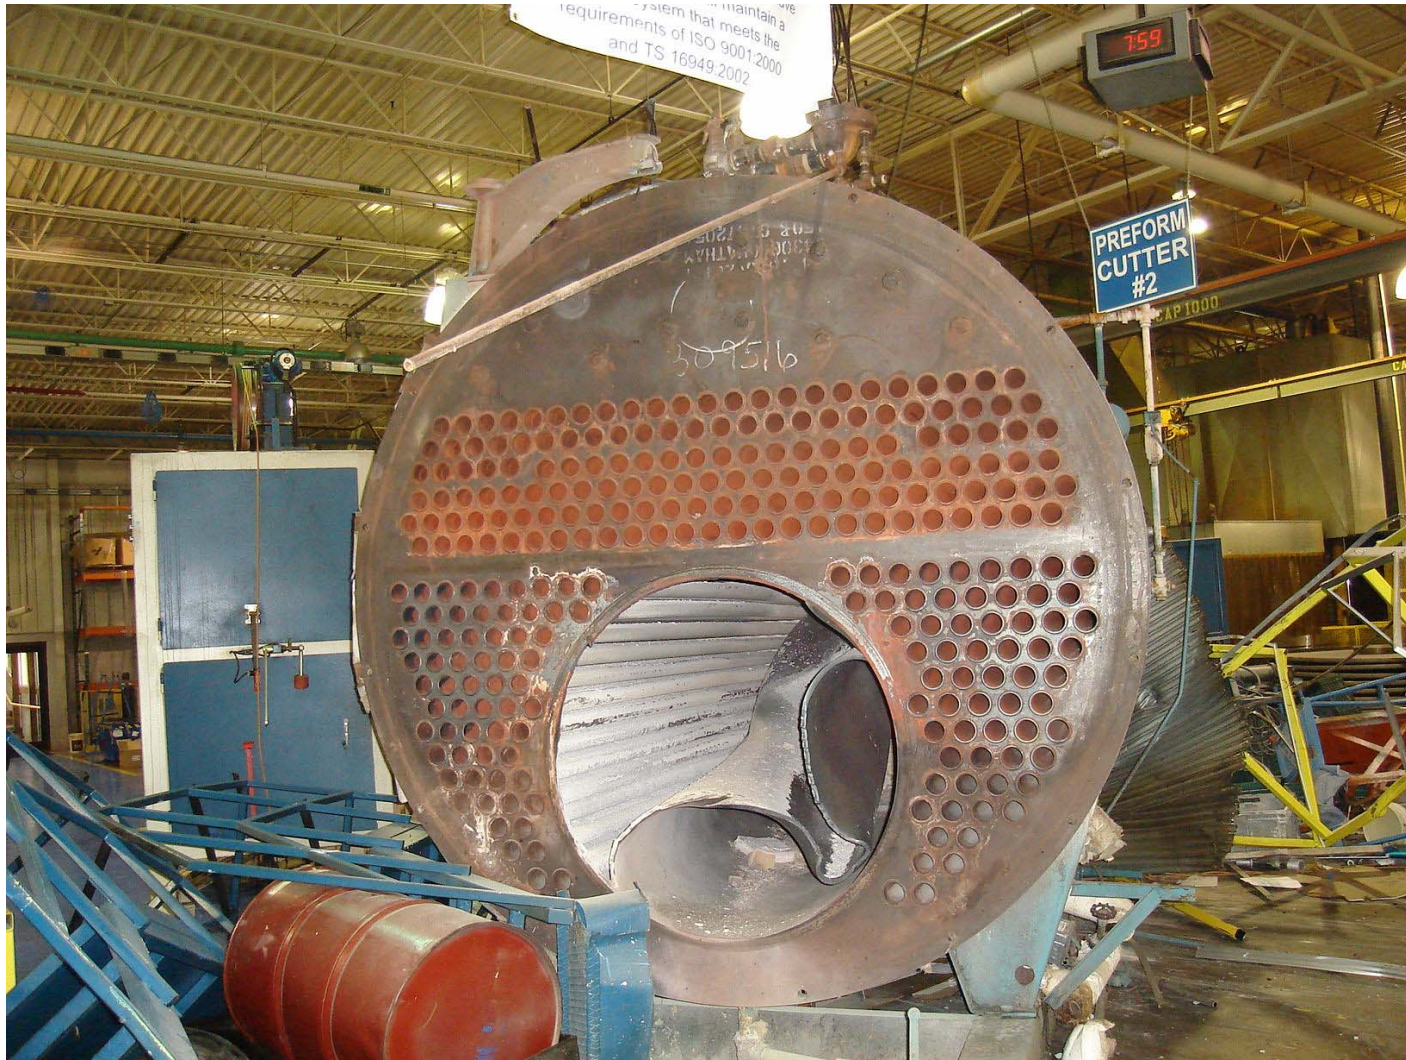
Photo #3 – Final Location of Boiler after Explosion (Exposed Furnace Tube)

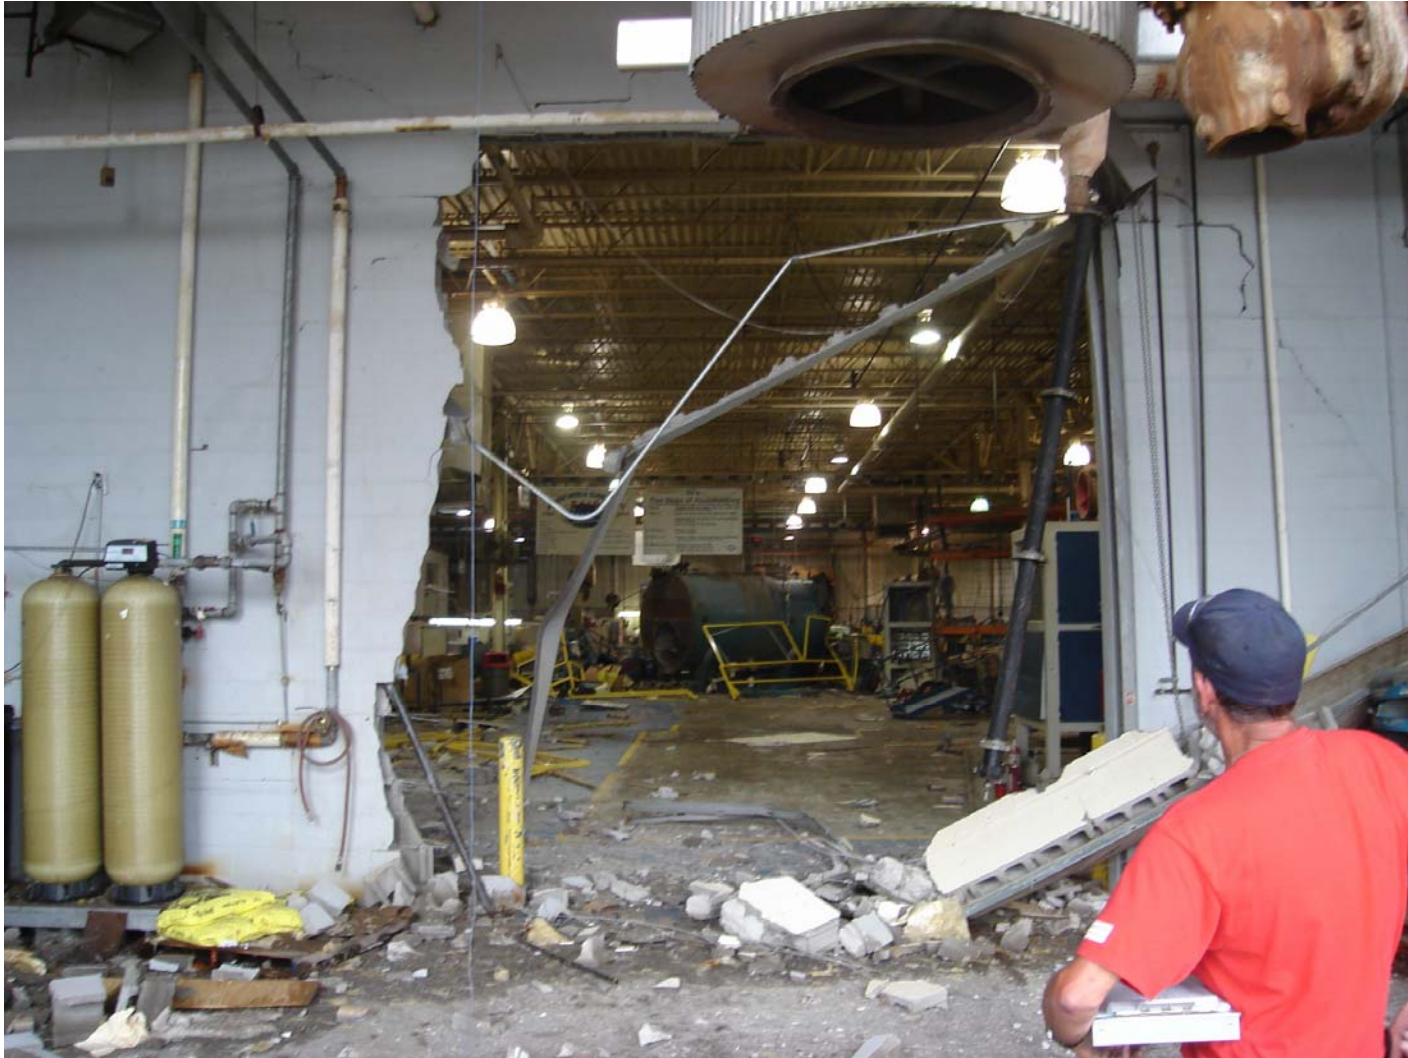
Photo #4 – Hole Created by Boiler through Roll Up Door Wall (West Wall)

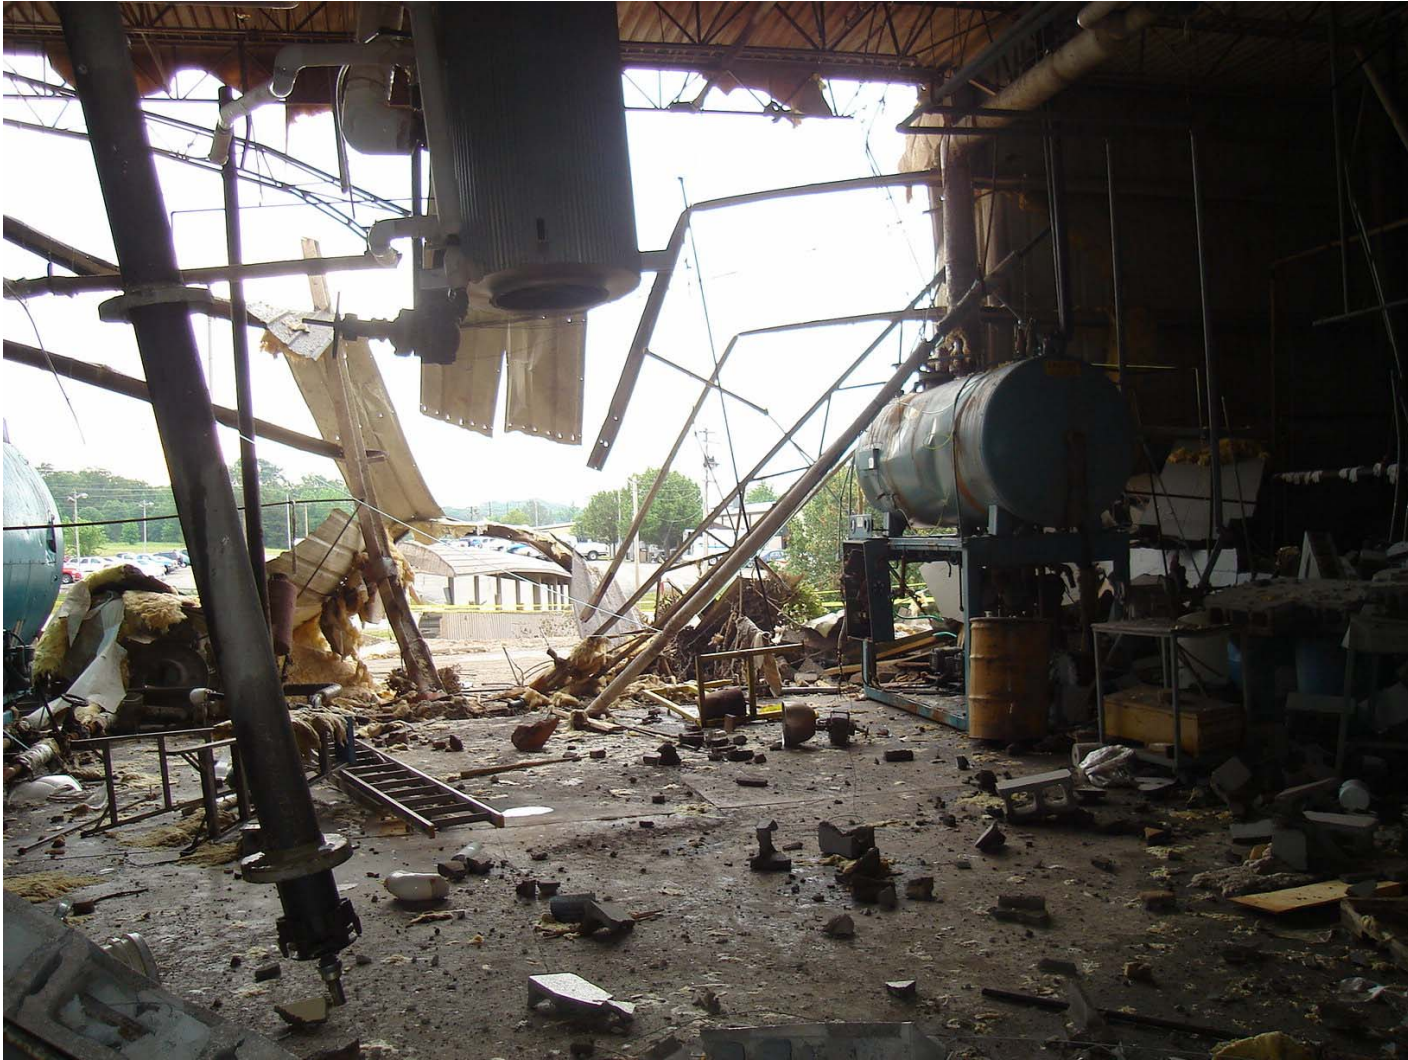
Photo #5 – Knocked Down Exterior Wall Viewed from Inside Boiler Room (East Wall)

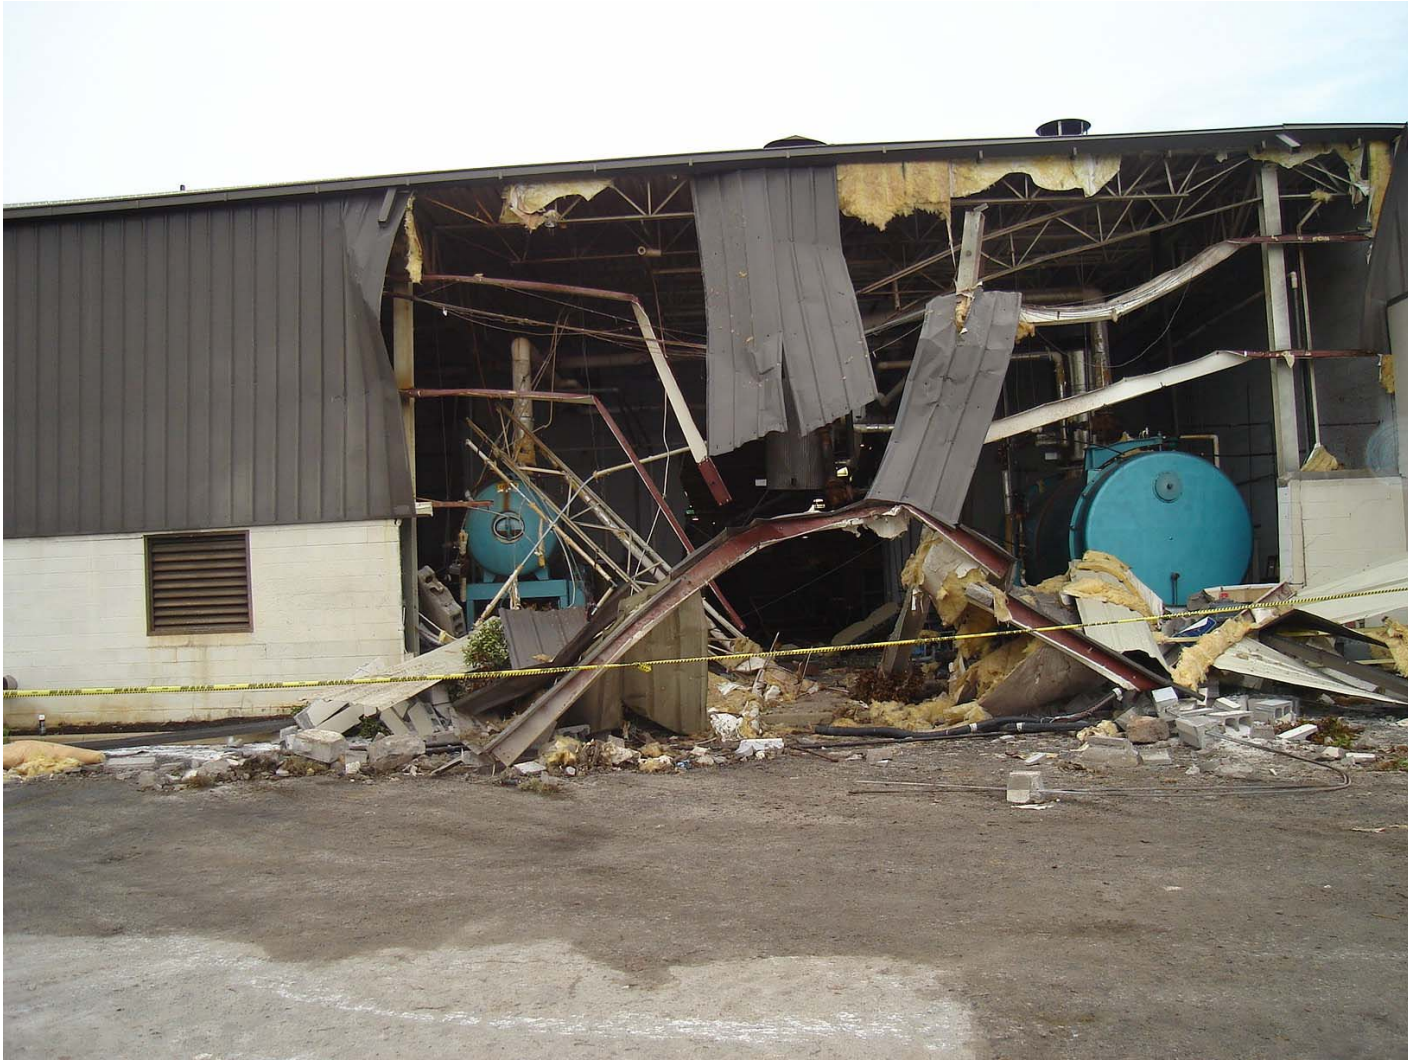
Photo #6 – View of East Wall from Outside Plant

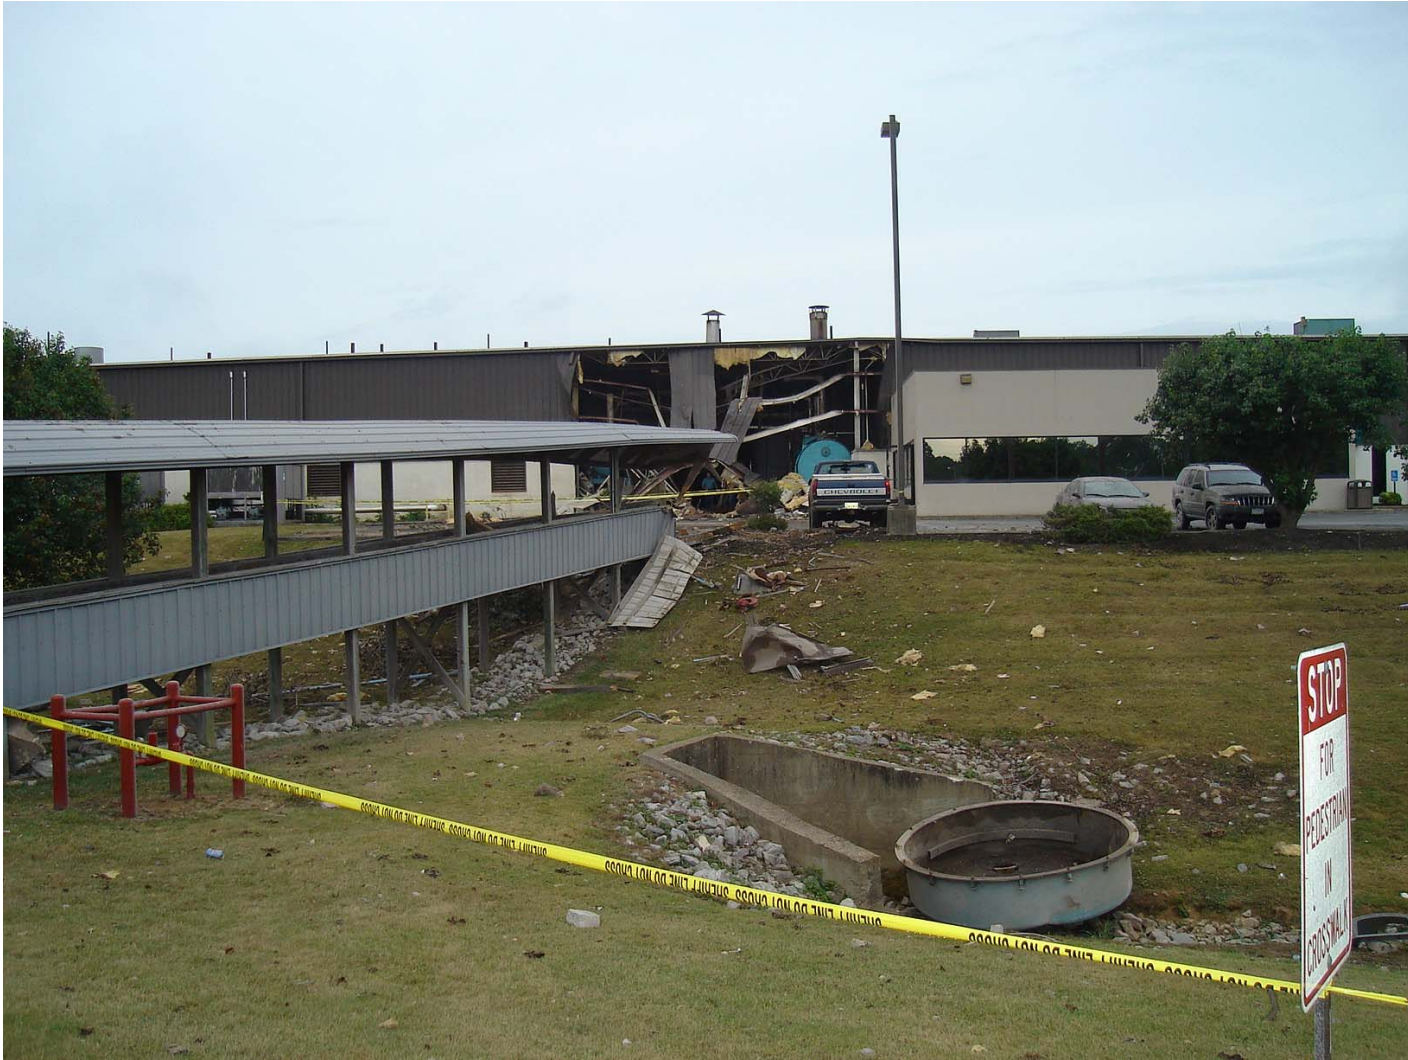
Photo #7 – View of East Wall from Outside Plant (Note Rear Boiler Door in Ditch)

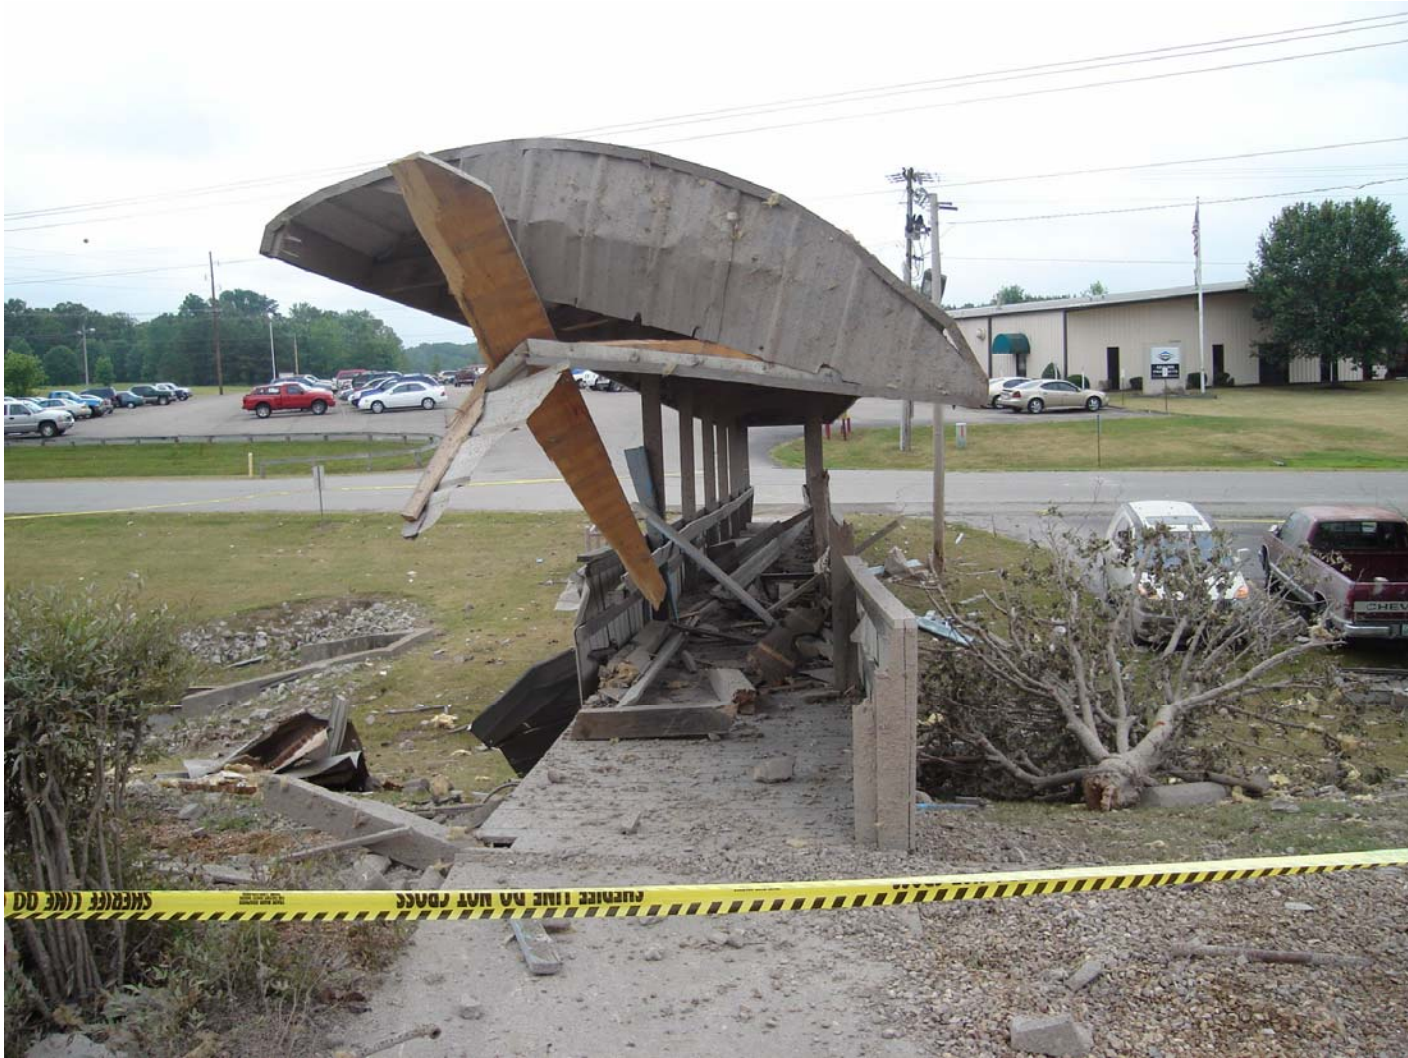
Photo #8 – View of Pedestrian Walkway Bridge

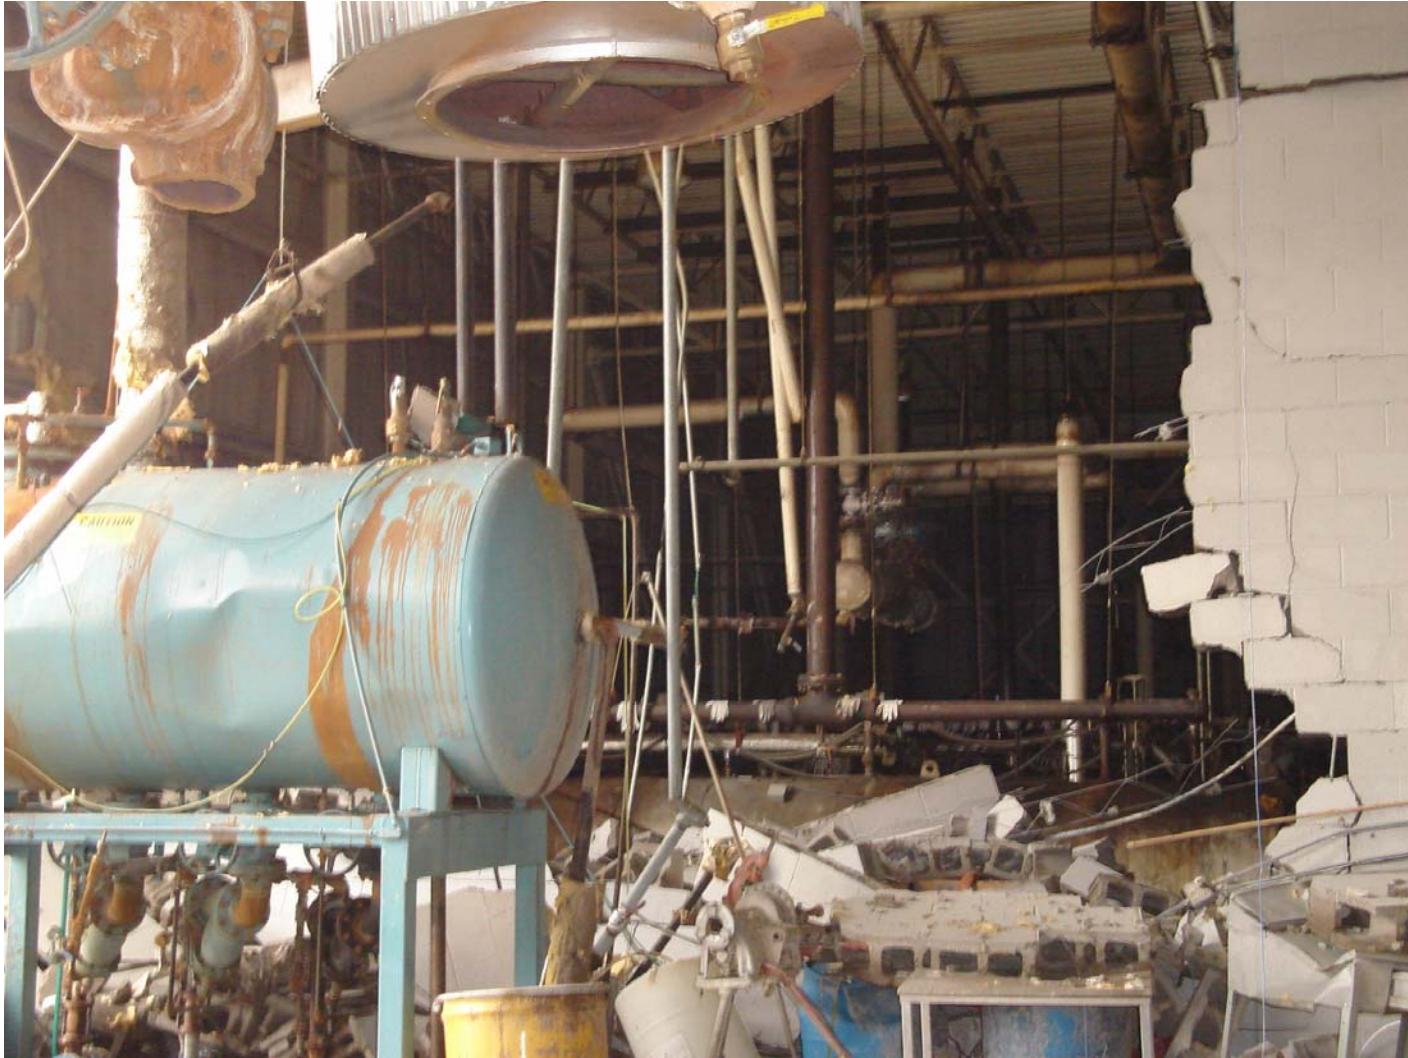
Photo #9 – Interior Wall of Boiler Room (South Wall)

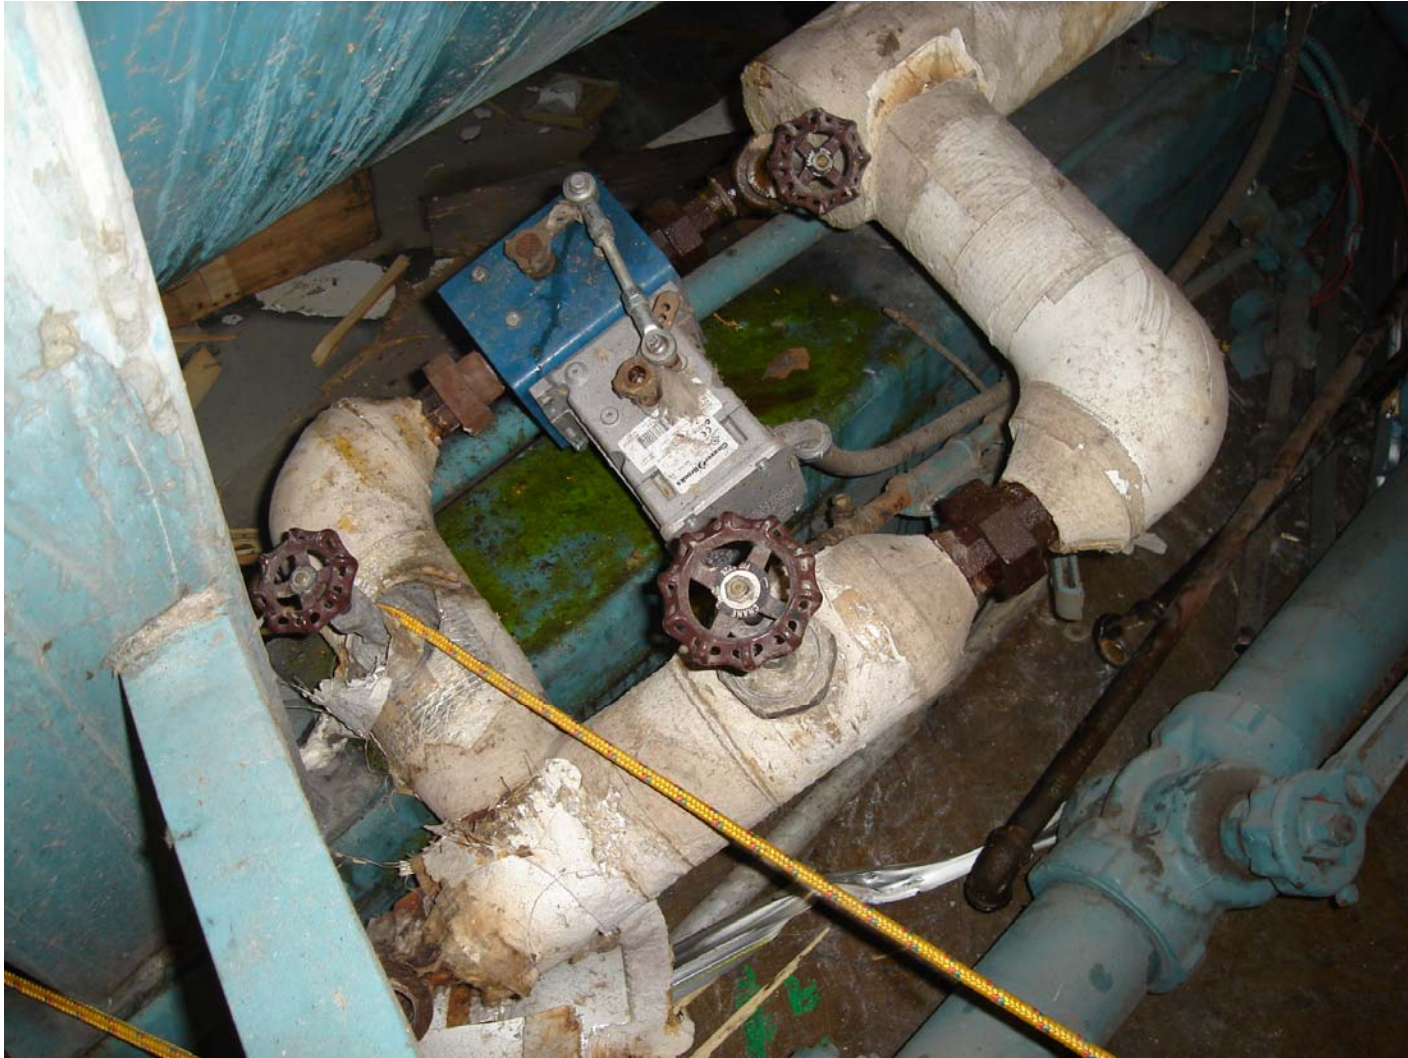
Photo #10 – Modulating Feed Controller, Valve, and Bypass (Note Disconnected Operating Arm)

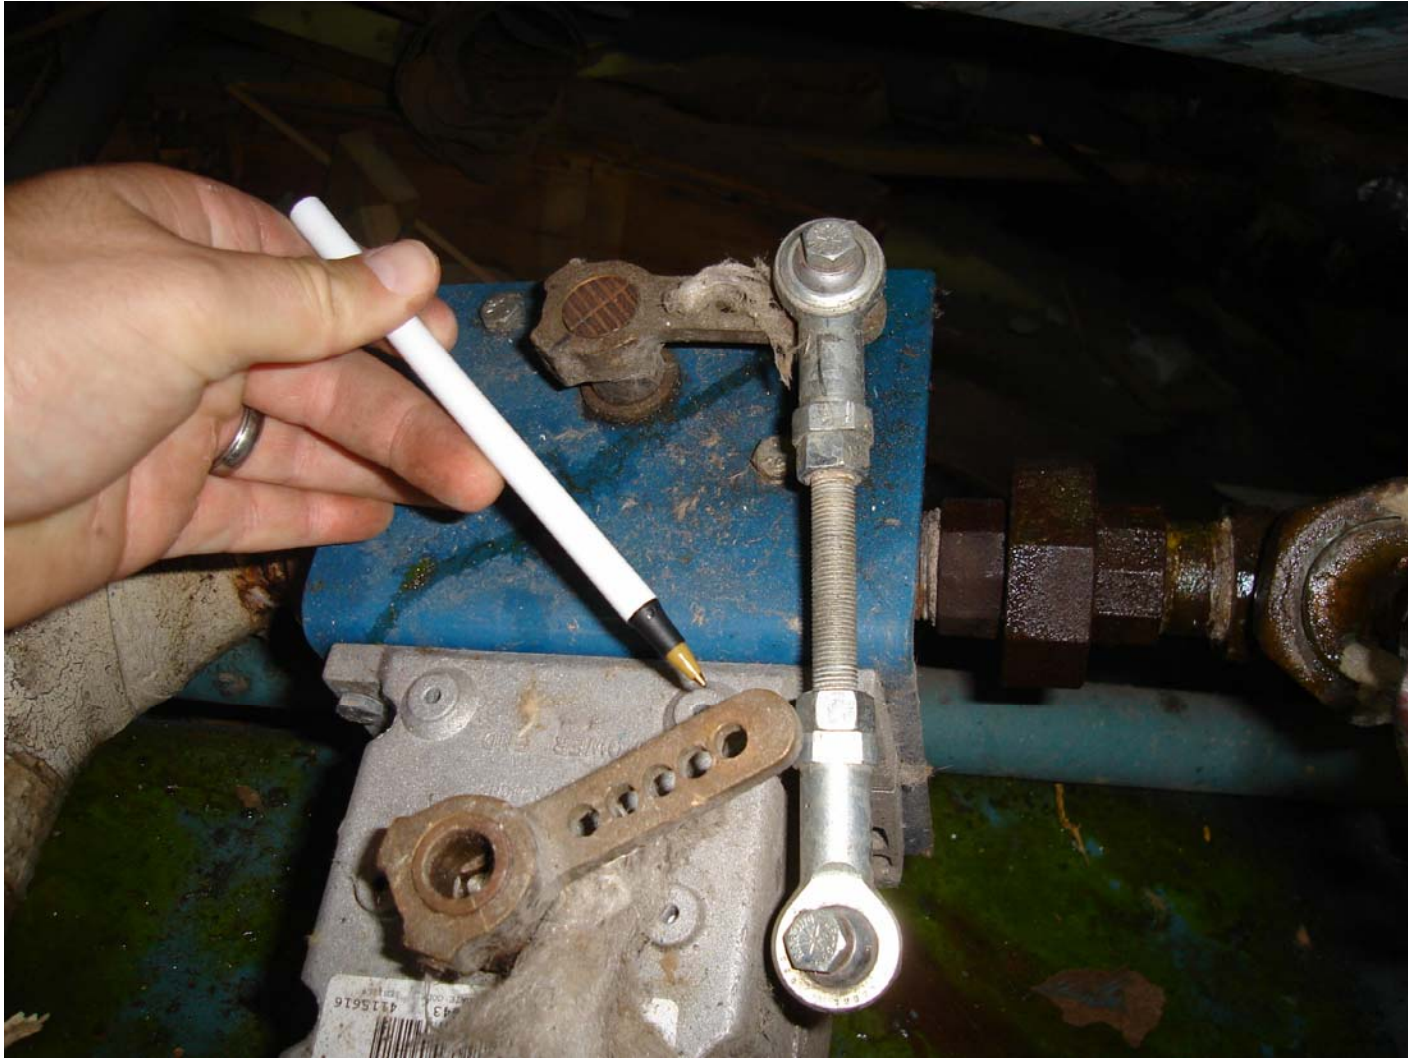
Photo #11 – Modulating Feed Controller and Valve with Disconnected Operating Arm

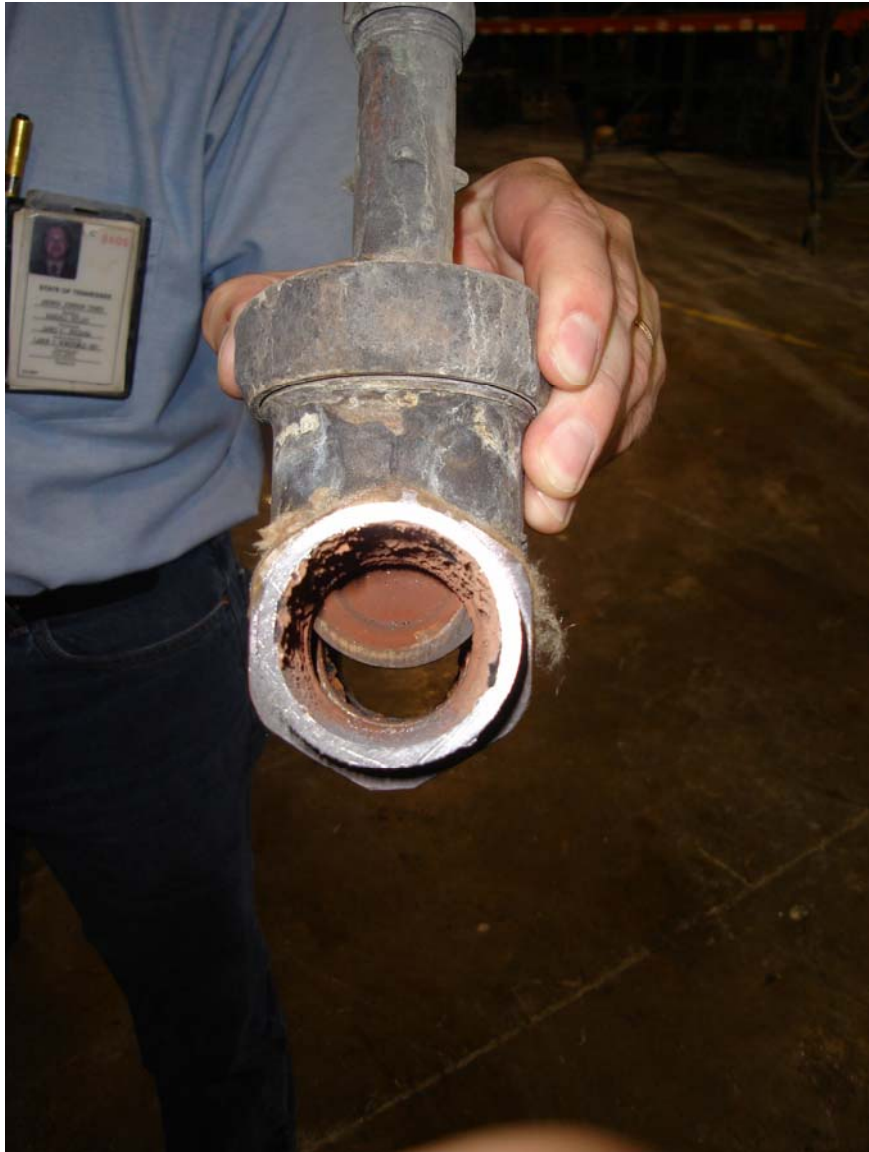
Photo #12 - Bypass to the Modulating Feed Valve. Valve was found in the half open position.

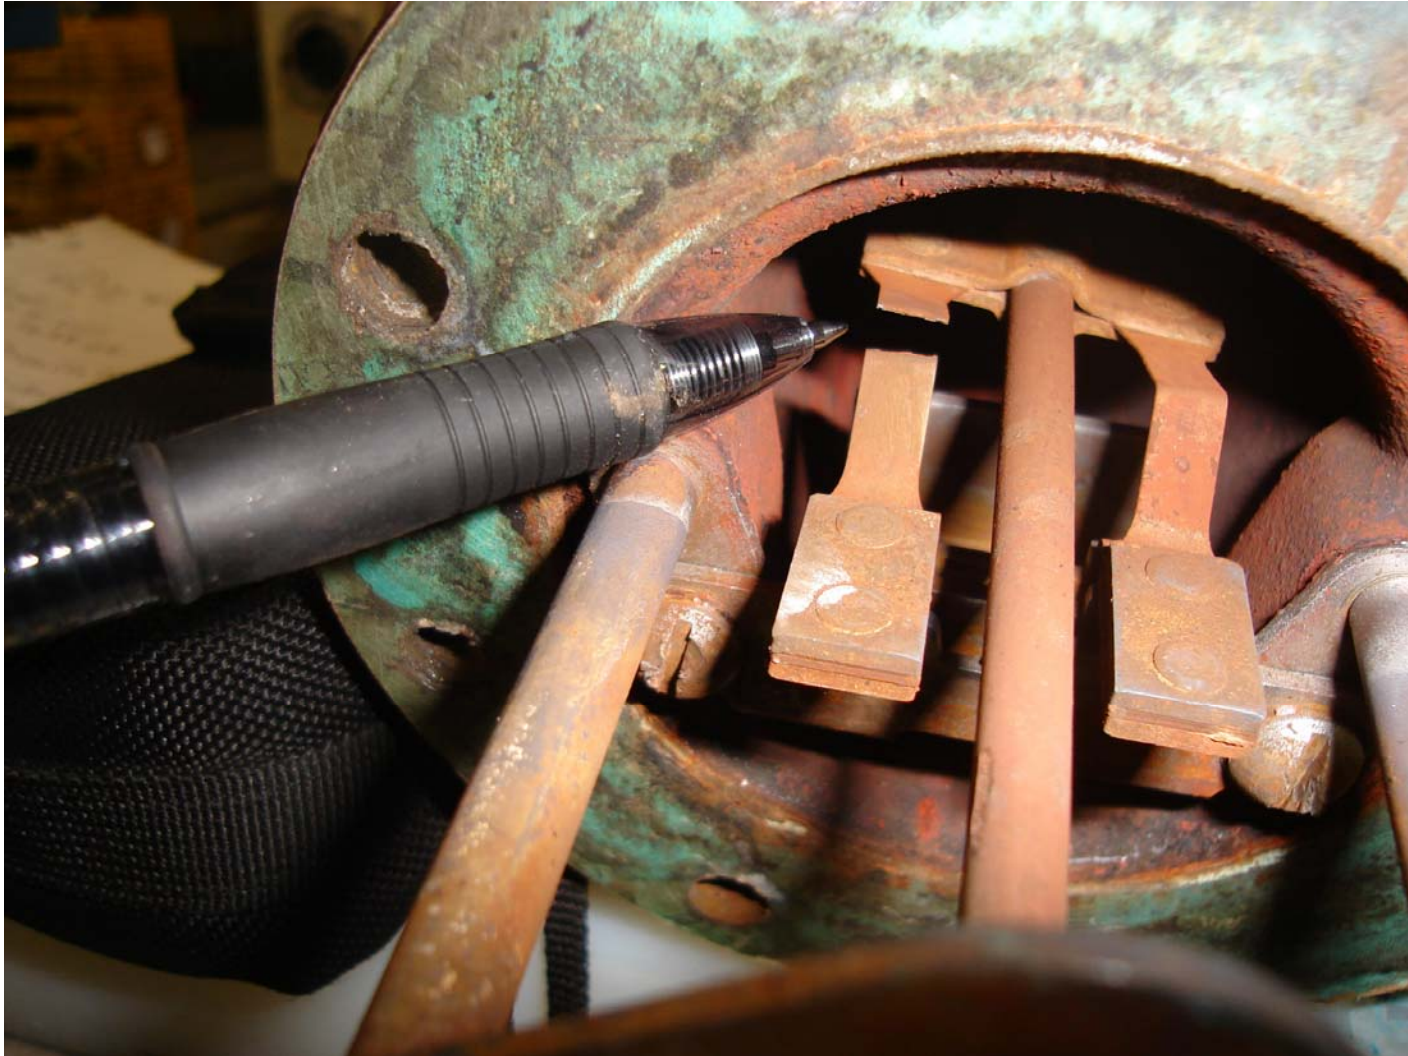
Photo #13 – Bent and Broken Spring on McDonald & Miller (M&M) Series 193-7B Mechanical Combination Low Water Cut-Off/Pump Controller

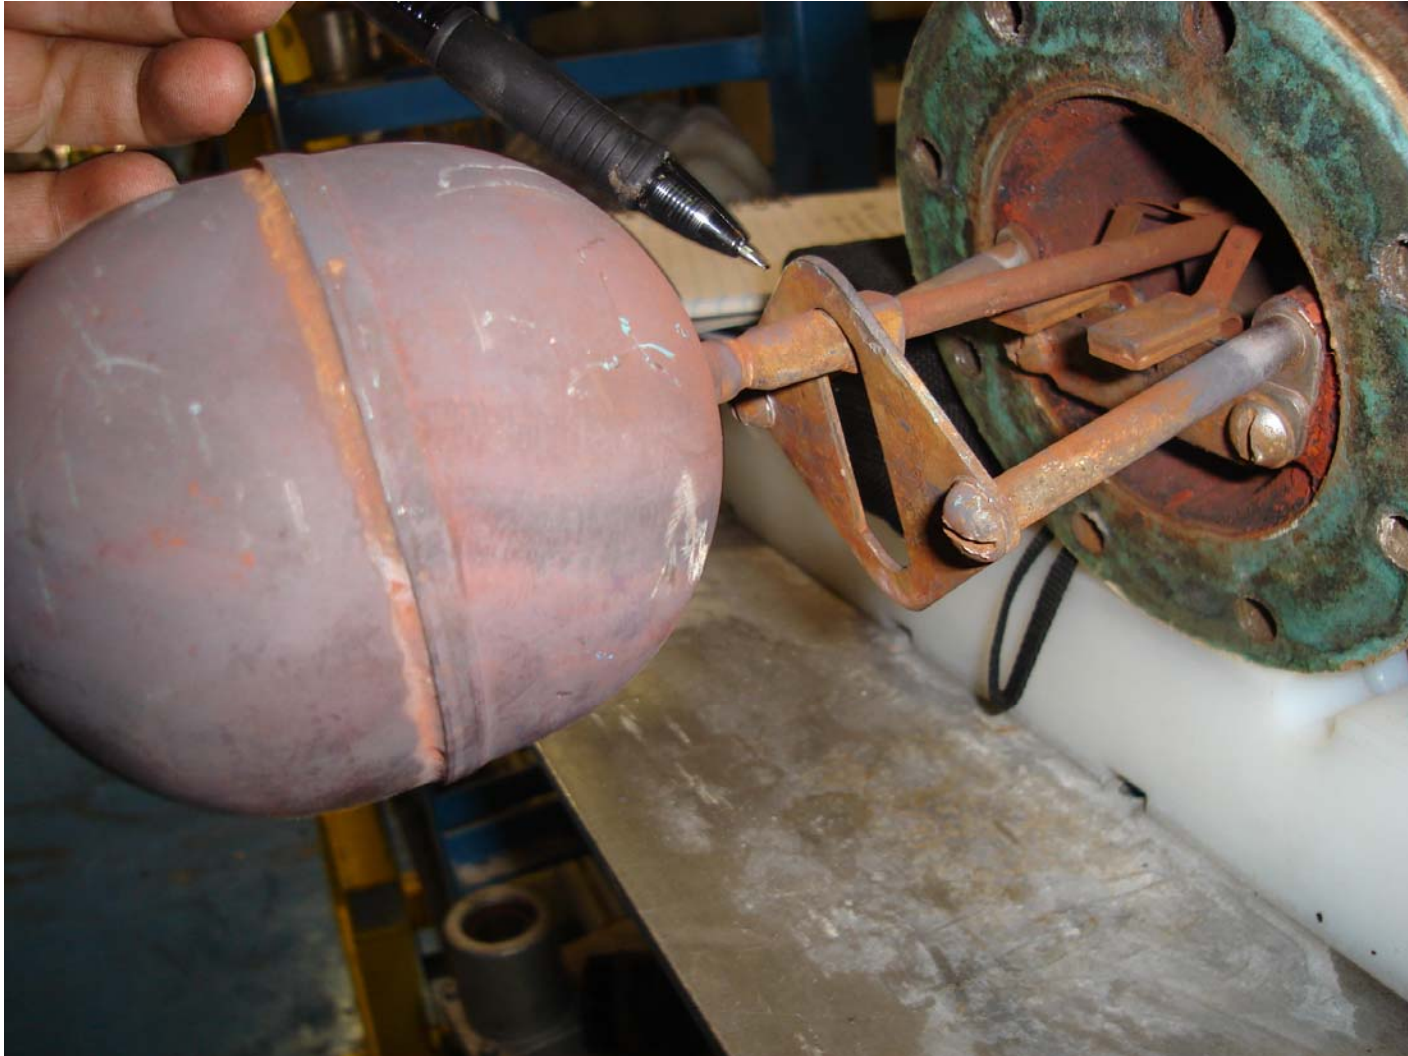
Photo #14 - McDonald & Miller (M&M) Series 193-7B Mechanical Combination Low Water Cut-Off/Pump Controller stuck in the up position

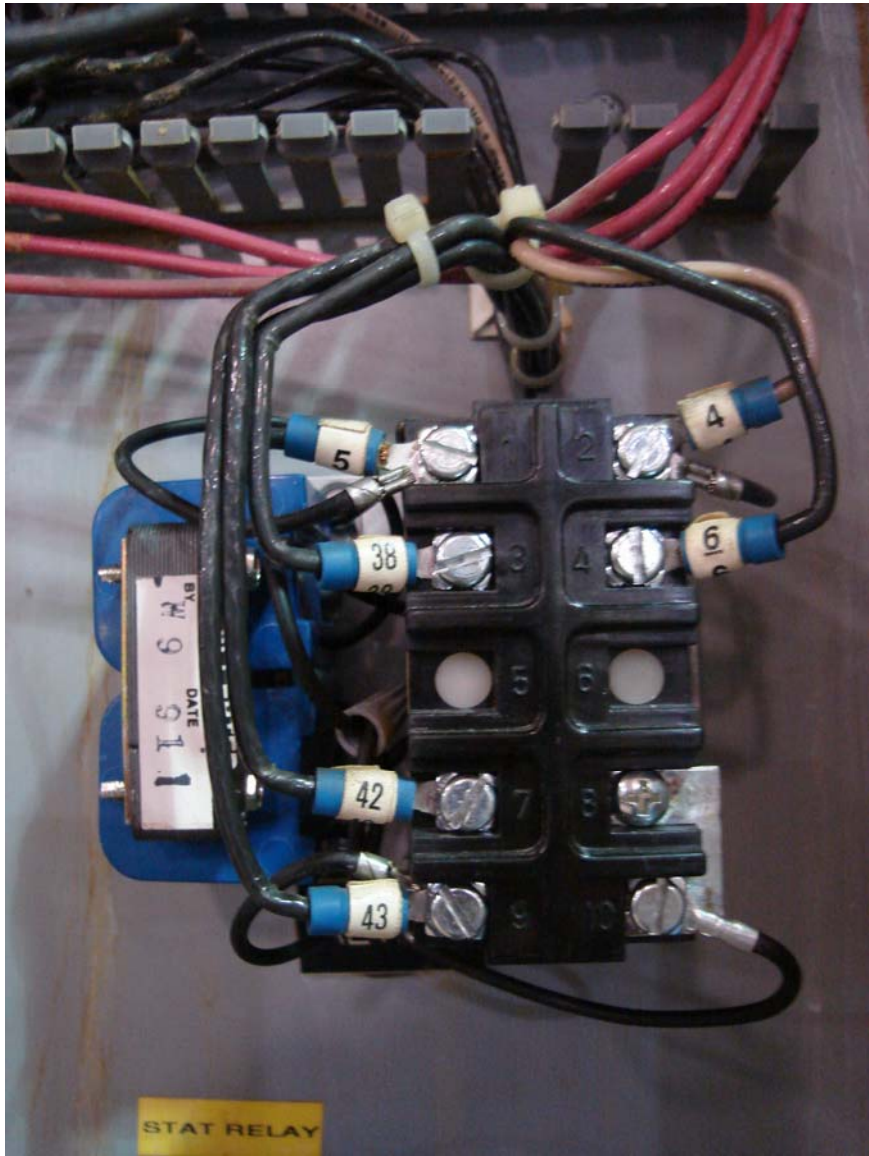
Photo #15 – Improper relay that was installed by Dana Corporation maintenance personnel for the Auxiliary LWCO

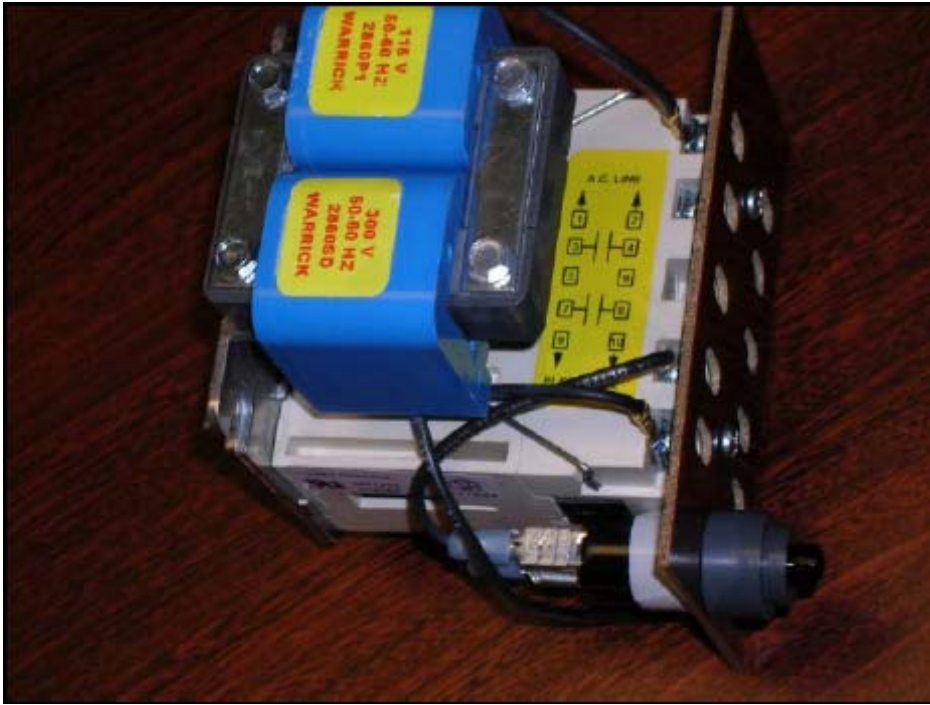
Photo #16a – 1c1d0a Relay with Manual Reset

***Note the difference in the contact configuration diagrams**

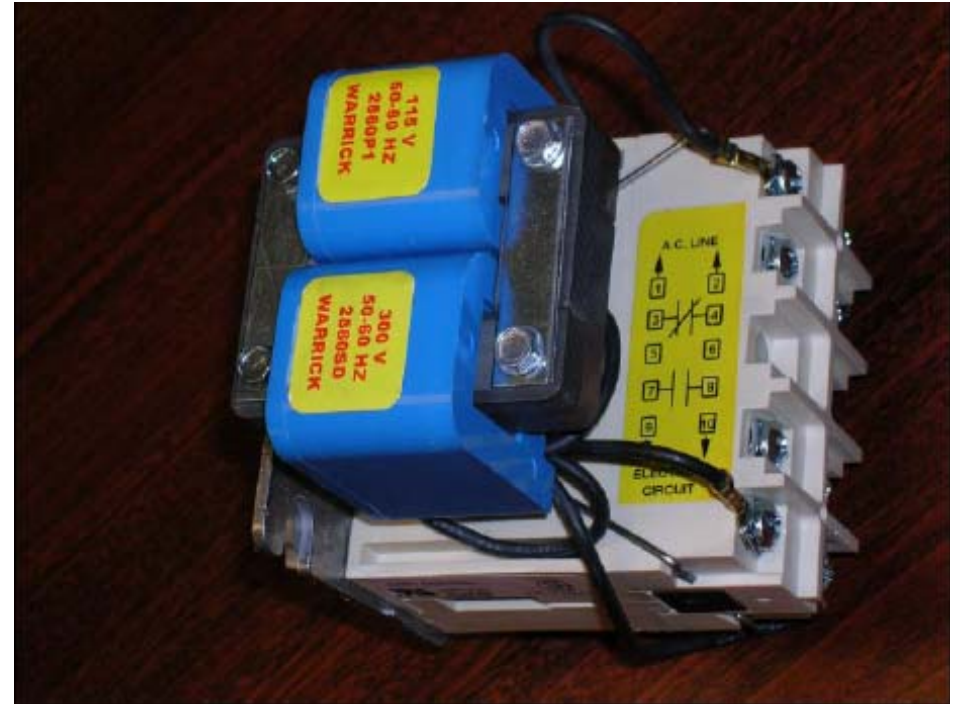
Photo #16b – 1d1d0 Relay without Manual Reset
