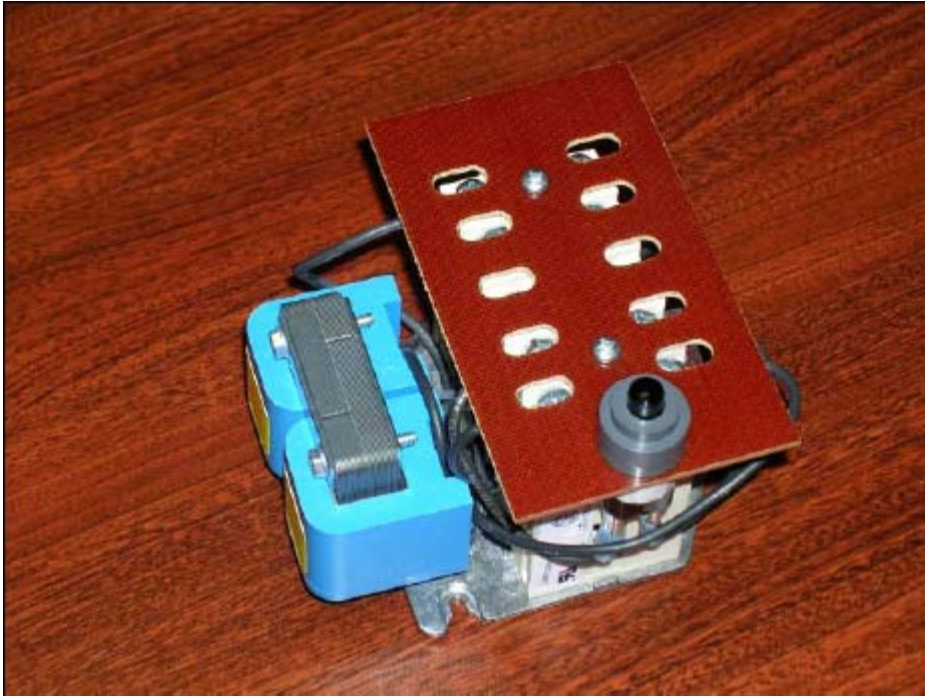
Photo #17a –1c1d0a (Proper Relay with Manual Reset)

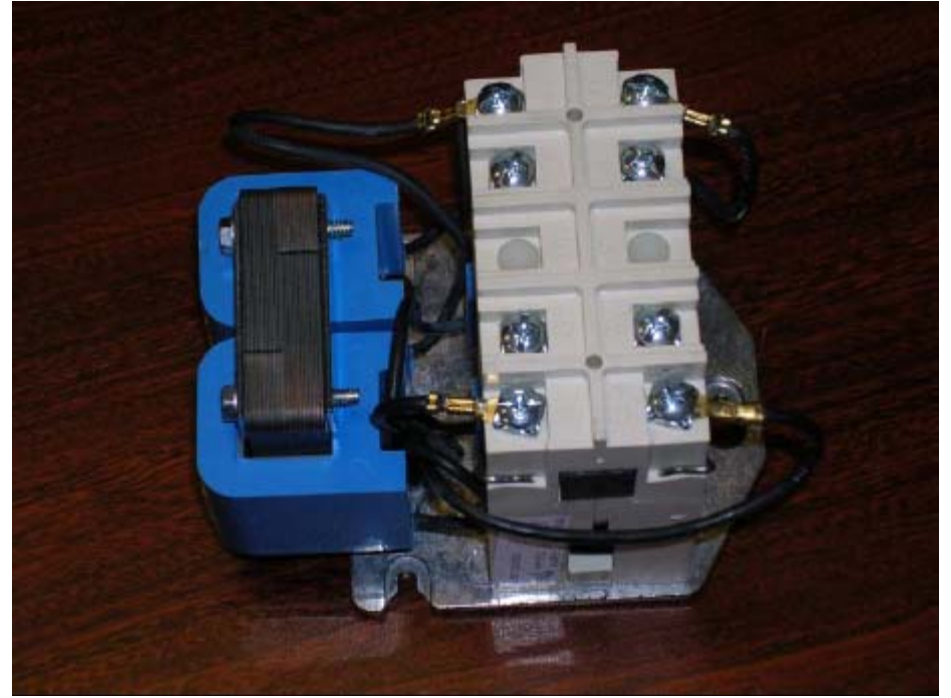
Photo #17b – 1d1d0 (Improper Relay without Manual Reset)
