July 31, 2008

Commonwealth of Massachusetts
Department of Public Safety
INCIDENT REPORT

Dominion Energy New England - Salem Harbor Station
Salem, MA
Boiler #3 Failure - November 6, 2007

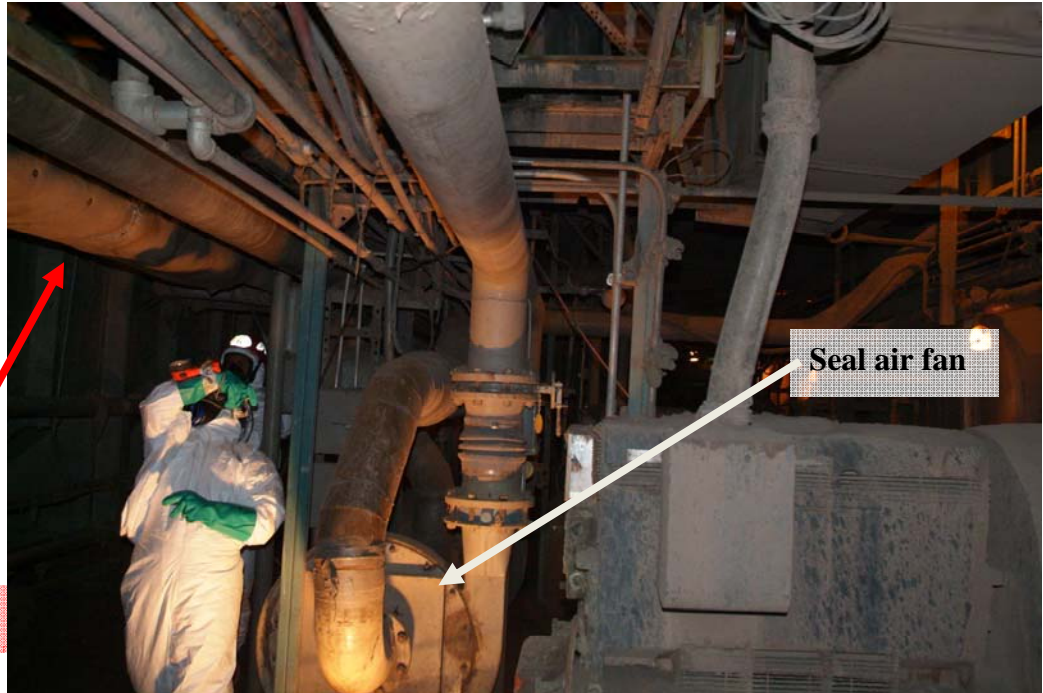
7. Area adjacent to point area below failure (facing south)

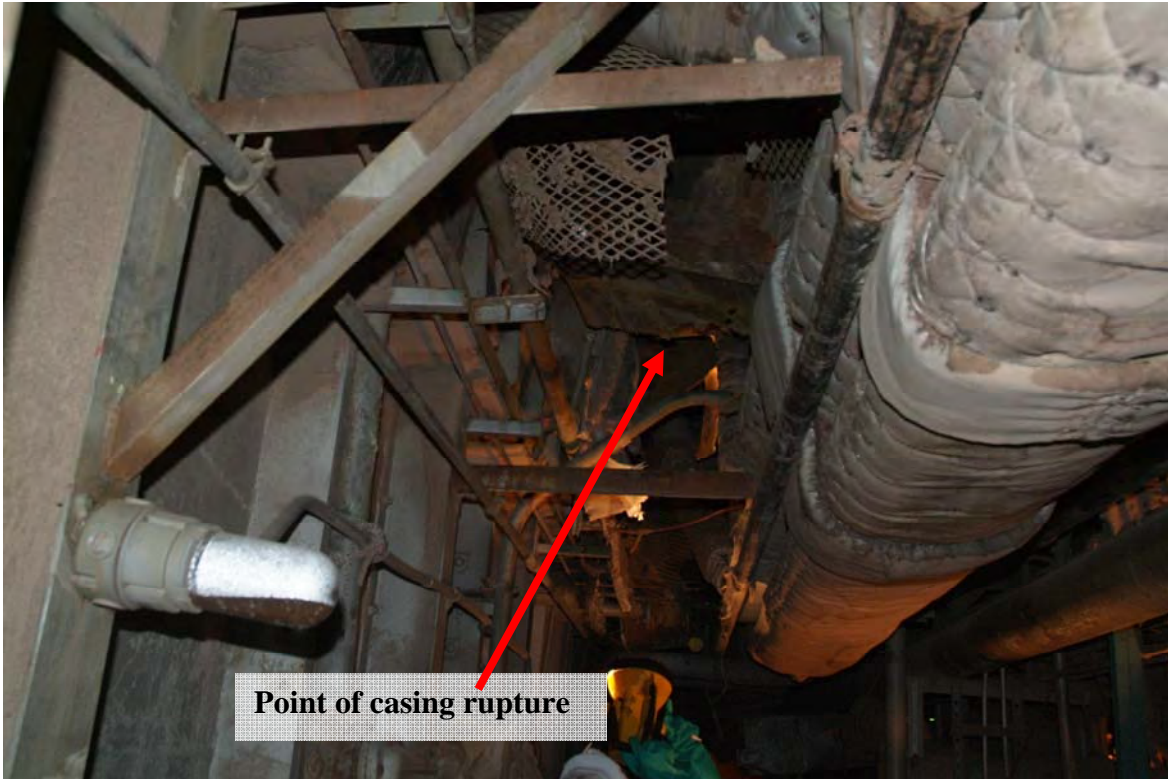
8. Area immediately below casing failure (facing south)

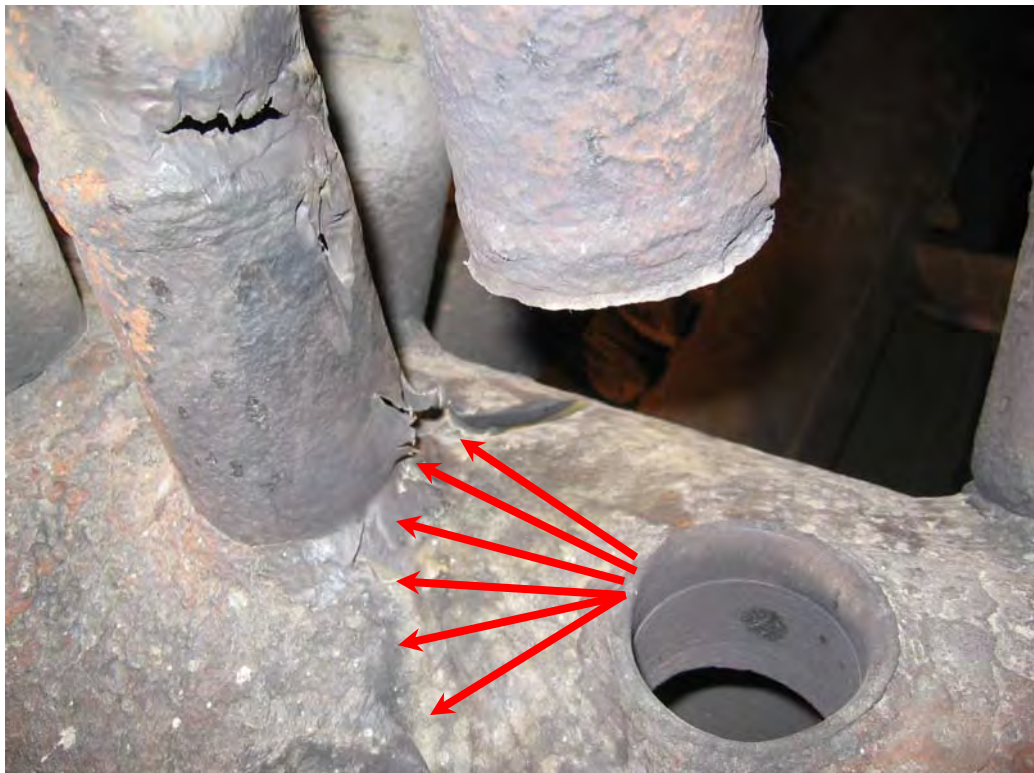
14. Close-up of header at tube 9 and 11

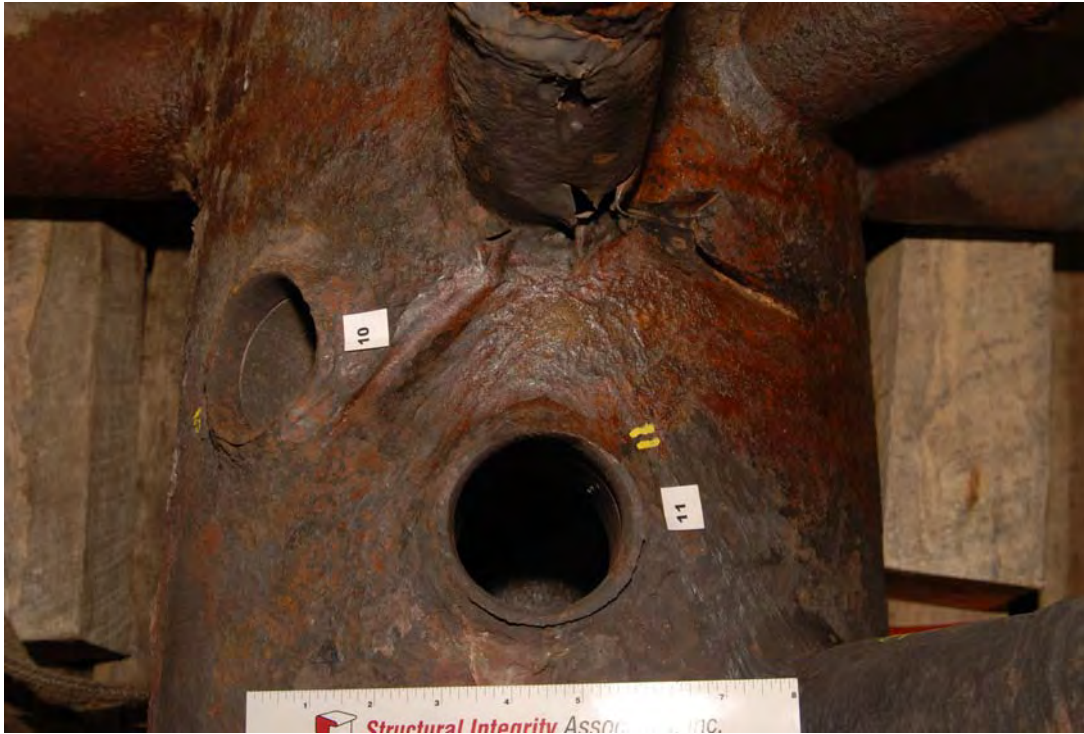
17. Overview of header at failure area

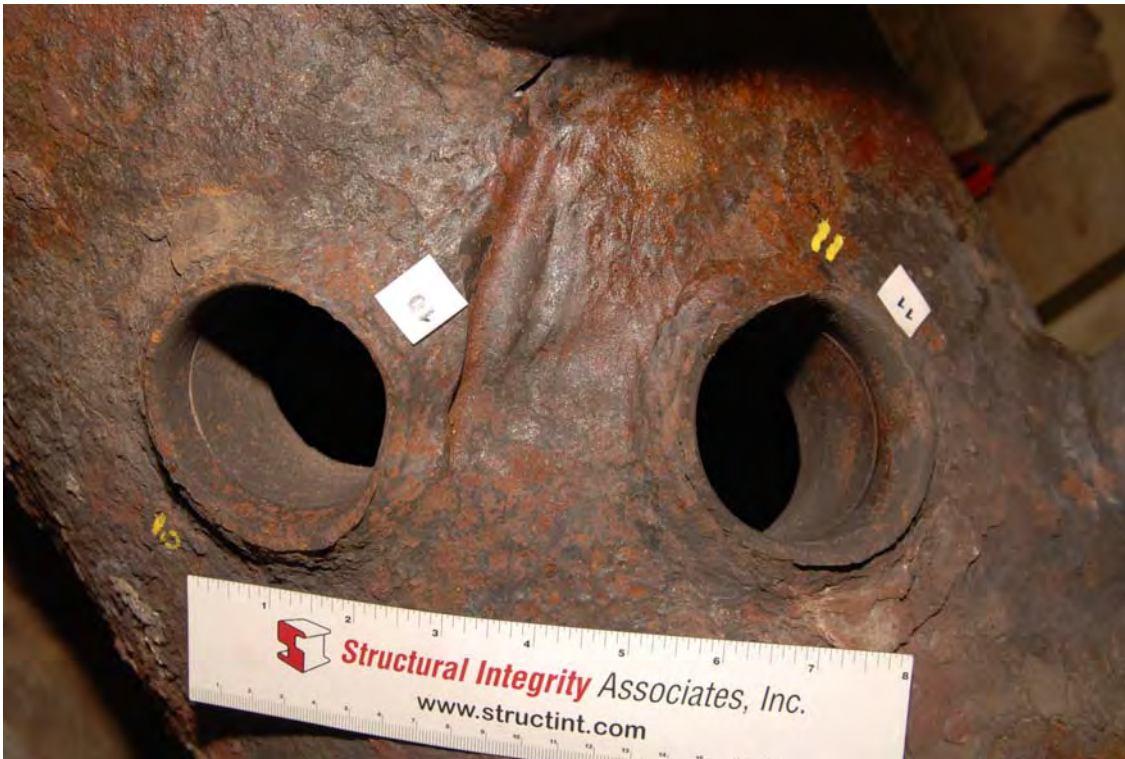
18. Close-up of header at tube 10 and 11

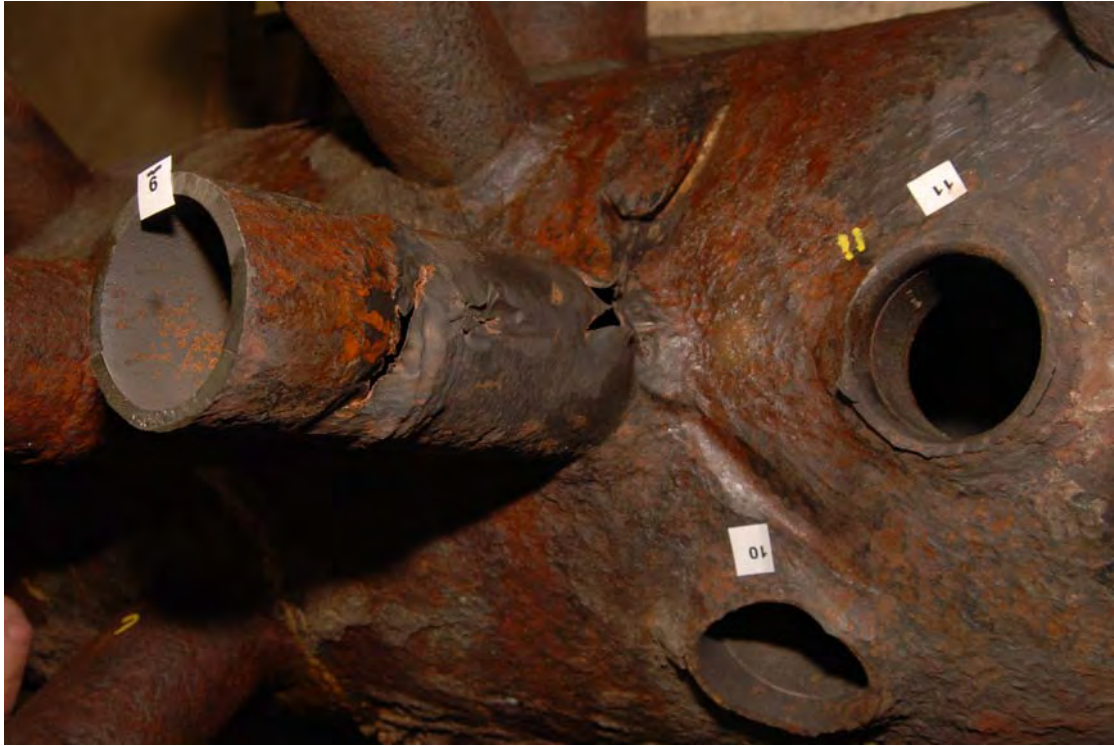
19. Overview of header at point of failures

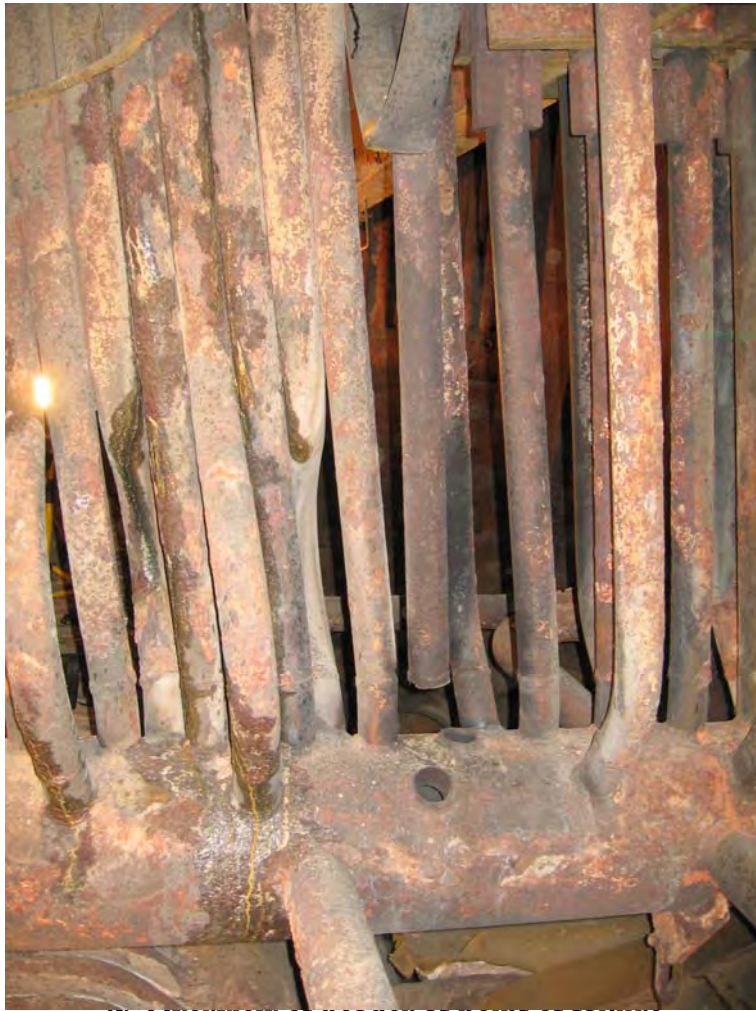
28. Overview of header at point of failure

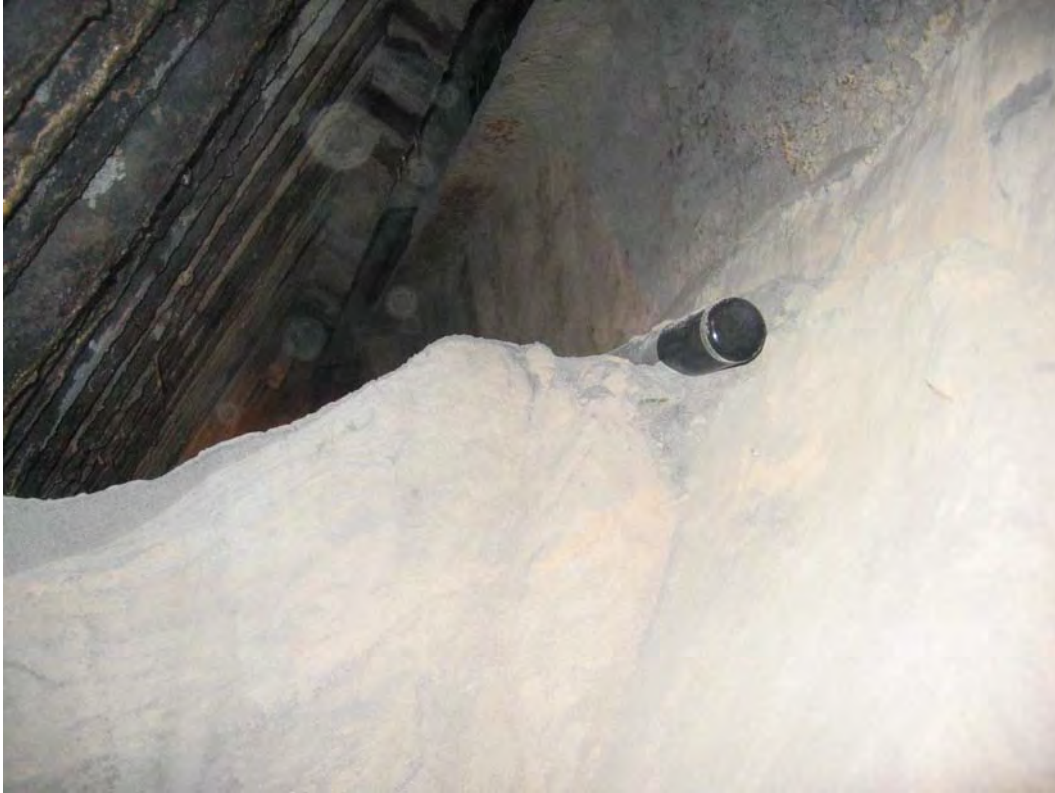
42. West side dead air space before ash is completely removed

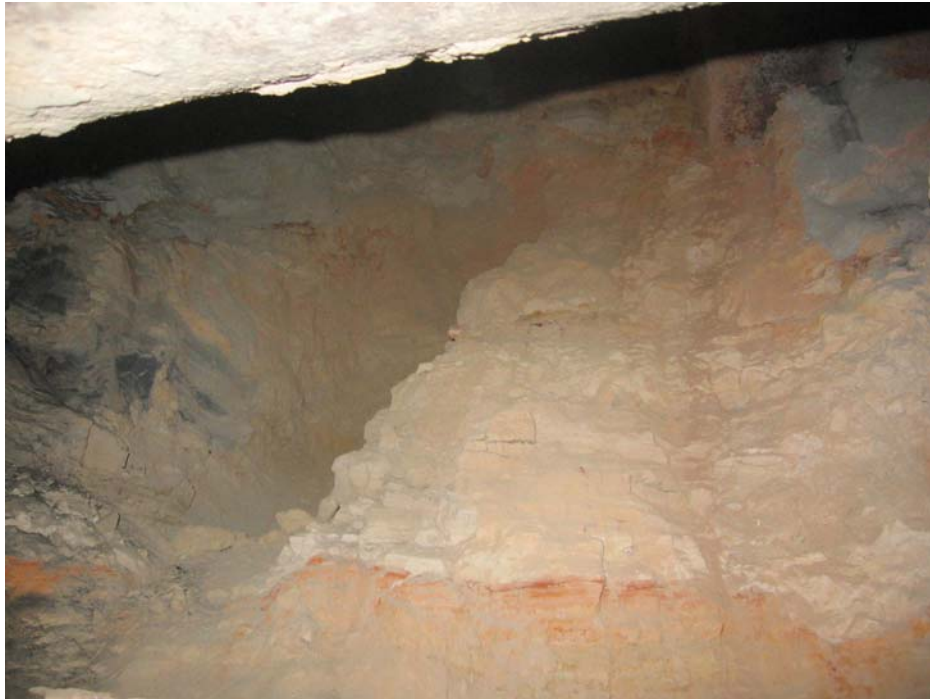
46. West side dead air space before ash is completely removed

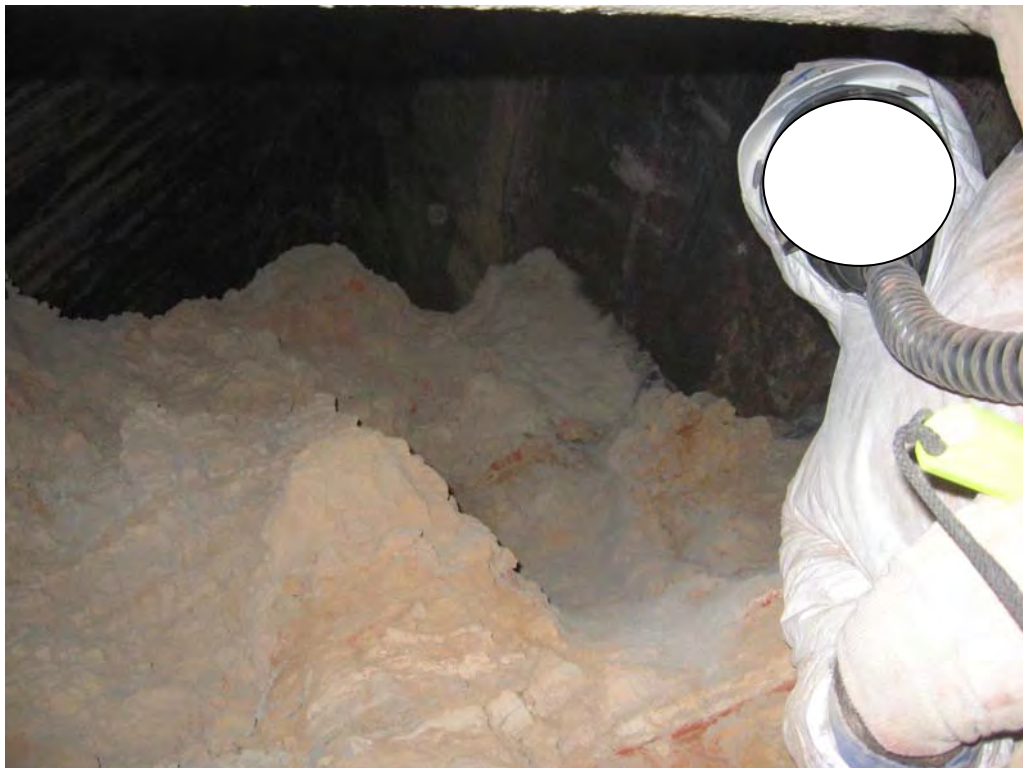
47. West side dead air space before ash is completely removed

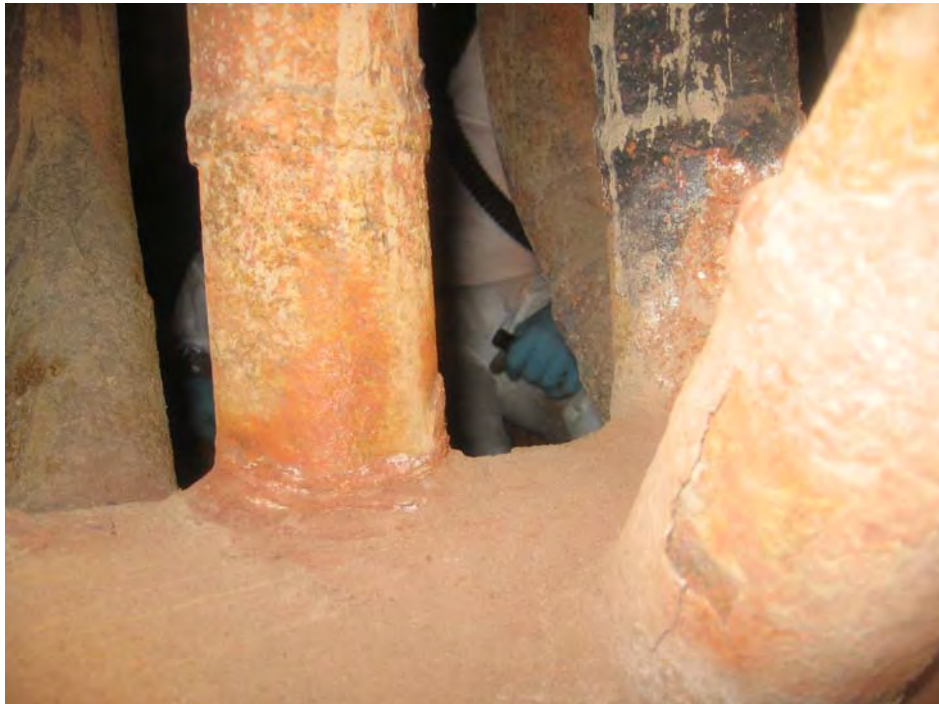
Further, when the west side dead air space was opened, these tubes did not have any obvious signs of urea contamination. It was determined that the ash acted as an insulator from any excessive urea slip (urea overspray). Combined with the large volume of ash that was in the dead air space, and the time it takes for the Urea to leak down to the dead air space if not restricted by ash, the presence of the Urea was discounted as a significant factor in the failure. Mooney and Kawa determined that the corrosion of the tubes and header within the dead air space was caused primarily from the interaction of the boiler metal with the ash and water (from boiler washing).

51. West side dead air space header after ash is initially vacuumed out

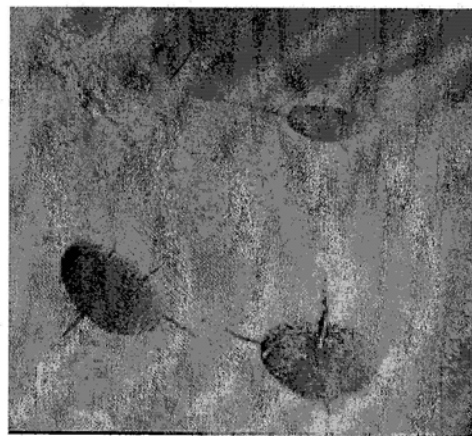
Fig. 4 Large ligament cracks on header ID.
