Underwriters  
Laboratories

**Report  
on  
Structural Stability of Engineered Lumber in Fire Conditions**

**Project Number: 07CA42520**

**September 30, 2008**

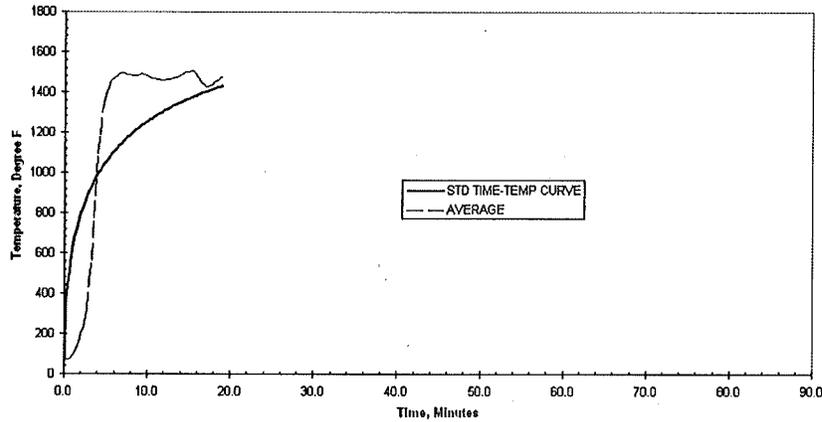
**Character and Distribution of the Furnace Fire** - The furnace fire was luminous and well distributed throughout the test. A plot of the furnace temperature can be seen on Figure 1.

**Figure 1 - UL263 Standard Time Temperature Curve and Average Furnace Temperature vs. Time for Assembly No. 1**

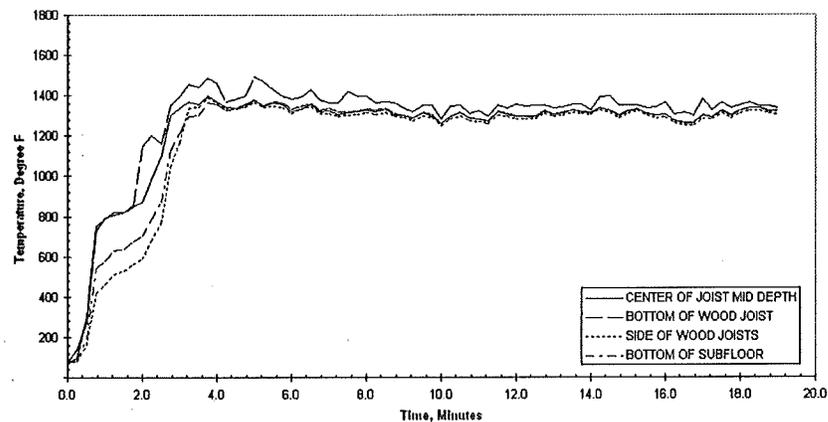
**Temperatures of the Sub Floor Between Wood Joists** – The average and maximum temperatures of the sub floor between the wood joists just before the moment of collapse (18 min 45 sec) were 1122°F and 1161°F respectively. The maximum individual temperature was recorded by thermocouple number 46. The average temperature was plotted on Figure 2.

Figure 2 - Plot of Temperatures Below Subfloor vs. Time for Assembly No. 1

**Temperatures of the Mid Depth Between Wood Joists** – The average and maximum temperatures of the mid depth between the wood joists just before the moment of collapse (18 min 45 sec) were 1114°F and 1147°F respectively. The maximum individual temperature was recorded by thermocouple number 38. The average temperature was plotted on Figure 1.2.

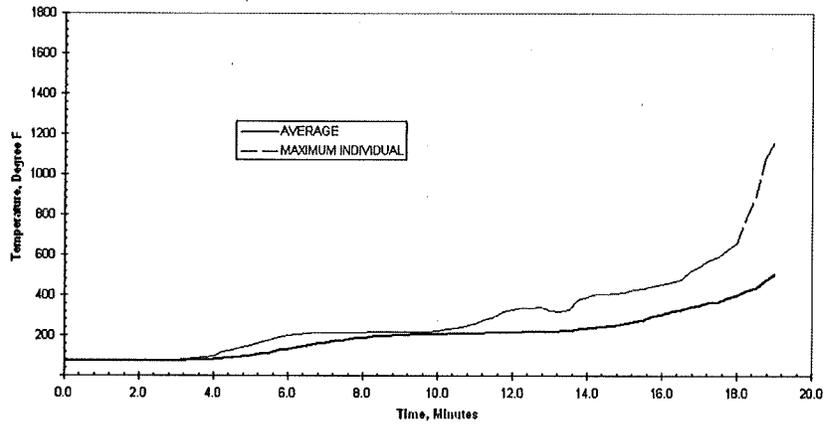
**Temperatures of Between the Sub Floor and Finish Floor** – The average and maximum temperatures between the sub floor and finish floor just before the moment of collapse (18 min 45 sec) were 383°F and 939°F respectively. The maximum individual temperature was recorded by thermocouple number 8. The average temperature was plotted on Figure 3.

Figure 3 - Plot of the Subfloor Temperatures vs. Time for Assembly No. 1

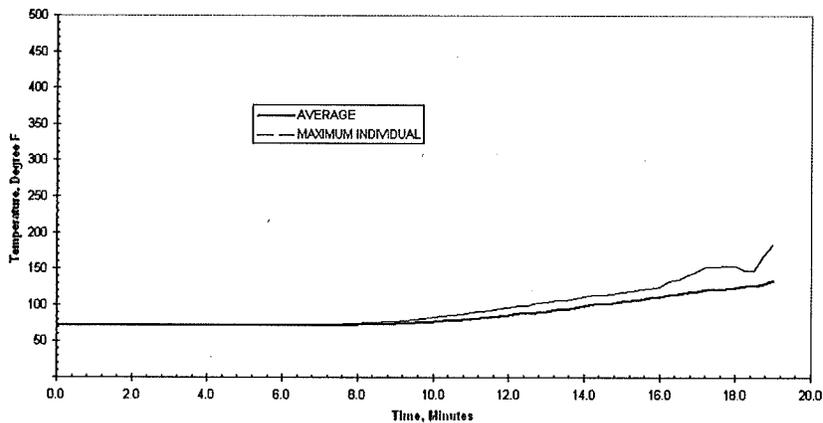
**Temperatures of the Unexposed Surface** – The average and maximum temperatures of the unexposed surface just before the moment of collapse (18 min 45 sec) were 122°F and 616°F respectively. The maximum individual temperature was recorded by thermocouple number 61. The average temperature and maximum temperatures were plotted on Figure 4.

**Figure 4 - Plot of the Unexposed Surface Temperatures vs. Time for Assembly No. 1**

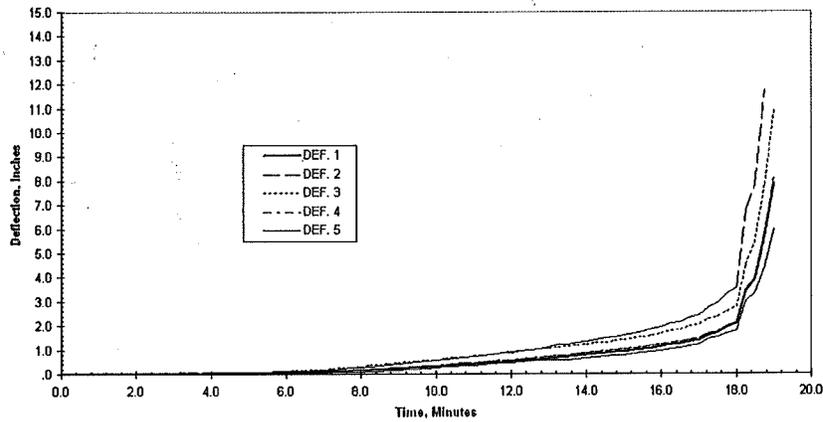
**Deflection of the Assembly** - The deflection of the floor-ceiling assembly during the fire test is shown on Figure 5. The location of each deflection transducer can be seen in Appendix A under Test Assembly 1.

**Figure 5 - Plot of Deflections vs. Time for Assembly No. 1**

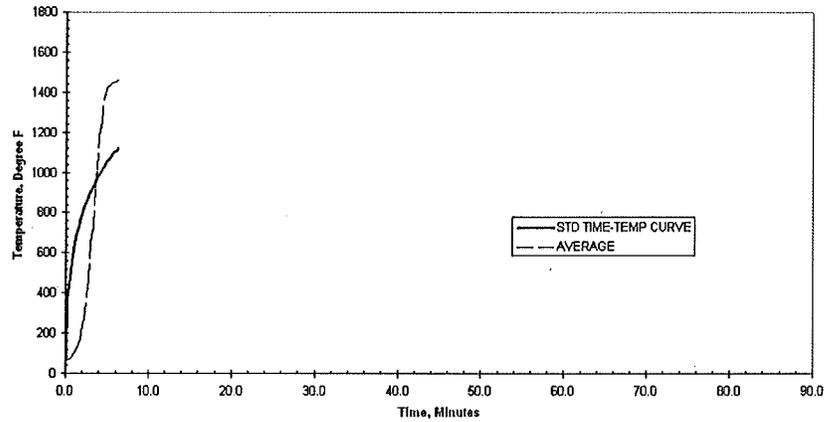
Character and Distribution of the Furnace Fire - The furnace fire was luminous and well distributed throughout the test. A plot of the furnace temperature can be seen on Figure 6.

Figure 6 – UL263 Standard Time Temperature Curve and Average Furnace Temperature vs. Time for Assembly No. 2

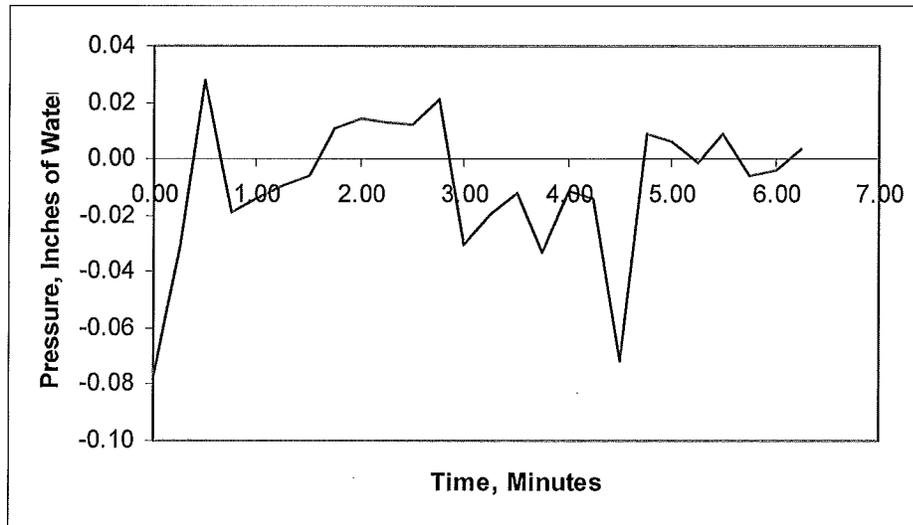
The furnace pressure and oxygen concentration measured in the furnace are presented in Figure 7 and Figure 8.

Figure 7 - Furnace Pressure vs. Time for Assembly No. 2

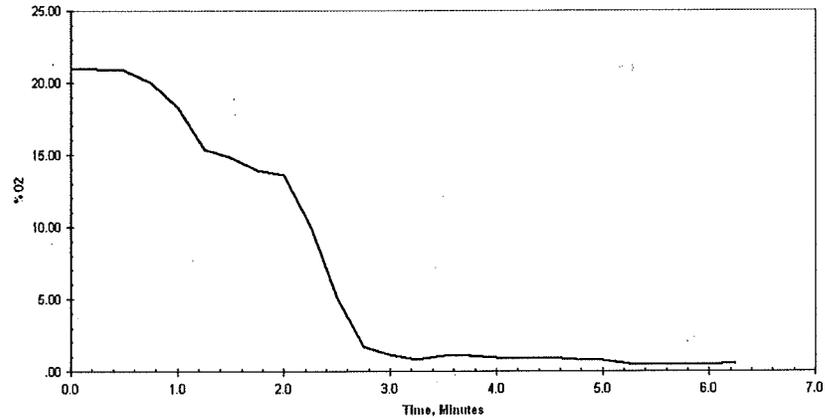
Figure 8 - Oxygen Content vs. Time Oxygen Content vs. Time for Assembly No. 2

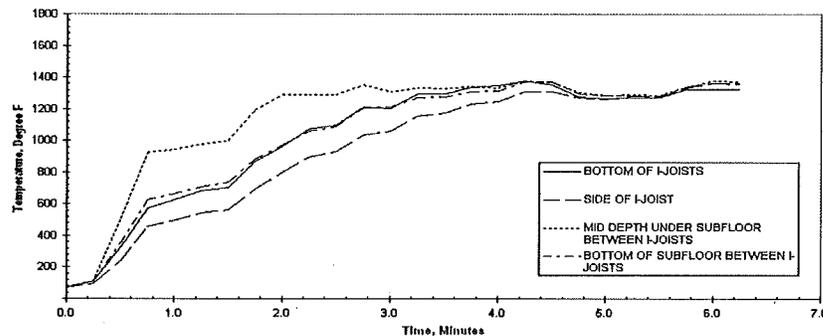
**Temperatures on the Side of Mid Depth of the Wood I Joists** – The average and maximum temperatures of the sides of the wood joists just before the moment of collapse (6 min 3 sec) were 1362°F and 1486°F respectively. The individual temperature was recorded by thermocouple number 45. A plot of these temperatures can be seen on Figure 9.

**Temperatures of the Mid Depth Between Wood Joists** – The average and maximum temperatures of the mid depth between the wood joists just before the moment of collapse (6 min 3 sec) were 1377°F and 1430°F respectively. The individual temperature was recorded by thermocouple number 58. A plot of these temperatures can be seen on Figure 9.

**Temperatures of the Sub Floor Between Wood Joists** – The average and maximum temperatures of the sub floor between the wood joists just before the moment of collapse (6 min 3 sec) were 1361°F and 1417°F respectively. The individual temperature was recorded by thermocouple number 70. A plot of these temperatures can be seen on Figure 9.

Figure 9 - Plot of Temperatures Below Subfloor vs. Time for Assembly No. 2

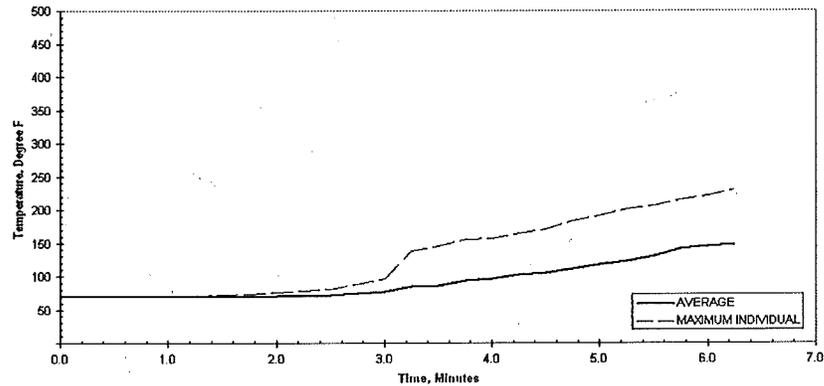
**Temperatures of Between the Sub Floor and Carpet Padding** – The average and maximum temperatures between the sub floor and finish floor just before the moment of collapse (6 min 3 sec) were 228°F and 1371°F respectively. The individual temperature

was recorded by thermocouple number 3. A plot of these temperatures can be seen on Figure 10.

Figure 10 - Plot of the Subfloor Temperatures vs. Time for Assembly No. 2

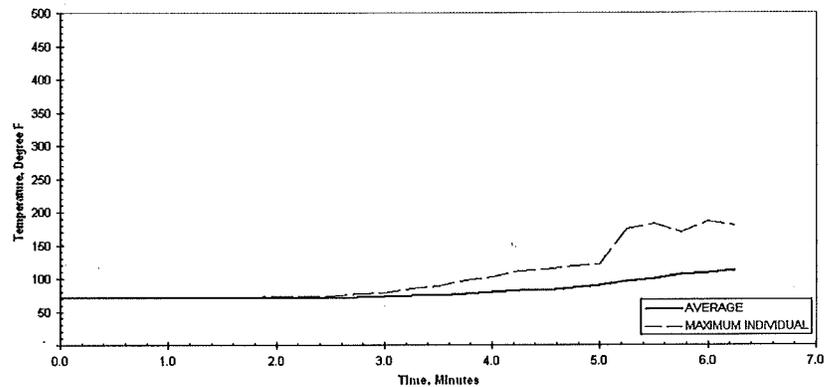
**Temperatures of Between the Carpet Padding and Carpet** – The average and maximum temperatures between the carpet padding and carpet just before the moment of collapse (6 min 3 sec) were 109°F and 187°F respectively. The individual temperature was recorded by thermocouple number 29. A plot of these temperatures can be seen on Figure 11.

Figure 11 - Plot of Temperature of the Carpet Padding vs. Time for Assembly No. 2

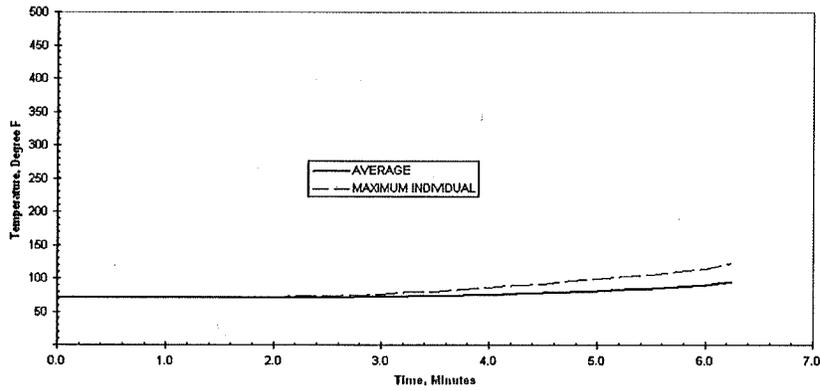
**Temperatures of the Unexposed Surface** – The average and maximum temperatures of the unexposed surface just before the moment of collapse (6 min 3 sec) were 90°F and

114°F respectively. The individual temperature was recorded by thermocouple number 83. A plot of these temperatures can be seen on Figure 12.

Figure 12 - Plot of Unexposed Surface Temperatures vs. Time for Assembly No. 2

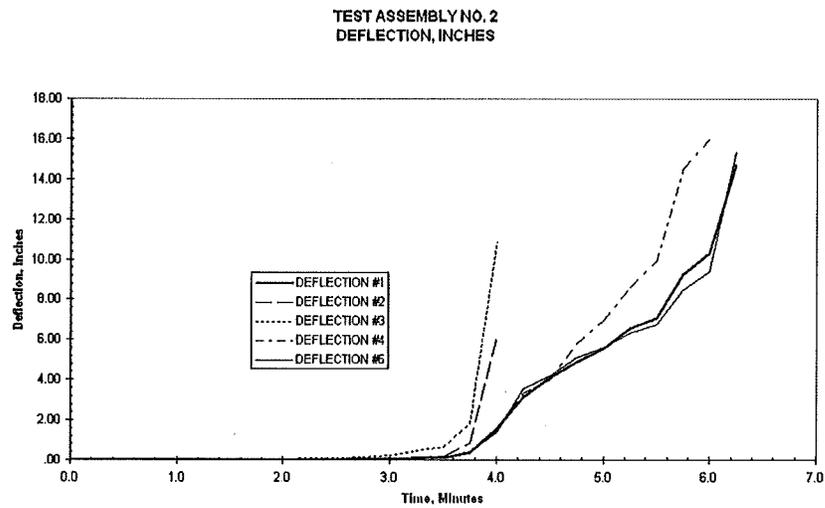
**Deflection of the Assembly** - The deflection of the floor-ceiling assembly during the fire test is shown on Figure 13. The location of each deflection transducer can be seen in Appendix A under Test Assembly 2.

Figure 13 - Plot of Deflections vs. Time for Assembly No. 2

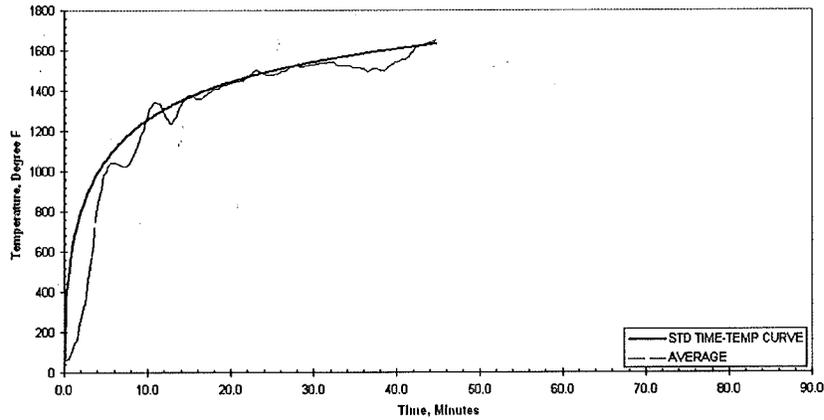
**Character and Distribution of the Furnace Fire** - The furnace fire was luminous and well distributed throughout the test. A plot of the furnace temperature can be seen on Figure 14.

**Figure 14 - UL263 Standard Time Temperature Curve and Average Furnace Temperature vs. Time for Test Assembly No. 3**

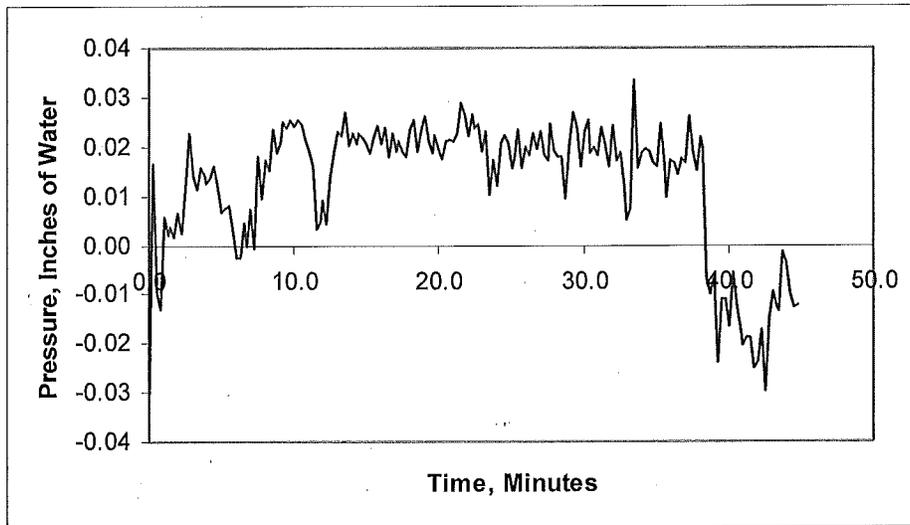
The furnace pressure and oxygen concentration during the test are presented in Figure 15 and Figure 16.

**Figure 15 - Furnace Pressure vs. Time for Test Assembly No. 3**

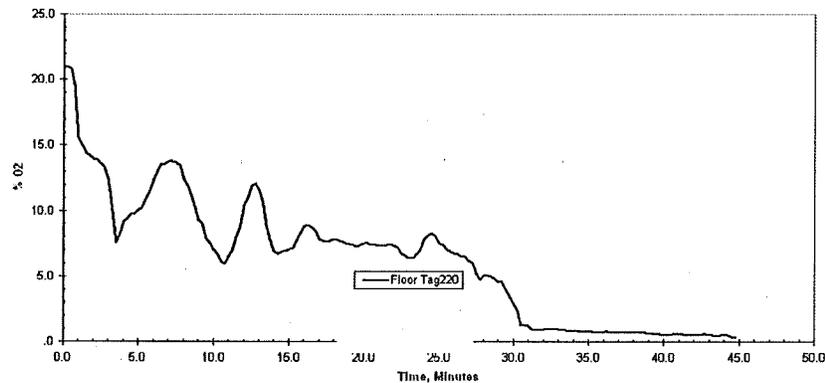
Figure 16 - Oxygen Content vs. Time for Test Assembly No. 3

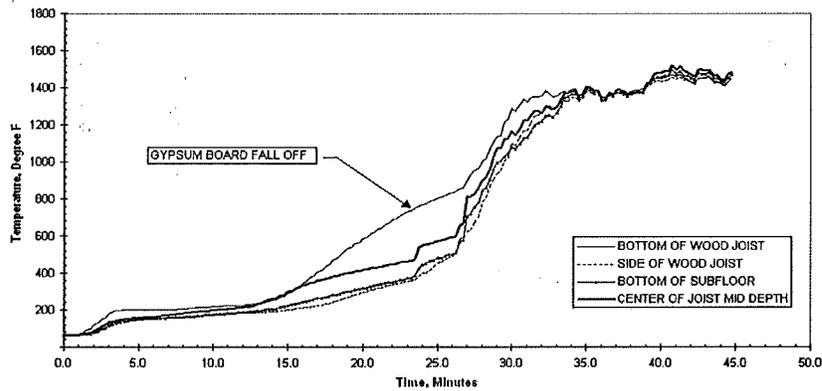
**Temperatures of the Side of Mid Depth of Wood Joists** – The average and maximum temperatures of the sides of the wood joists just before the moment of collapse (44 min 45 sec) were 1450°F and 1550°F respectively. The individual temperature was recorded by thermocouple number 33. A plot of these temperatures can be seen on Figure 17.

**Temperatures of the Mid Depth Between Wood Joists** – The average and maximum temperatures of the mid depth between the wood joists just before the moment of collapse (44 min 45 sec) were 1482°F and 1566°F respectively. The individual temperature was recorded by thermocouple number 52. A plot of these temperatures can be seen on Figure 17.

**Temperatures of the Sub Floor Between Wood Joists** – The average and maximum temperatures of the sub floor between the wood joists just before the moment of collapse (44 min 45 sec) were 1467°F and 1528°F respectively. The individual temperature was recorded by thermocouple number 62. A plot of these temperatures can be seen on Figure 17.

Figure 17 - Plot of Temperature Below Subfloor vs. Time for Assembly No. 3

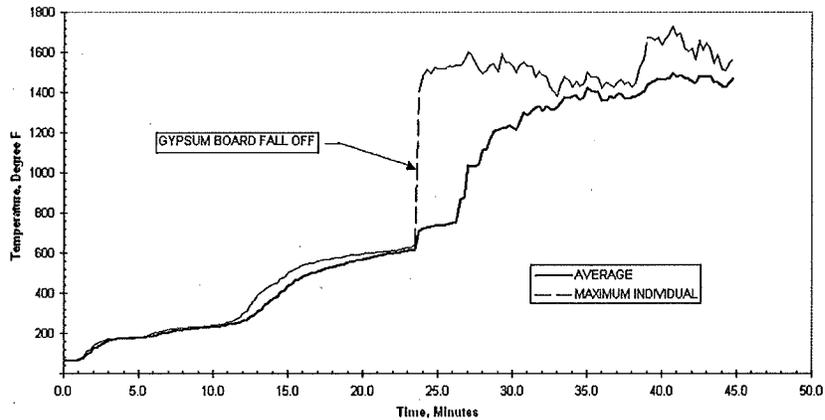
**Temperatures of the Unexposed Side of Gypsum Board** - The average and maximum temperatures of the unexposed surface just before the moment of gypsum board fall off (23 min 30 sec) were 605°F and 617°F respectively. The individual temperature was recorded by thermocouple number 41. A plot of these temperatures can be seen on Figure 18.

**Figure 18 - Plot of Temperature of the Unexposed Surface of Gypsum Board vs. Time for Assembly No. 3**

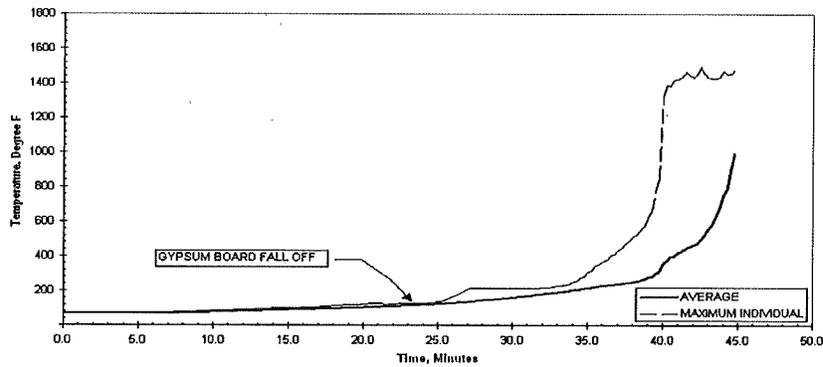
**Temperatures of Between the Sub Floor and Finish Floor** – The average and maximum temperatures between the sub floor and finish floor just before the moment of collapse (44 min 45 sec) were 993°F and 1479°F respectively. The individual temperature was recorded by thermocouple number 6. A plot of these temperatures can be seen on Figure 19.

**Figure 19 - Plot of Temperature of the Subfloor Temperatures vs. Time for Assembly No. 3**

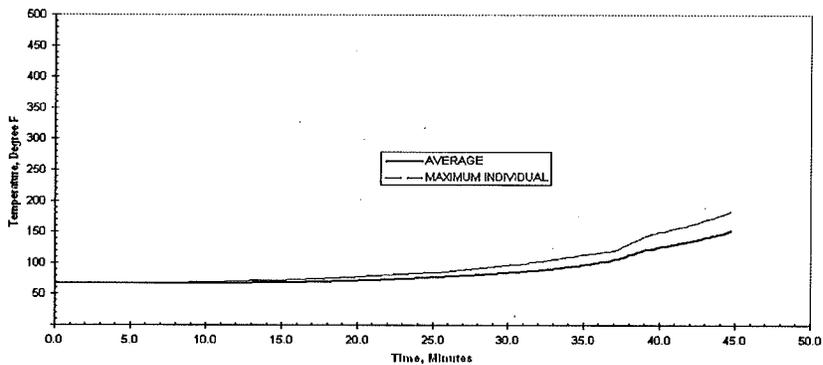
**Temperatures of the Unexposed Surface** – The average and maximum temperatures of the unexposed surface just before the moment of collapse (44 min 45 sec) were 152°F and 183°F respectively. The individual temperature was recorded by thermocouple number 77. A plot of these temperatures can be seen on Figure 20.

**Figure 20 - Plot of Temperatures of the Unexposed Surface vs. Time for Assembly No. 3**

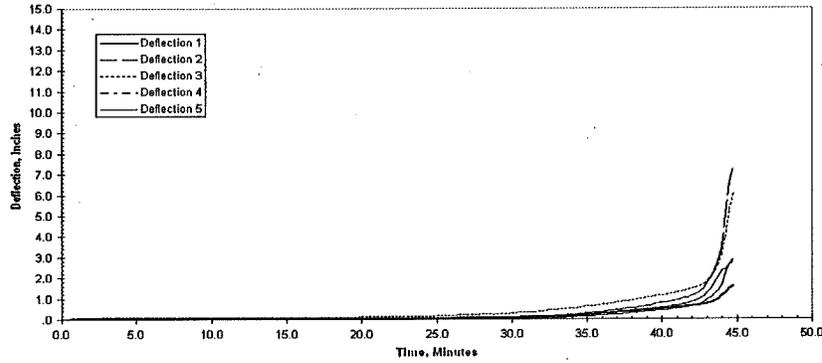
**Deflection of the Assembly** - The deflection of the floor-ceiling assembly during the fire test is shown on Figure 21. The location of each deflection transducer can be seen in Appendix A under Test Assembly 3.

**Figure 21 - Plot of Deflections vs. Time for Assembly No. 3**

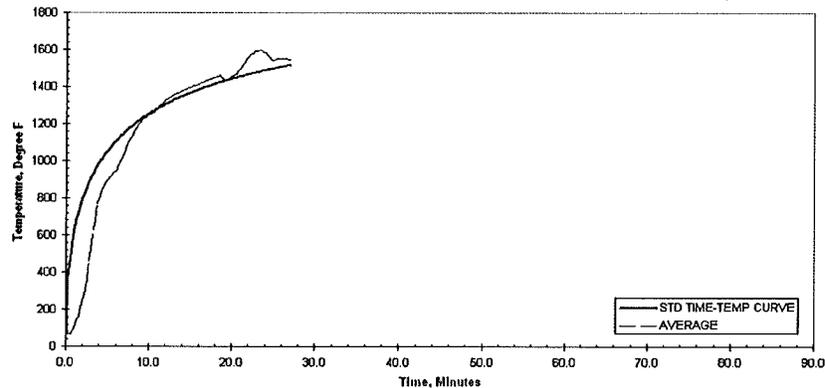
Character and Distribution of the Furnace Fire - The furnace fire was luminous and well distributed throughout the test. A plot of the furnace temperature can be seen on Figure 22.

Figure 22 - UL263 Standard Time Temperature Curve and Average Furnace Temperature vs. Time for Assembly No. 4

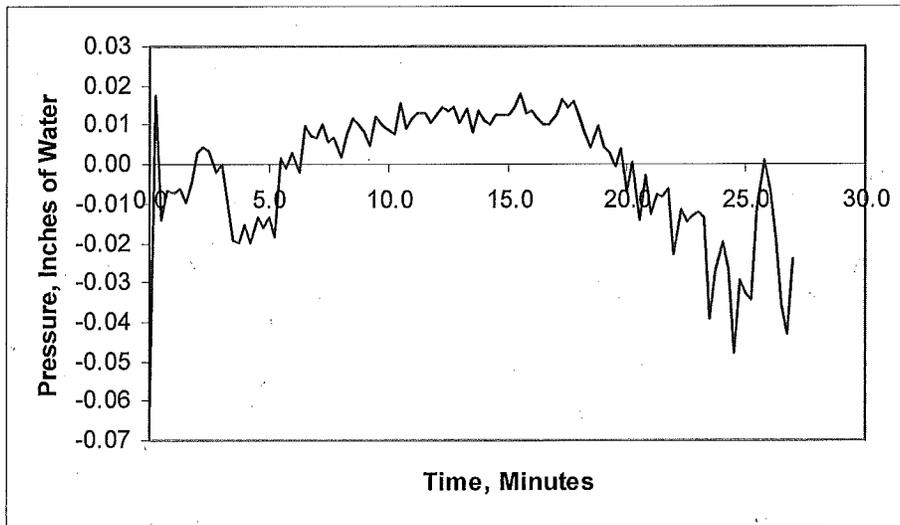
The furnace pressure and oxygen concentration during the test are shown in Figure 23 and Figure 24.

Figure 23 – Furnace Pressure vs. Time for Assembly No. 4

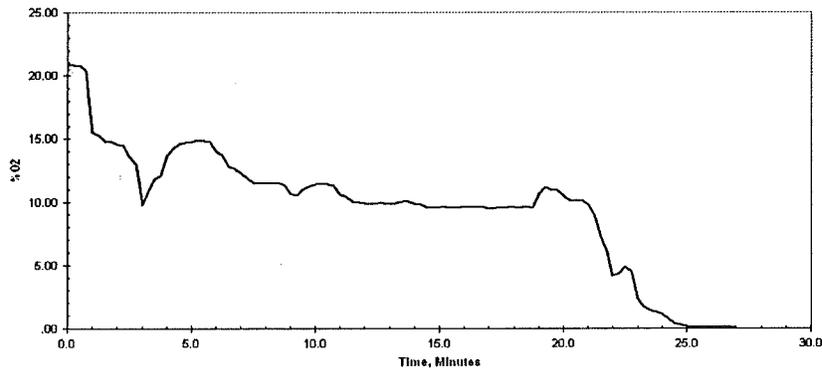
Figure 24 - Oxygen Content vs. Time for Assembly No. 4

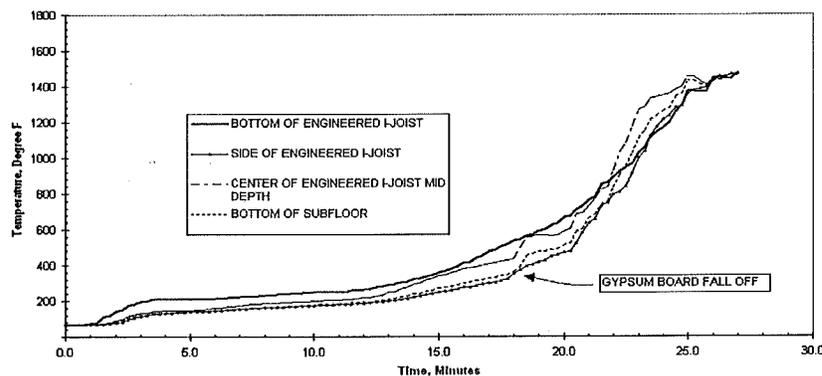
**Temperatures of the Side of Mid Depth of Wood Joists** – The average and maximum temperatures of the sides of the wood joists just before the moment of collapse (26 min 45 sec) were 1467°F and 1597°F respectively. The individual temperature was recorded by thermocouple number 48. A plot of these temperatures can be seen on Figure 25.

**Temperatures of the Mid Depth Between Wood Joists** – The average and maximum temperatures of the mid depth between the wood joists just before the moment of collapse (26 min 45 sec) were 1475°F and 1547°F respectively. The individual temperature was recorded by thermocouple number 70. A plot of these temperatures can be seen on Figure 25.

**Temperatures of the Bottom of the Sub Floor Between Wood Joists** – The average and maximum temperatures of the sub floor between the wood joists just before the moment of collapse (26 min 45 sec) were 1467°F and 1549°F respectively. The individual temperature was recorded by thermocouple number 80. A plot of these temperatures can be seen on Figure 25.

Figure 25 - Plot of Temperatures Below Subfloor vs. Time for Assembly No. 4

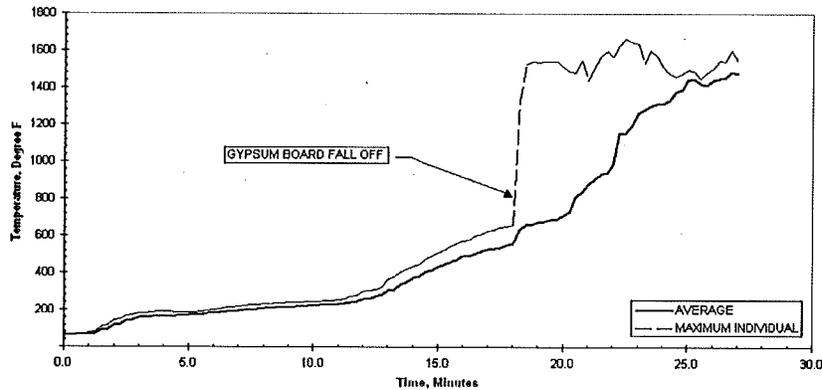
**Temperatures of the Unexposed Side of Gypsum Board** – The average and maximum temperatures of the unexposed surface just before the gypsum board fall off (17 min 15 sec) were 531°F and 634°F respectively. The individual temperature was recorded by thermocouple number 57. A plot of these temperatures can be seen on Figure 26.

**Figure 26 - Plot of Temperature of the Unexposed Surface of Gypsum Board vs. Time for Assembly No. 4**

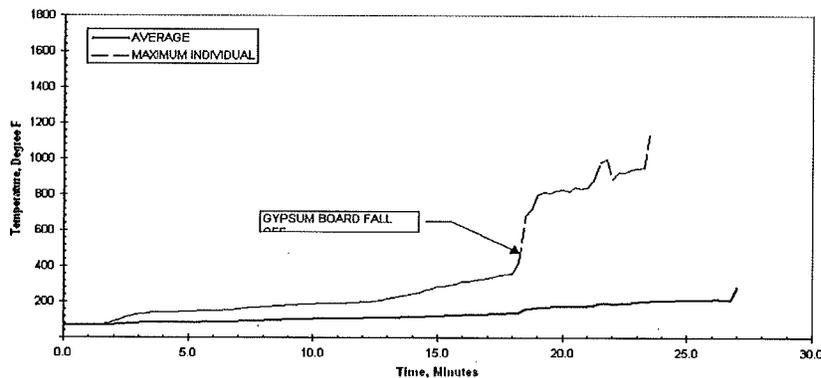
**Temperatures Between the Sub Floor and Carpet Padding** – The average and maximum temperatures between the sub floor and finish floor just before the moment of collapse (26 min 45 sec) were 191°F and 361°F respectively. The individual temperature was recorded by thermocouple number 7. A plot of these temperatures can be seen on Figure 27.

**Figure 27 - Plot of Temperature of the Subfloor Temperatures vs. Time**

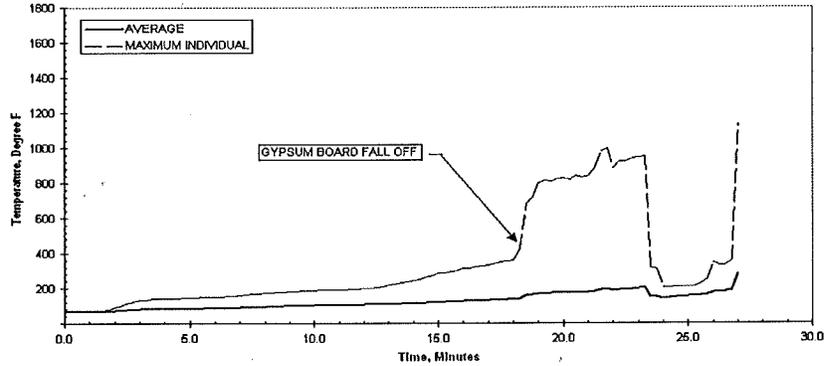
**Temperatures Between the Carpet Padding and Carpet** – The average and maximum temperatures between the sub floor and finish floor just before the moment of collapse (26 min 45 sec) were 135°F and 188°F respectively. The individual temperature was recorded by thermocouple number 29. A plot of these temperatures can be seen on Figure 28.

Figure 28 - Plot of Temperature of the Carpet Padding vs. Time for Assembly No. 4

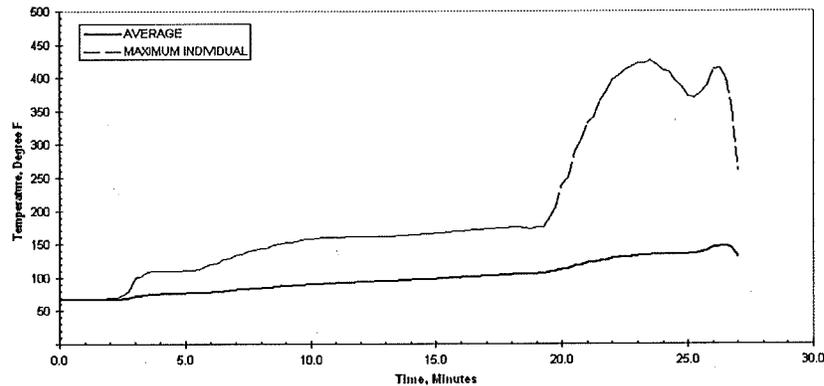
**Temperatures of the Unexposed Surface** – The average and maximum temperatures of the unexposed surface just before the moment of collapse (26 min 45 sec) were 144°F and 355°F respectively. The individual temperature was recorded by thermocouple number 87. A plot of these temperatures can be seen on Figure 29.

Figure 29 - Plot of Temperature of the Unexposed Surface vs. Time for Assembly No. 4

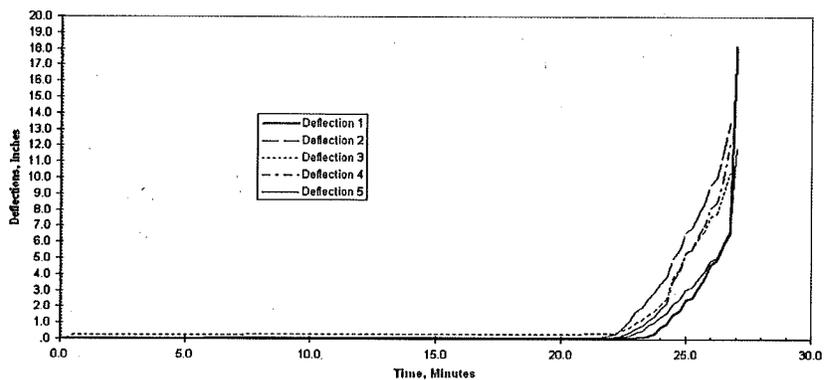
**Deflection of the Assembly** - The deflection of the floor-ceiling assembly during the fire test is shown on Figure 30. The location of each deflection transducer can be seen in Appendix A under Test Assembly 4.

Figure 30 - Plot of Deflections vs. Time for Assembly No. 4

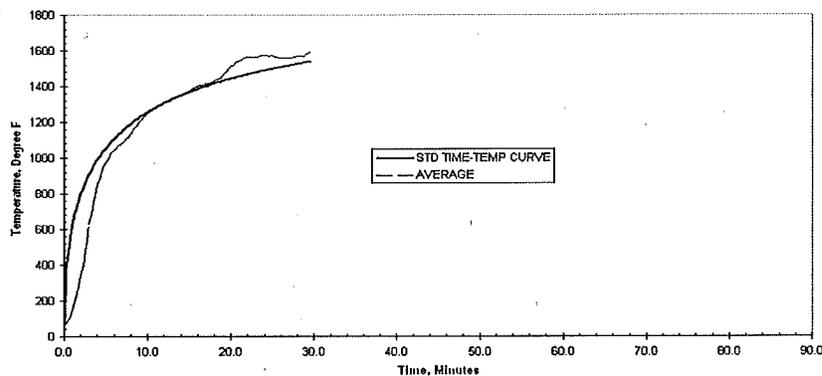
Figure 31 - UL263 Standard Time Temperature Curve and Average Furnace Temperature vs. Time for Assembly No. 5

Character and Distribution of the Furnace Fire - The furnace fire was luminous and well distributed throughout the test. A plot of the furnace temperature can be seen on Figure 31.

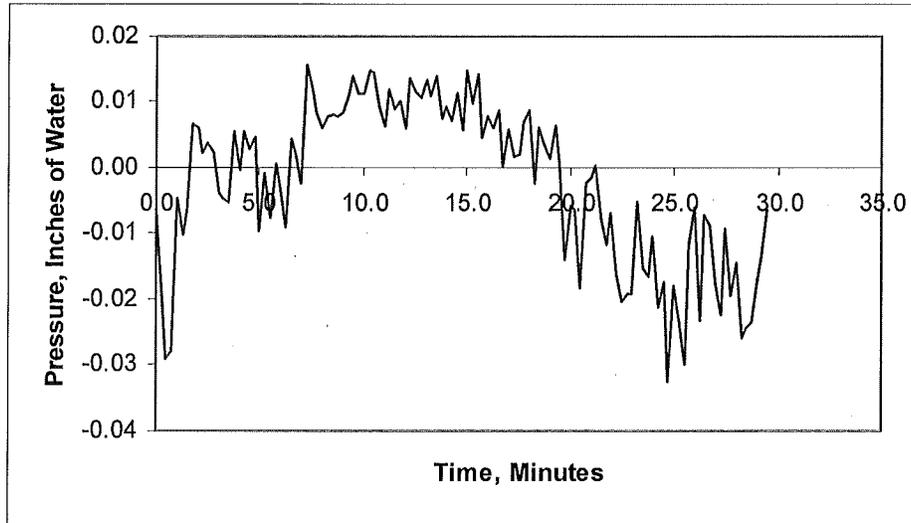
Figure 32 - Furnace Pressure vs. Time for Assembly No. 5

The furnace pressure and oxygen concentration during the test are presented in Figure 32 and Figure 33.

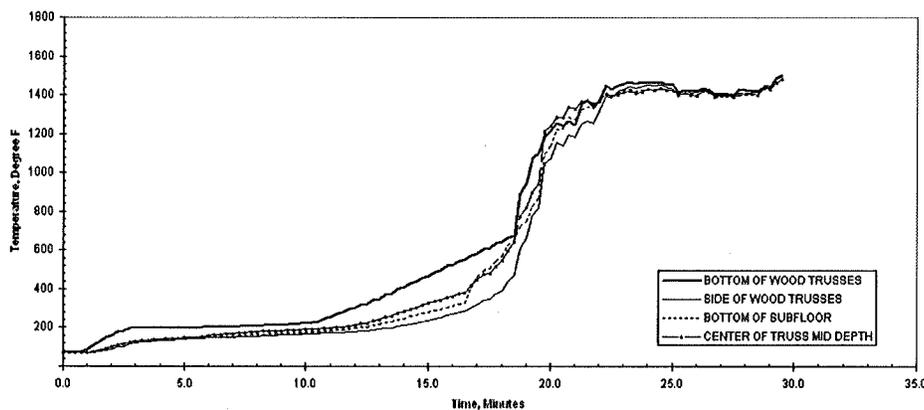
Figure 34 - Plot of Temperature of the Average Interstitial Space vs. Time for Assembly No. 5

**Temperatures at Mid Depth on the Side the Wood Trusses** – The average and maximum temperatures of the sides of the wood trusses just before the moment of collapse (29 min 15 sec) were 1488°F and 1561°F respectively. The individual temperature was recorded by thermocouple number 41. A plot of these temperatures can be seen Figure 34.

**Temperatures of the Mid Depth Between Wood Trusses** – The average and maximum temperatures of the mid depth between the wood trusses just before the moment of collapse (29 min 15 sec) were 1464°F and 1534°F respectively. The individual temperature was recorded by thermocouple number 63. A plot of these temperatures can be seen on Figure 34.

**Temperatures of the Sub Floor Between Wood Trusses** – The average and maximum temperatures of the sub floor between the wood trusses just before the moment of collapse (29 min 15 sec) were 1464°F and 1538°F respectively. The individual temperature was recorded by thermocouple number 71. A plot of these temperatures can be seen on Figure 34.

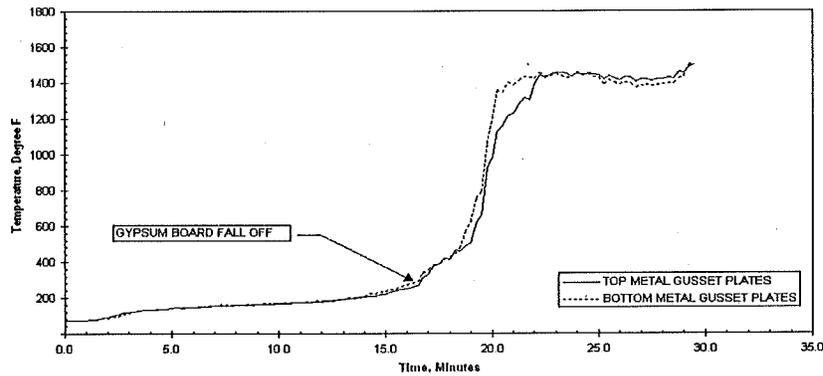
**Figure 35 - Plot of Temperature of the Top and Bottom Metal Gusset Plates vs. Time for Assembly No. 5**

**Temperatures of the Metal Gusset Plates** – The average and maximum temperatures of the top metal gusset plates just before the moment of collapse (29 min 15 sec) were 1487°F and 1537°F respectively. The individual temperature was recorded by thermocouple number 81. The average and maximum temperatures of the bottom metal gusset plate just before the moment of collapse (29 min 15 sec) were 1502°F and 1581°F respectively. The individual temperature was recorded by thermocouple number 86. A plot of the metal gusset temperatures can be seen on Figure 5.5.

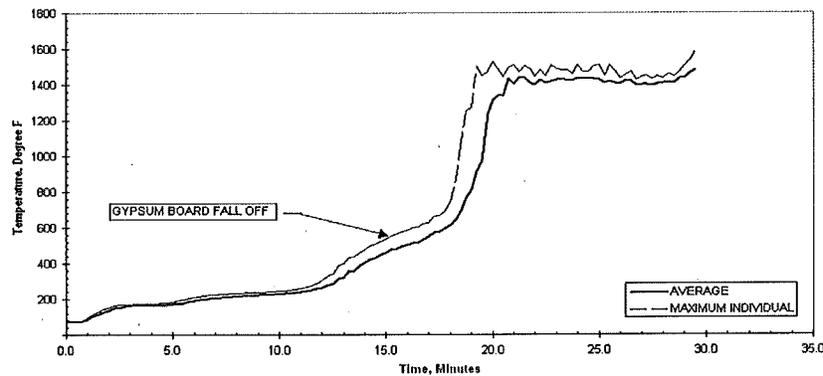
**Figure 36 - Plot of Temperature of the Unexposed Surface of Gypsum Board vs. Time for Assembly No. 5**

**Temperatures of the Unexposed Side of Gypsum Board** – The average and maximum temperatures of the unexposed surface just before the gypsum board fall off (16 min 30 sec) were 519°F and 606°F respectively. The individual temperature was recorded by thermocouple number 54. A plot of these temperatures can be seen on Figure 36.

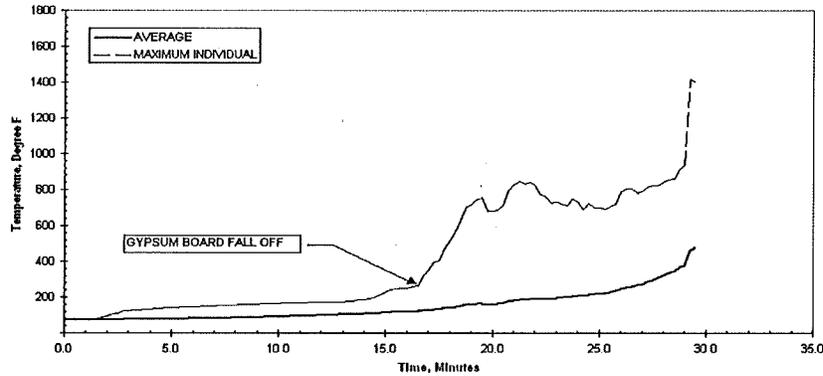
Figure 37 - Plot of Temperature of the Subfloor Temperatures vs. Time for Assembly No. 5

**Temperatures Between the Sub Floor and Carpet Padding** – The average and maximum temperatures between the sub floor and finish floor just before the moment of collapse (29 min 15 sec) were 459°F and 1416°F respectively. The individual temperature was recorded by thermocouple number 9. A plot of these temperatures can be seen on Figure 37.

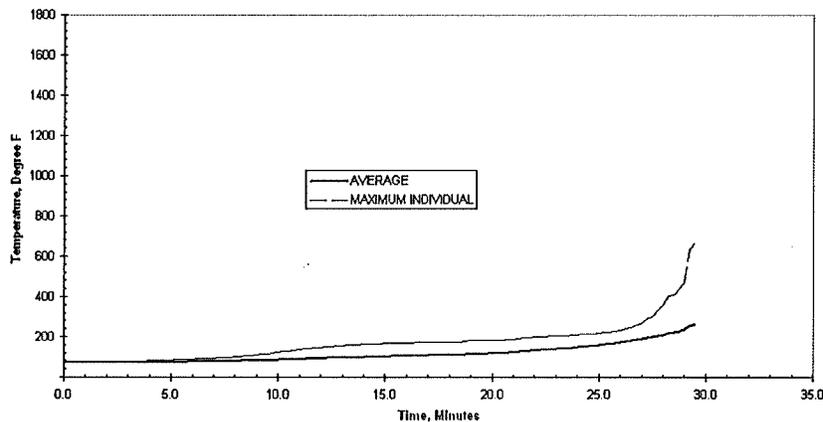
Figure 38 - Plot of Temperature of the Carpet Padding vs. Time for Assembly No. 5

**Temperatures Between the Carpet Padding and Carpet** – The average and maximum temperatures between the sub floor and finish floor just before the moment of collapse (29 min 15 sec) were 256°F and 636°F respectively. The individual temperature was recorded by thermocouple number 24. A plot of these temperatures can be seen on Figure 38.

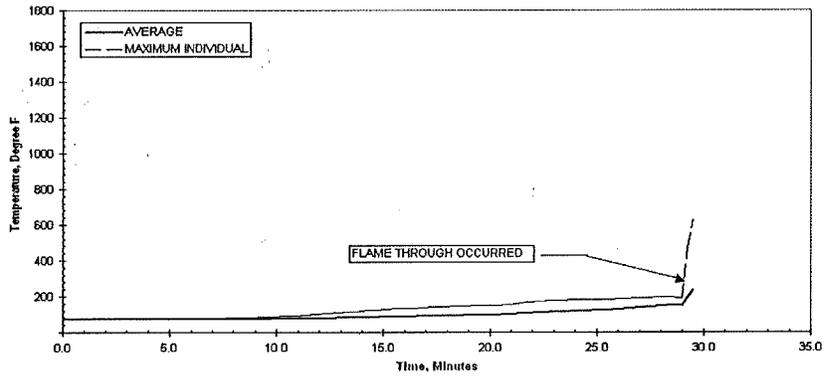
Figure 39 - Plot of Temperatures of the Unexposed Surface vs. Time for Assembly No. 5

**Temperatures of the Unexposed Surface** – The average and maximum temperatures of the unexposed surface just before the moment of collapse (29 min 15 sec) were 194°F

and 474°F respectively. The individual temperature was recorded by thermocouple number 96. A plot of these temperatures can be seen on Figure 5.9.

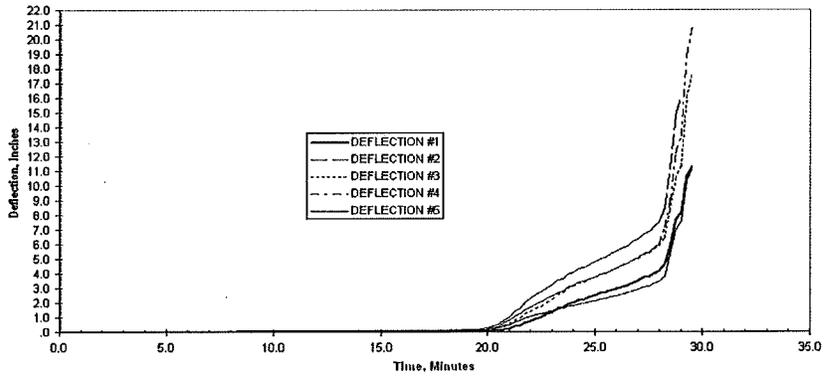
Figure 40 - Plot of Deflections vs. Time for Assembly No. 5

**Deflection of the Assembly** - The deflection of the floor-ceiling assembly during the fire test is shown on Figure 40. The location of each deflection transducer can be seen in Appendix A under Test Assembly 5.

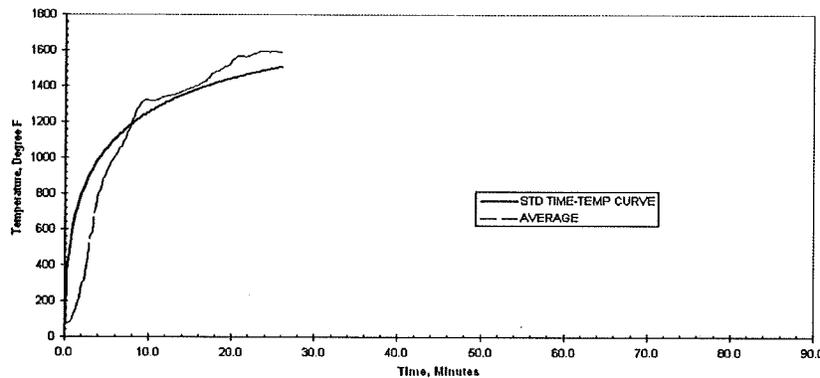
Figure 41 - UL263 Standard Time Temperature Curve and Average Furnace Temperature vs. Time for Assembly No. 6

Character and Distribution of the Furnace Fire - The furnace fire was luminous and well distributed throughout the test. A plot of the furnace temperature can be seen on Figure 41.

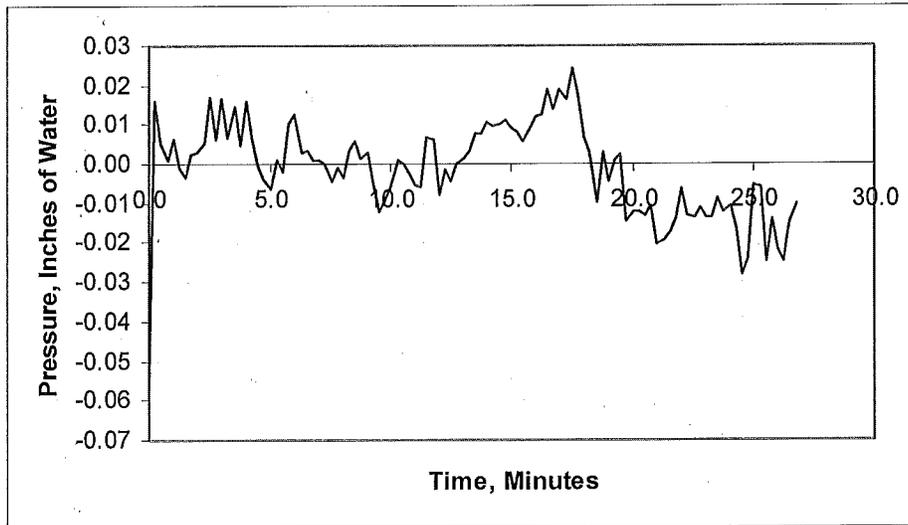
Figure 42 - Furnace Pressure vs. Time for Assembly No. 6

The furnace pressure and oxygen concentration are presented in Figure 42 and Figure 43.

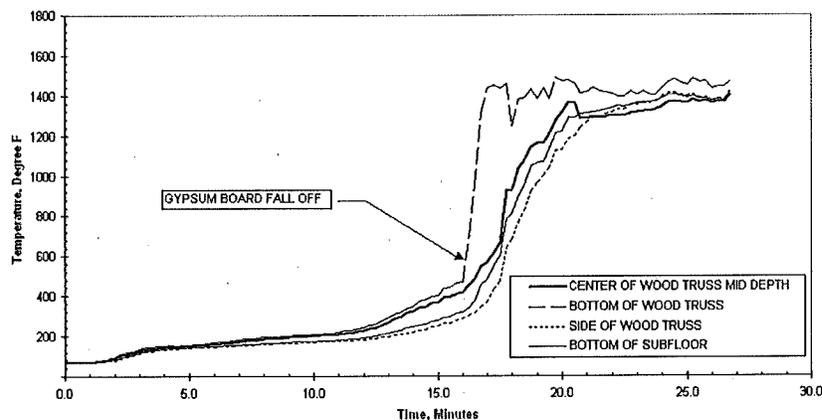
Figure 44 - Plot of Temperatures of Below Subfloor vs. Time

**Temperatures of the Mid Depth Between Wood Trusses** – The average and maximum temperatures of the mid depth between the wood trusses just before the moment of collapse (29 min 45 sec) were 1403°F and 1474°F respectively. The individual temperature was recorded by thermocouple number 66. A plot of these temperatures can be seen on Figure 6.4.

**Temperatures of the Sub Floor Between Wood Trusses** – The average and maximum temperatures of the sub floor between the wood joists just before the moment of collapse (29 min 45 sec) were 1411°F and 1476°F respectively. The individual temperature was recorded by thermocouple number 75. A plot of these temperatures can be seen on Figure 6.4.

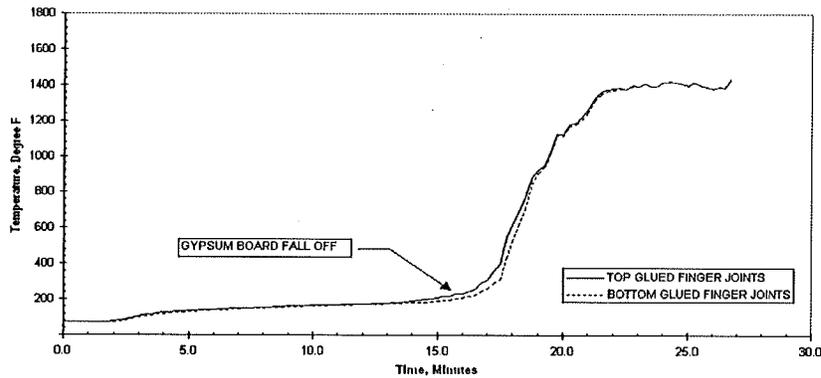
Figure 45 - Plot of Temperature of the Top and Bottom Glued Finger Joints vs. Time for Assembly No. 6

**Temperatures of the Glued Finger Joints** – The average and maximum temperatures of the top glued finger joints just before the moment of collapse (29 min 45 sec) were 1435°F and 1477°F respectively. The individual temperature was recorded by thermocouple number 84. The average and maximum temperatures of the bottom glued finger joints just before the moment of collapse (29 min 45 sec) were 1434°F and 1474°F respectively. The individual temperature was recorded by thermocouple number 81. A plot of the glued finger joint temperatures can be seen on Figure 6.5.

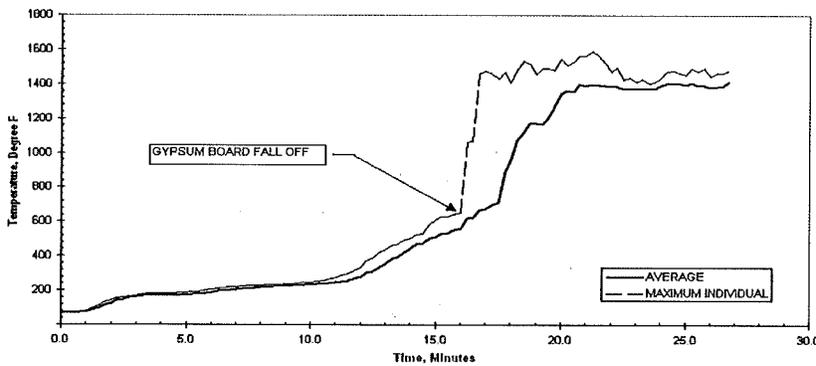
Figure 46 - Plot of Temperature of the Unexposed Surface of Gypsum Board vs. Time for Test Assembly No. 6

**Temperatures of the Unexposed Side of Gypsum Board** – The average and maximum temperatures of the unexposed surface just before the gypsum board fall off (16 min) were 559°F and 650°F respectively. The individual temperature was recorded by thermocouple number 52. A plot of these temperatures can be seen on Figure 46.

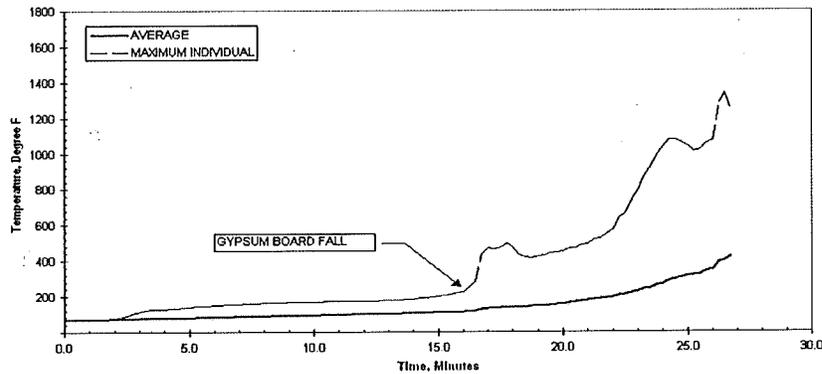
Figure 47 - Plot of Temperature of the Subfloor Temperatures vs. Time for Test Assembly No. 6

**Temperatures Between the Sub Floor and Carpet Padding** – The average and maximum temperatures between the sub floor and finish floor just before the moment of collapse (29 min 45 sec) were 424°F and 1240°F respectively. The individual temperature was recorded by thermocouple number 9. A plot of these temperatures can be seen on Figure 47.

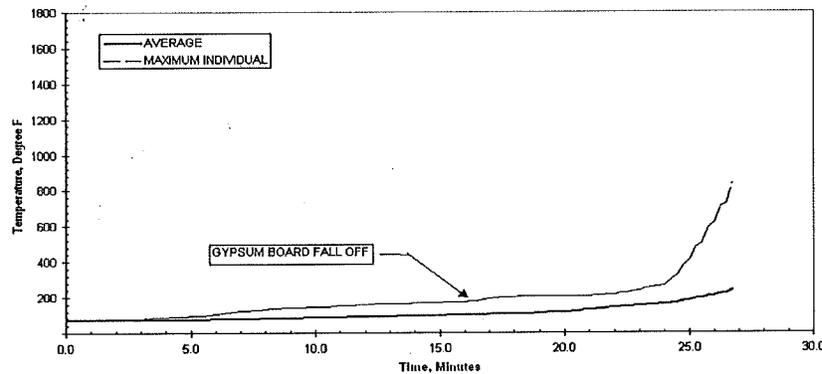
Figure 48 - Plot of Temperature of the Carpet Padding vs. Time for Test Assembly No. 6

**Temperatures Between the Carpet Padding and Carpet** – The average and maximum temperatures between the sub floor and finish floor just before the moment of collapse (29 min 45 sec) were 241°F and 843°F respectively. The individual temperature was recorded by thermocouple number 24. A plot of these temperatures can be seen on Figure 48.

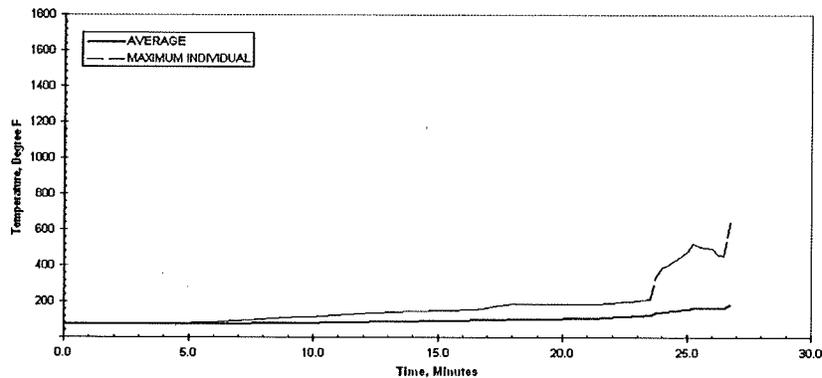
Figure 49 - Plot of Temperatures of the Unexposed Surface vs. Time for Test Assembly No. 6

**Temperatures of the Unexposed Surface** – The average and maximum temperatures of the unexposed surface just before the moment of collapse (29 min 45 sec) were 182°F and 646°F respectively. The individual temperature was recorded by thermocouple number 92. A plot of these temperatures can be seen on Figure 49.

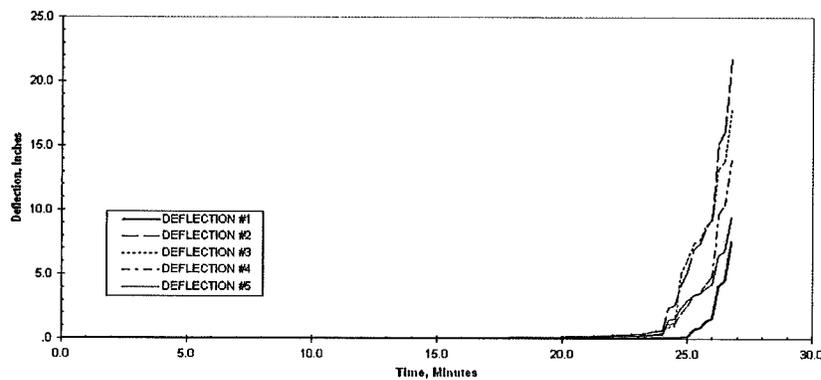
Figure 50 - Plot of Deflections vs. Time for Test Assembly No. 6

**Deflection of the Assembly** - The deflection of the floor-ceiling assembly during the fire test is shown on Figure 50. The location of each deflection transducer can be seen in Appendix A under Test Assembly 6.

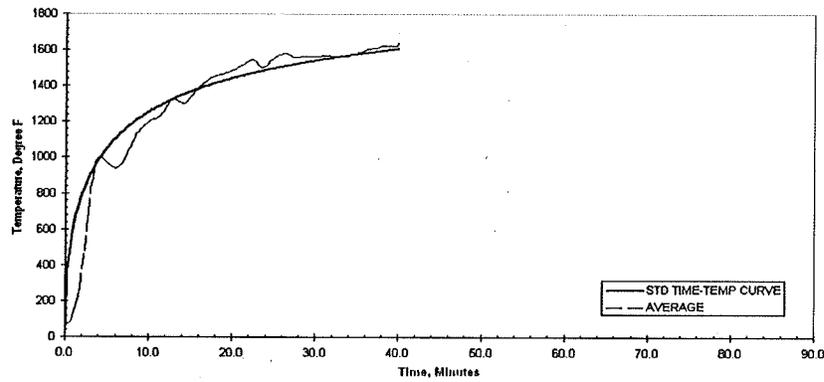
Figure 51 – UL263 Standard Time Temperature Curve and Average Furnace Temperature vs. Time for Assembly No. 7

Character and Distribution of the Furnace Fire - The furnace fire was luminous and well distributed throughout the test. A plot of the furnace temperature can be seen on Figure 51.
