Underwriters  
Laboratories

**Report  
on  
Structural Stability of Engineered Lumber in Fire Conditions**

**Project Number: 07CA42520**

**September 30, 2008**

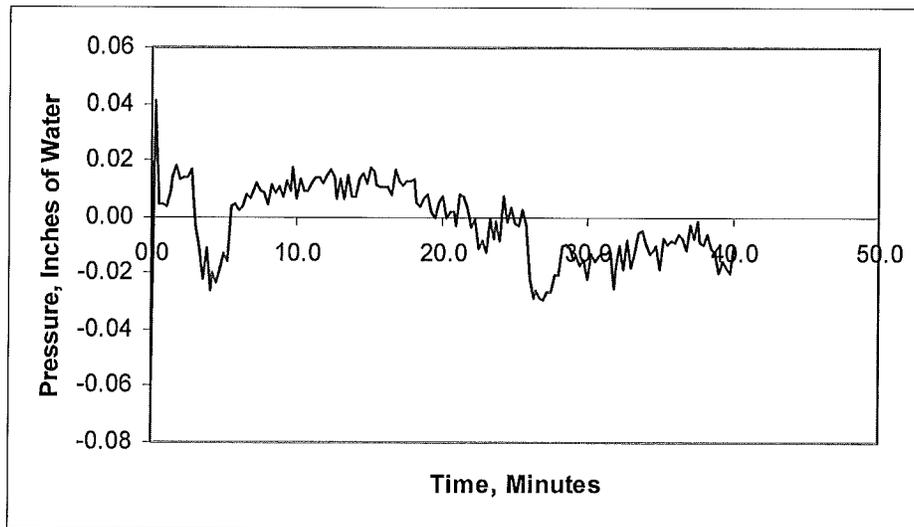
Figure 52 – Furnace Pressure vs. Time for Assembly No. 7

The furnace pressure and oxygen concentration are presented in Figure 52 and Figure 53.

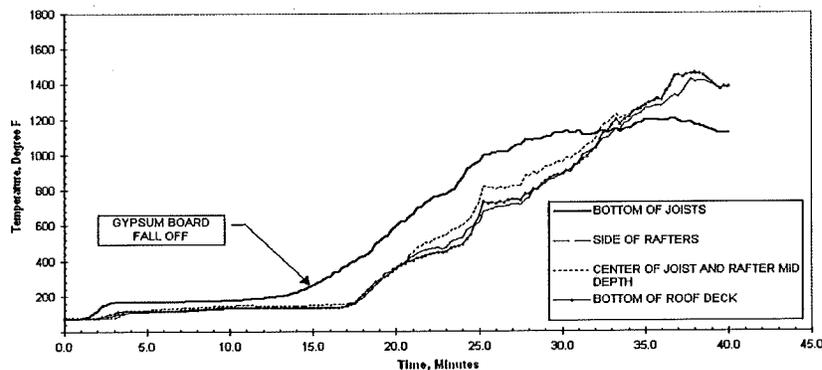
Figure 54 – Plot of Temperatures Below Subfloor vs. Time for Test Assembly No. 7

**Temperatures of the Mid Depth Between Wood Joists and Rafters** – The average and maximum temperatures of the mid depth between the wood trusses just before the moment of collapse (40 min 00 sec) were 1376°F and 1482°F respectively. The individual temperature was recorded by thermocouple number 63. A plot of these temperatures can be seen on Figure 54.

**Temperatures on the Bottom of the Roof Deck Between Wood Joists** – The average and maximum temperatures of the sub floor between the wood joists just before the moment of collapse (40 min 00 sec) were 1383°F and 1487°F respectively. The individual temperature was recorded by thermocouple number 72. A plot of these temperatures can be seen on Figure 54

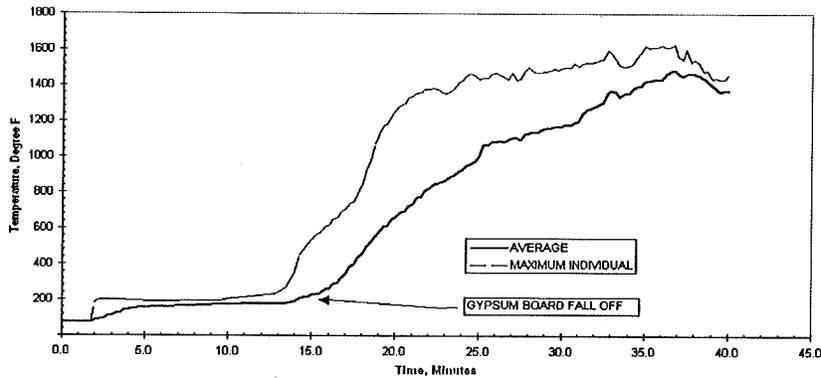
Figure 55 – Plot of Temperature of the Unexposed Surface of Gypsum Board vs. Time for Test Assembly No. 7

**Temperatures of the Unexposed Side of Gypsum Board** – The average and maximum temperatures of the unexposed surface just before the gypsum board fall off (15 min 45 sec) were 253°F and 606°F respectively. The individual temperature was recorded by thermocouple number 58. A plot of these temperatures can be seen on Figure 55

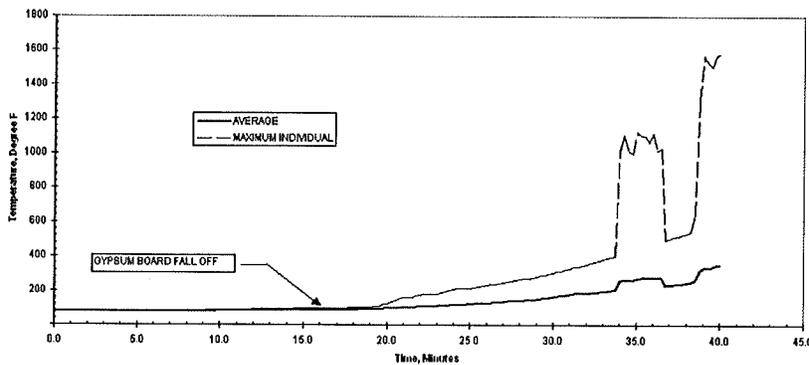
Figure 56 – Plot of the Roof Deck Temperatures vs. Time for Test Assembly No. 7

**Temperatures on the top of the Roof Deck** – The average and maximum temperatures between the roof deck and roof felt just before the moment of collapse (40 min 00 sec) were 352°F and 1585°F respectively. The individual temperature was recorded by thermocouple number 4. A plot of these temperatures can be seen on Figure 56.

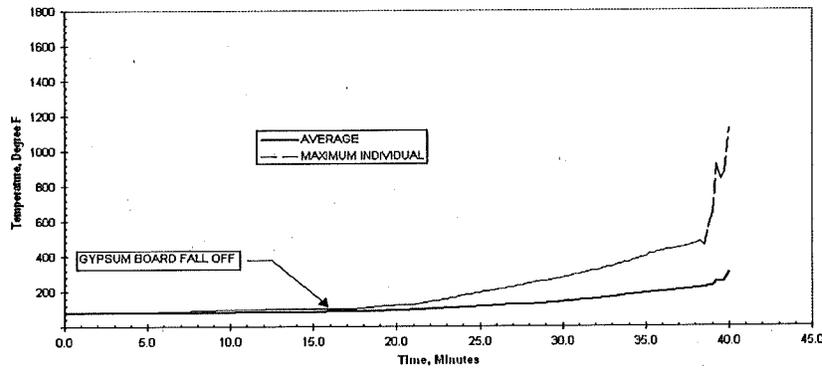
Figure 57 – Plot of Temperature of the Roofing Felt vs. Time for Test Assembly No. 7

**Temperatures on the Roofing Felt** – The average and maximum temperatures between the sub floor and finish floor just before the moment of collapse (40 min 00 sec) were 303°F and 1129°F respectively. The individual temperature was recorded by thermocouple number 19. A plot of these temperatures can be seen on Figure 57.

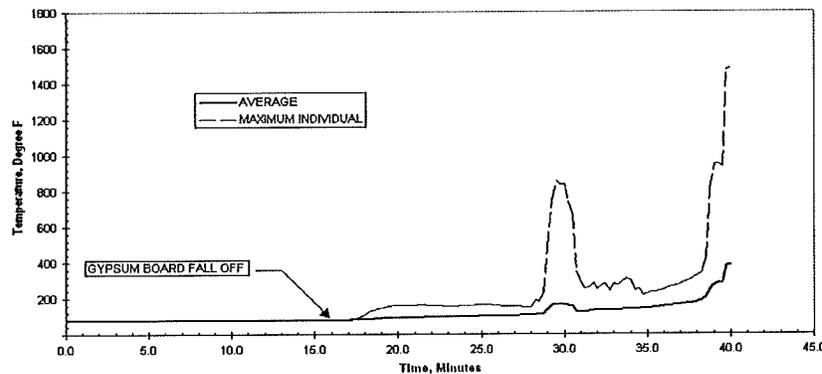
Figure 58 – Plot of Temperatures of the Unexposed Surface vs. Time for Test Assembly No. 7

**Temperatures of the Unexposed Surface** – The average and maximum temperatures of the unexposed surface just before the moment of collapse (40 min 00 sec) were 385°F and 1487°F respectively. The individual temperature was recorded by thermocouple number 81. A plot of these temperatures can be seen on Figure 58.

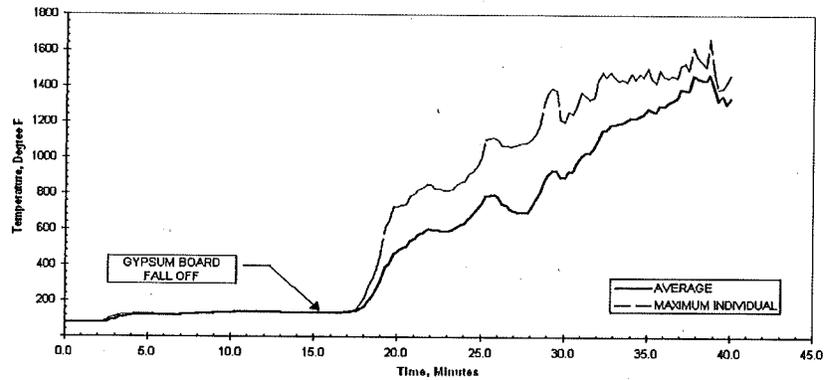
Figure 59 – Plot of Temperatures of the Unexposed Surface of the Mushroom Vent vs. Time for Test Assembly No. 7

**Temperatures of the Unexposed Surface of the Mushroom Vents** – The average and maximum temperatures of the unexposed surface just before the moment of collapse (40 min 00 sec) were 1338°F and 1470°F respectively. The individual temperature was recorded by thermocouple number 94. A plot of these temperatures can be seen on Figure 59.

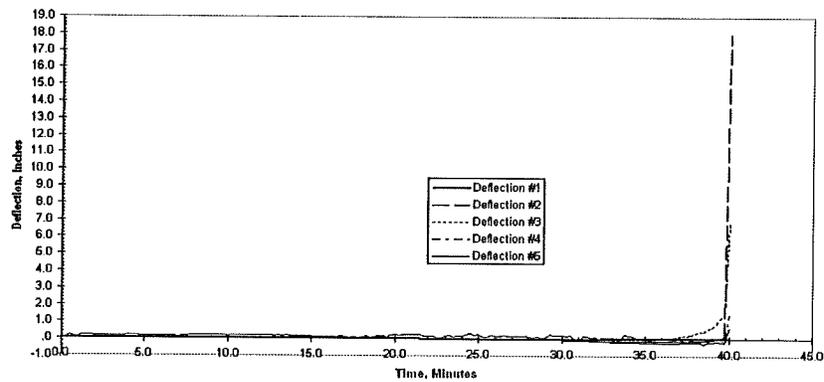
Figure 60 – Plot of Deflections vs. Time for Test Assembly No. 7

**Deflection of the Assembly** - The deflection of the floor-ceiling assembly during the fire test is shown on Figure 60. The location of each deflection transducer can be seen in Appendix A under Test Assembly 7.

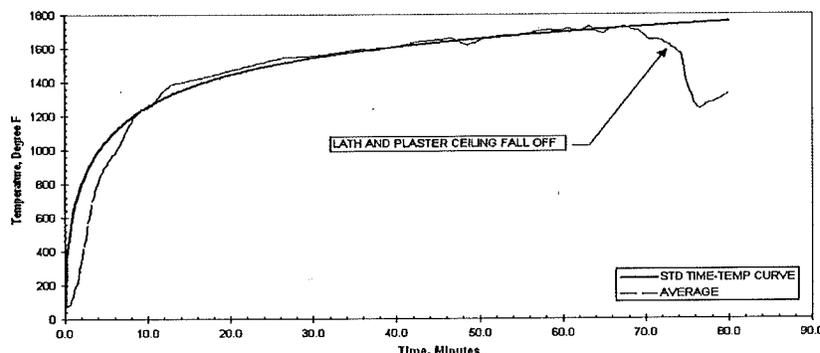
Figure 61 – UL263 Standard Time Temperature Curve and Average Furnace Temperature vs. Time for Test Assembly No. 8

**Character and Distribution of the Furnace Fire** - The furnace fire was luminous and well distributed throughout the test. A plot of the furnace temperature can be seen on Figure 61

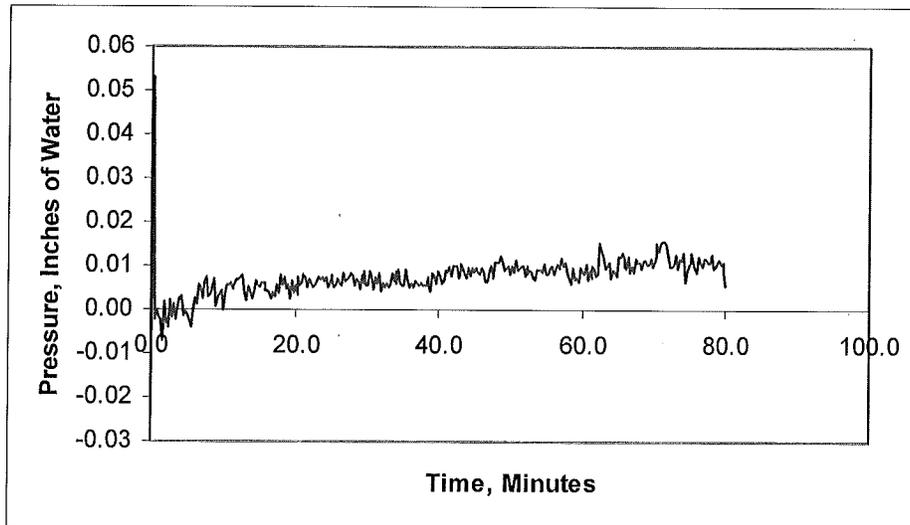
Figure 62 – Furnace Pressure vs. Time for Test Assembly No. 8

The furnace pressure and oxygen concentration are presented Figure 62 and Figure 63.

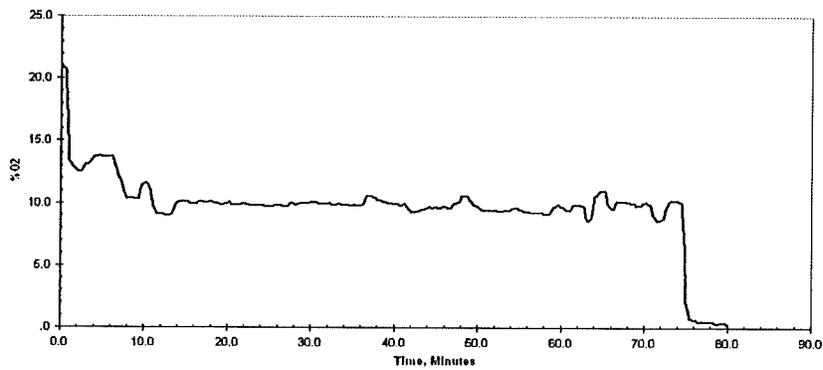
Figure 63 – Oxygen Content vs. Time for Test Assembly No. 8

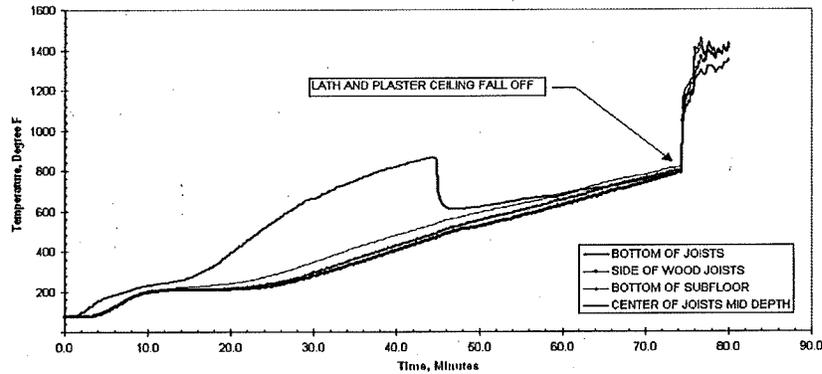
**Temperatures of the Side of Mid Depth of Wood Joists** – The average and maximum temperatures of the sides of the wood joists just before the moment of collapse (79 min 45 sec) were 1395°F and 1483°F respectively. The individual temperature was recorded by thermocouple number 27. The average temperatures were plotted on Figure 64.

**Temperatures of the Mid Depth Between Wood Joists** – The average and maximum temperatures of the mid depth between the wood joists just before the moment of collapse (79 min 45 sec) were 1403°F and 1466°F respectively. The individual temperature was recorded by thermocouple number 46. The average temperatures were plotted on Figure 64.

**Temperatures of the Sub Floor Between Wood Joists** – The average and maximum temperatures of the sub floor between the wood joists just before the moment of collapse (79 min 45 sec) were 1402°F and 1464°F respectively. The individual temperature was recorded by thermocouple number 55. The average temperatures were plotted on Figure 64.

Figure 64 – Plot of Temperatures Below Subfloor vs. Time for Test Assembly No. 8

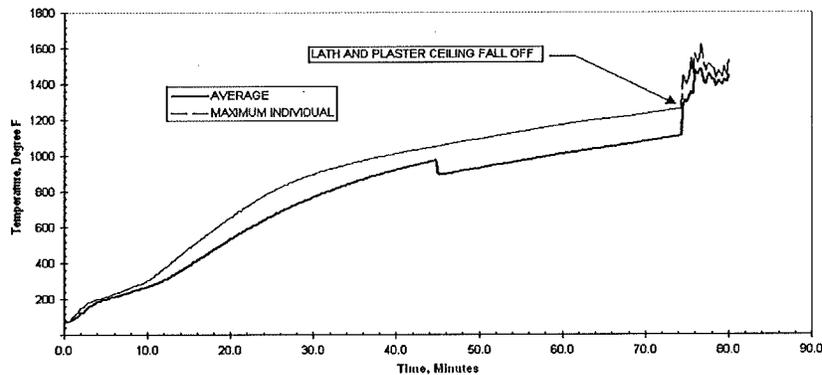
**Temperatures on the Back of the Metal Lath** – The average and maximum temperatures on the back of the metal lath just before the lath and plaster ceiling fall off (74 min) were 1109°F and 1259°F respectively. The individual temperature was recorded by thermocouple number 38. The average temperatures were plotted on Figure 65.

Figure 65 – Plot of Temperature of the Back of the Metal Lath vs. Time for Test Assembly No. 8

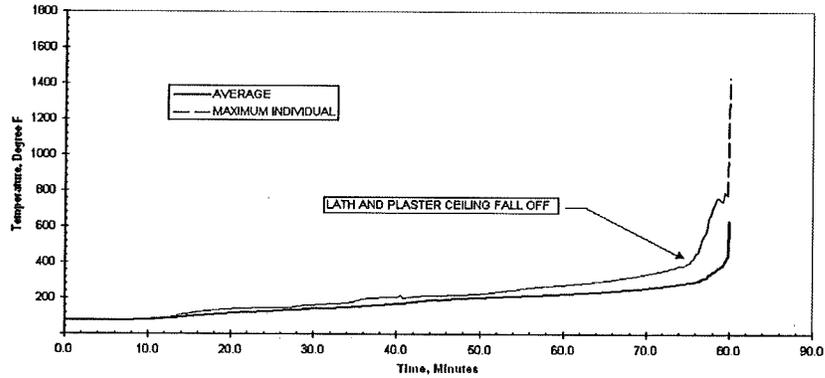
**Temperatures of Between the Sub Floor and Finish Floor** – The average and maximum temperatures between the sub floor and finish floor just before the moment of collapse (79 min 45 sec) were 430°F and 777°F respectively. The individual temperature was recorded by thermocouple number 4. The average temperatures were plotted on Figure 66.

Figure 66 – Plot of Temperature of the Subfloor Temperatures vs. Time for Test Assembly No. 8

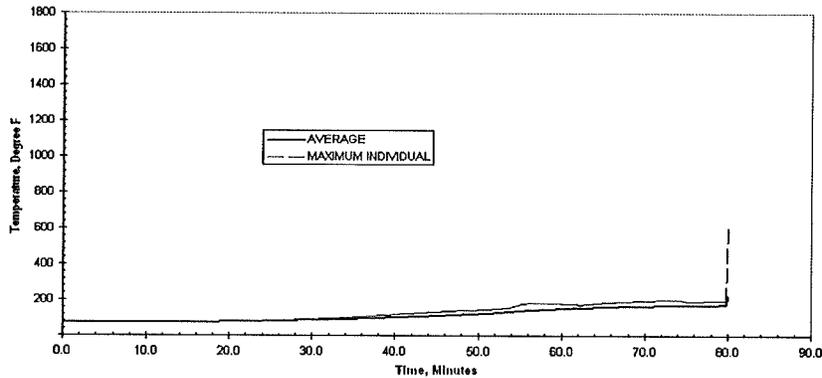
**Temperatures of the Unexposed Surface** – The average and maximum temperatures of the unexposed surface just before the moment of collapse (79 min 45 sec) were 174°F and 197°F respectively. The individual temperature was recorded by thermocouple number 65. The average temperatures were plotted on Figure 67.

Figure 67 – Plot of Temperatures of the Unexposed Surface vs. Time for Test Assembly No. 8

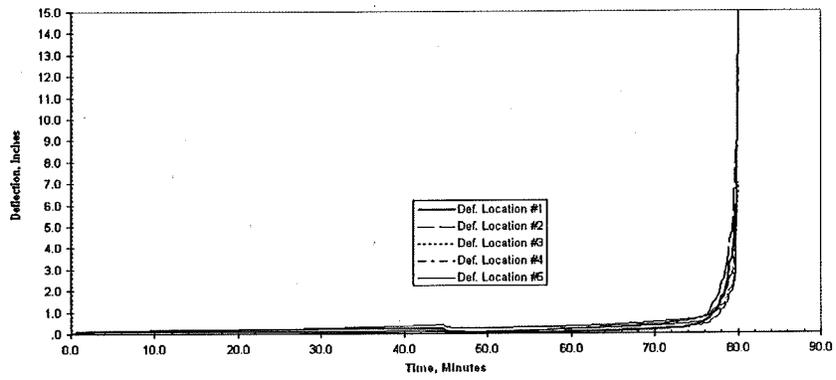
**Deflection of the Assembly** - The deflection of the floor-ceiling assembly during the fire test is shown on Figure 68. The location of each deflection transducer can be seen in Appendix A under Test Assembly 8.

Figure 68 – Plot of Deflections vs. Time for Test Assembly No. 8

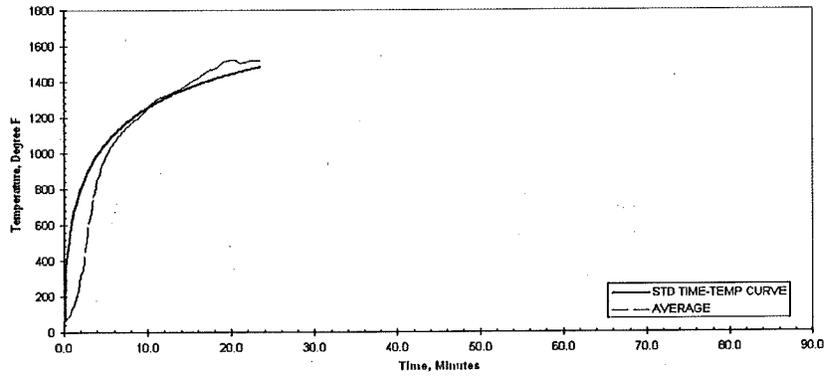
**Character and Distribution of the Furnace Fire** - The furnace fire was luminous and well distributed throughout the test. A plot of the furnace temperature can be seen on Figure 69.

Figure 69 – UL263 Standard Time Temperature Curve and Average Furnace Temperature vs. Time for Test Assembly No. 9

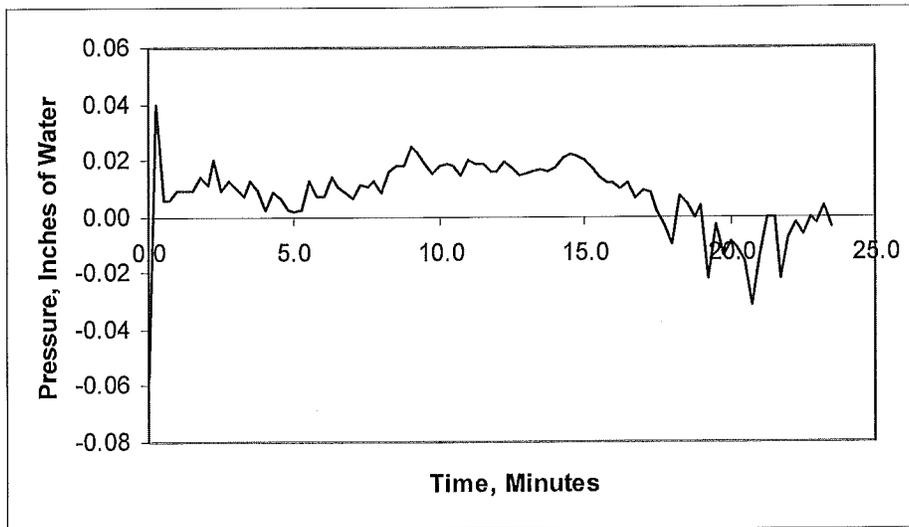
Figure 70 – Furnace Pressure vs. Time for Test Assembly No. 9

The furnace pressure and oxygen concentration are presented in Figure 70 and Figure 71.

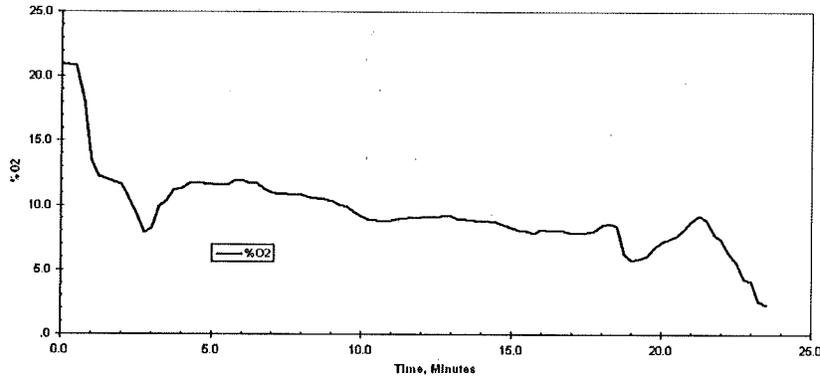
Figure 71 – Oxygen Content vs. Time for Test Assembly No. 9

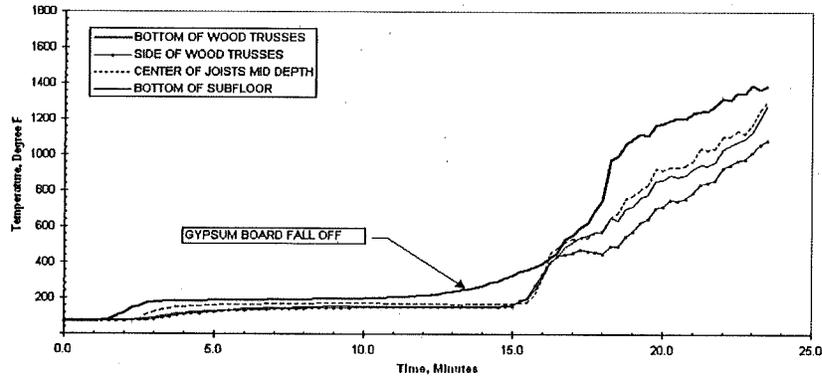
**Temperatures at Mid Depth on the Side the Trusses** – The average and maximum temperatures of the sides of the wood trusses just before the moment of collapse (23 min 15 sec) were 1061°F and 1432°F respectively. The individual temperature was recorded by thermocouple number 46. A plot of these temperatures can be seen on Figure 72.

**Temperatures of the Mid Depth Between Wood Trusses** – The average and maximum temperatures of the mid depth between the wood trusses just before the moment of collapse (23 min 15 sec) were 1255°F and 1500°F respectively. The individual temperature was recorded by thermocouple number 64. A plot of these temperatures can be seen on Figure 72.

**Temperatures on the Bottom of the Roof Deck Between Wood Trusses** – The average and maximum temperatures of the sub floor between the wood joists just before the moment of collapse (23 min 15 sec) were 1206°F and 1499°F respectively. The individual temperature was recorded by thermocouple number 74. A plot of these temperatures can be seen on Figure 72.

Figure 72 – Plot of Temperature Below Subfloor vs. Time

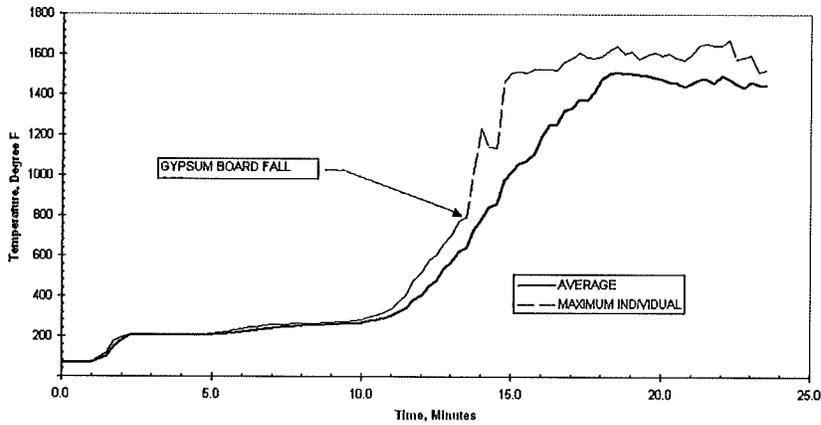
**Temperatures of the Unexposed Side of Gypsum Board** – The average and maximum temperatures of the unexposed surface just before the gypsum board fall off (13 min 45 sec) were 731°F and 1033°F respectively. The individual temperature was recorded by thermocouple number 56. A plot of these temperatures can be seen on Figure 73

Figure 73 – Plot of Temperature of the Unexposed Surface of Gypsum Board vs. Time

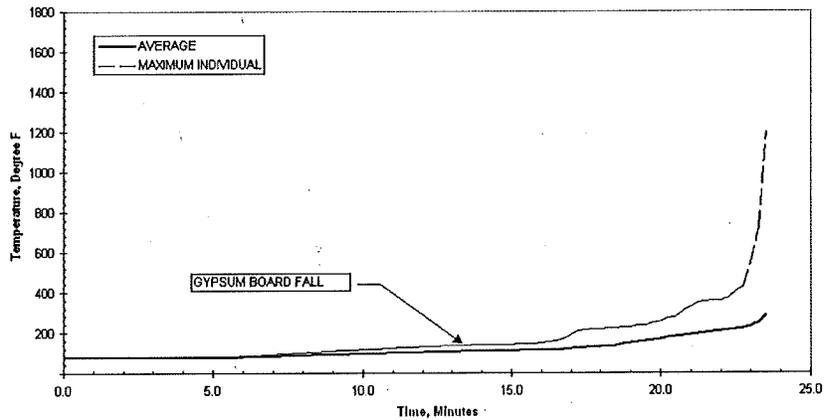
**Temperatures on the Top of the Roof Deck** – The average and maximum temperatures between the roof deck and roof felt just before the moment of collapse (23 min 15 sec) were 249°F and 723°F respectively. The individual temperature was recorded by thermocouple number 9. A plot of these temperatures can be seen on Figure 9.6.

Figure 9.6 – Plot of Temperature of the Roof Deck Temperatures vs. Time

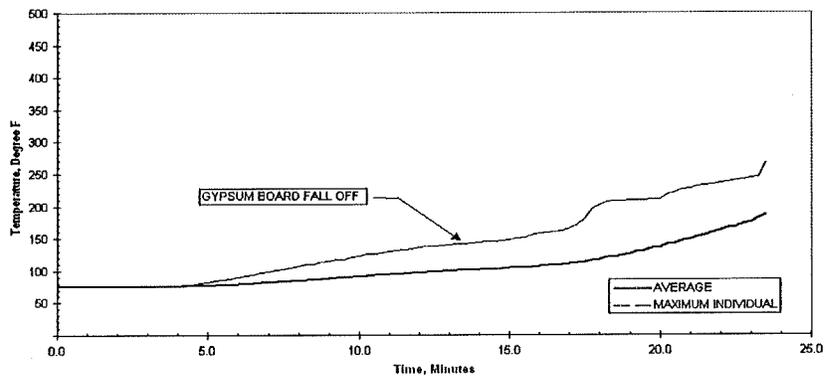
**Temperatures on the Roofing Felt** – The average and maximum temperatures between the sub floor and finish floor just before the moment of collapse (23 min 15 sec) were 182°F and 245°F respectively. The individual temperature was recorded by thermocouple number 23. A plot of these temperatures can be seen on Figure 9.7.

Figure 74 – Plot of Temperature of the Roofing Felt vs. Time

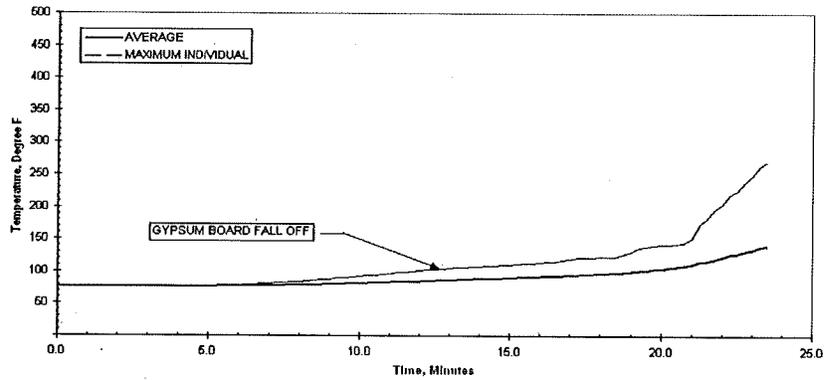
**Temperatures of the Unexposed Surface** – The average and maximum temperatures of the unexposed surface just before the moment of collapse (23 min 15 sec) were 138°F and 263°F respectively. The individual temperature was recorded by thermocouple number 92. A plot of these temperatures can be seen on Figure 75.

Figure 75 – Plot of Temperatures of the Unexposed Surface vs. Time

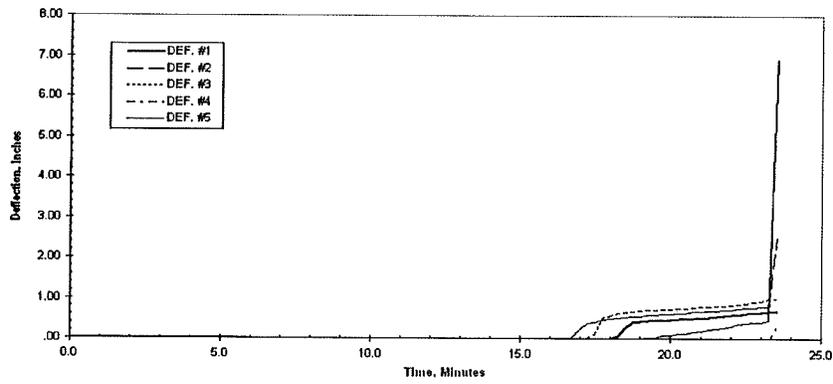
**Deflection of the Assembly** - The deflection of the floor-ceiling assembly during the fire test is shown on Figure 9.9. The location of each deflection transducer can be seen in Appendix A under Figure 76.

Figure 76 – Plot of Deflections vs. Time

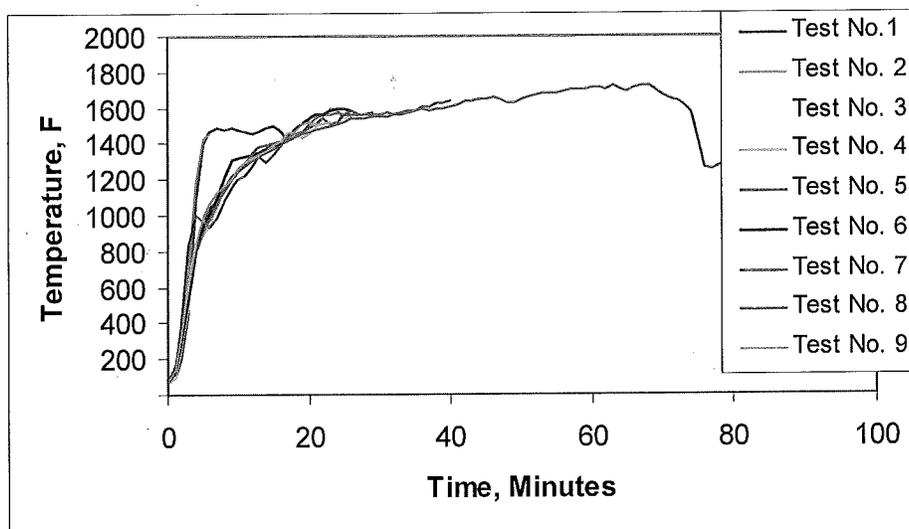
Figure 77 - Furnace Temperature

The furnace temperature during the initial portion of Test Nos. 1 and 2 were significantly higher than recorded during Test Nos. 3 through 9 because the combustible supports and sub-floors for both of these assemblies were exposed to the furnace fire at the start of the test. The relatively low furnace temperatures recorded during the later stages of Test No. 8 reflect the collapse of the plaster ceiling upon the thermocouples in the furnace.

The average temperature within the furnace, the pressure within the furnace and the percent oxygen content in the furnace exhaust duct were plotted in Figure 77, Figure 78 and Figure 79, respectively.

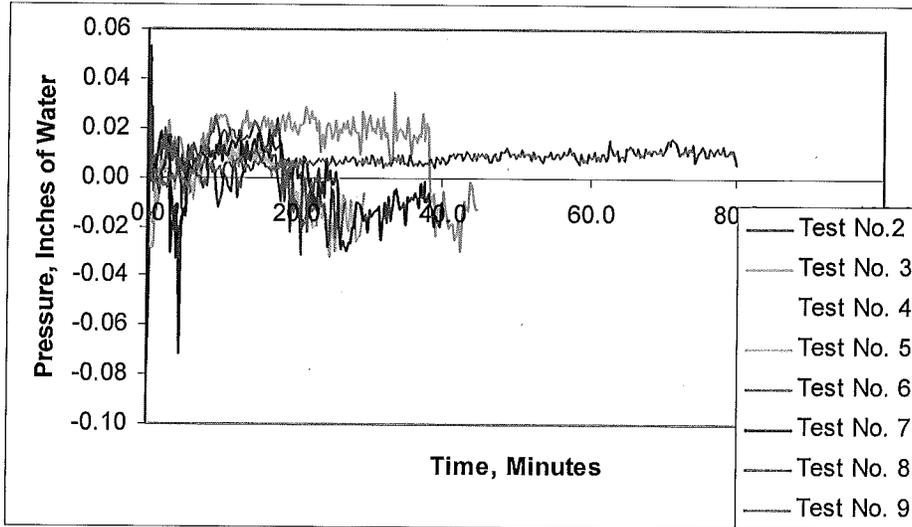
Figure 78 - Furnace Pressure

The furnace pressure was measured at a level approximately 4 inches below the ceiling surface. After the initial few minutes, the furnace pressure ranged from 0.01 to 0.02 inches of water until the ceiling fell. Then the furnace pressure became negative and ranged for 0.01 to 0.03 inches of water.

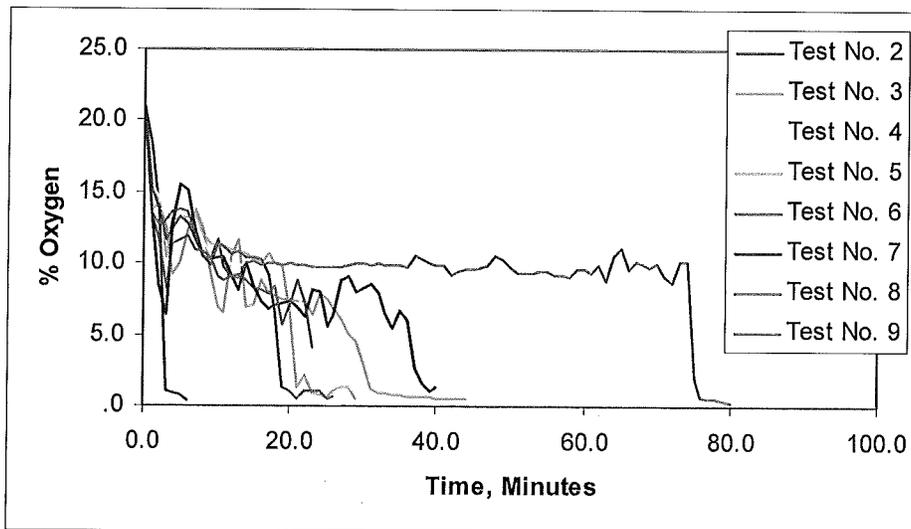
Figure 79 - Percent Oxygen in Furnace

The percent oxygen content at the beginning of the tests was approximately 19 to 20 percent and was reduced to approximately 6 to 8 percent during the tests when the ceilings were in place. The percent oxygen content dropped to near zero after the ceilings fell and the combustible supports and sub-floor were exposed to the furnace flames.

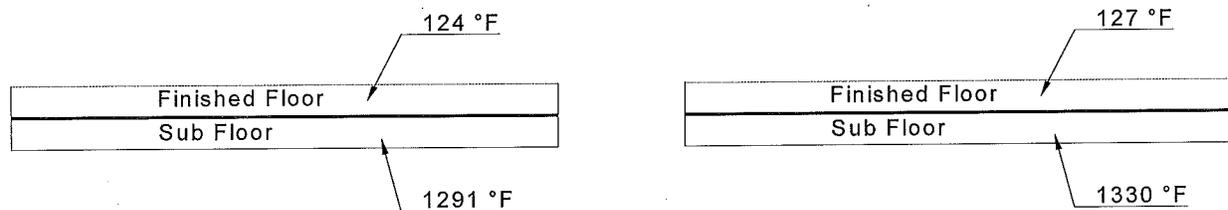
Figure 80 -Test Assembly No. 1

60 seconds before collapse

30 seconds before collapse

Collapse at 18 min.: 45 sec.

The use of thermal imaging cameras by firefighters continues to grow and has many current and potential life safety applications. The temperature on the surfaces of the floor and roof were measured at several locations during each fire test. The temperatures of these surfaces at 60 seconds and at 30 seconds before collapse are shown in Figure 80 to Figure 88.

Table 15 provides a summary of the temperature data in the previous Figure 80 through Figure 88.

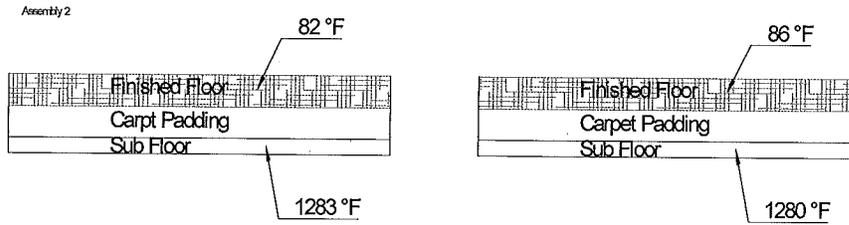
Figure 81- Test Assembly No. 2

60 seconds before collapse

30 seconds before collapse

Collapse at 6 min.: 3 sec.

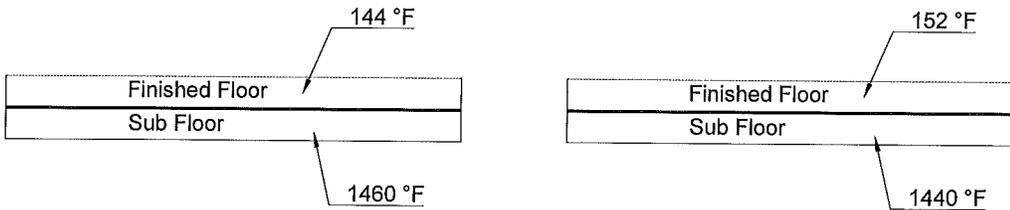
Figure 82 - Test Assembly No. 3

60 seconds before collapse

30 seconds before collapse

Collapse at 44 min.: 45 sec.

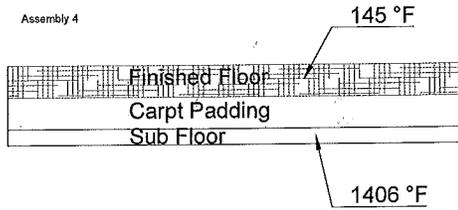
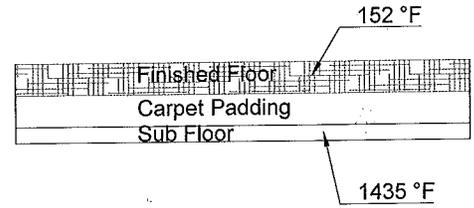
Figure 83 - Test Assembly No. 4

60 seconds before collapse

30 seconds before collapse

Collapse at 26 min.: 45 sec.

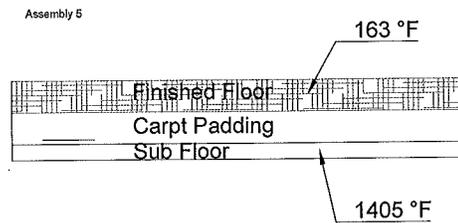
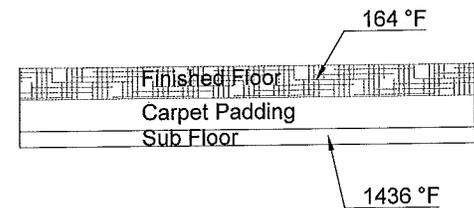
Figure 84 - Test Assembly No. 5

60 seconds before collapse

30 seconds before collapse

Collapse at 29 min.: 15 sec.

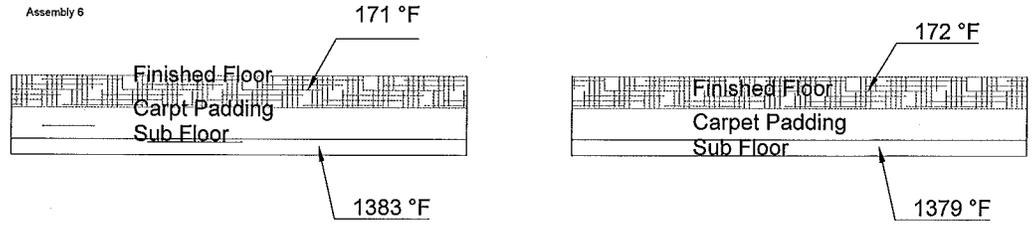
Figure 85 - Test Assembly No. 6

60 seconds before collapse

30 seconds before collapse

Collapse at 26 min.: 45 sec.

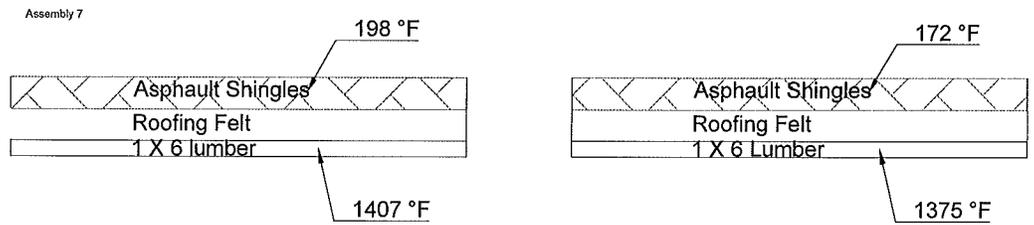
Figure 86 - Test Assembly No. 7

60 seconds before collapse

30 seconds before collapse

Collapse at 40 min.

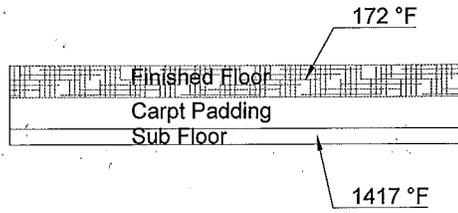
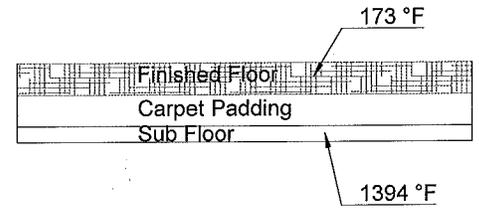
Figure 87 - Test Assembly No. 8

60 seconds before collapse

30 seconds before collapse

Collapse at 79 min.: 45 sec.

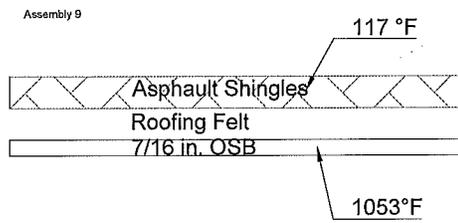
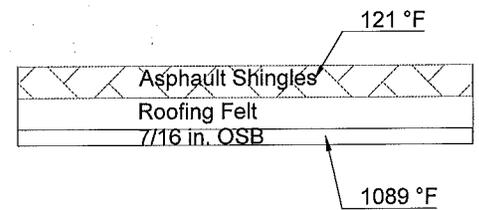
60 seconds before collapse

30 seconds before collapse

Collapse at 23 min.: 15 sec.

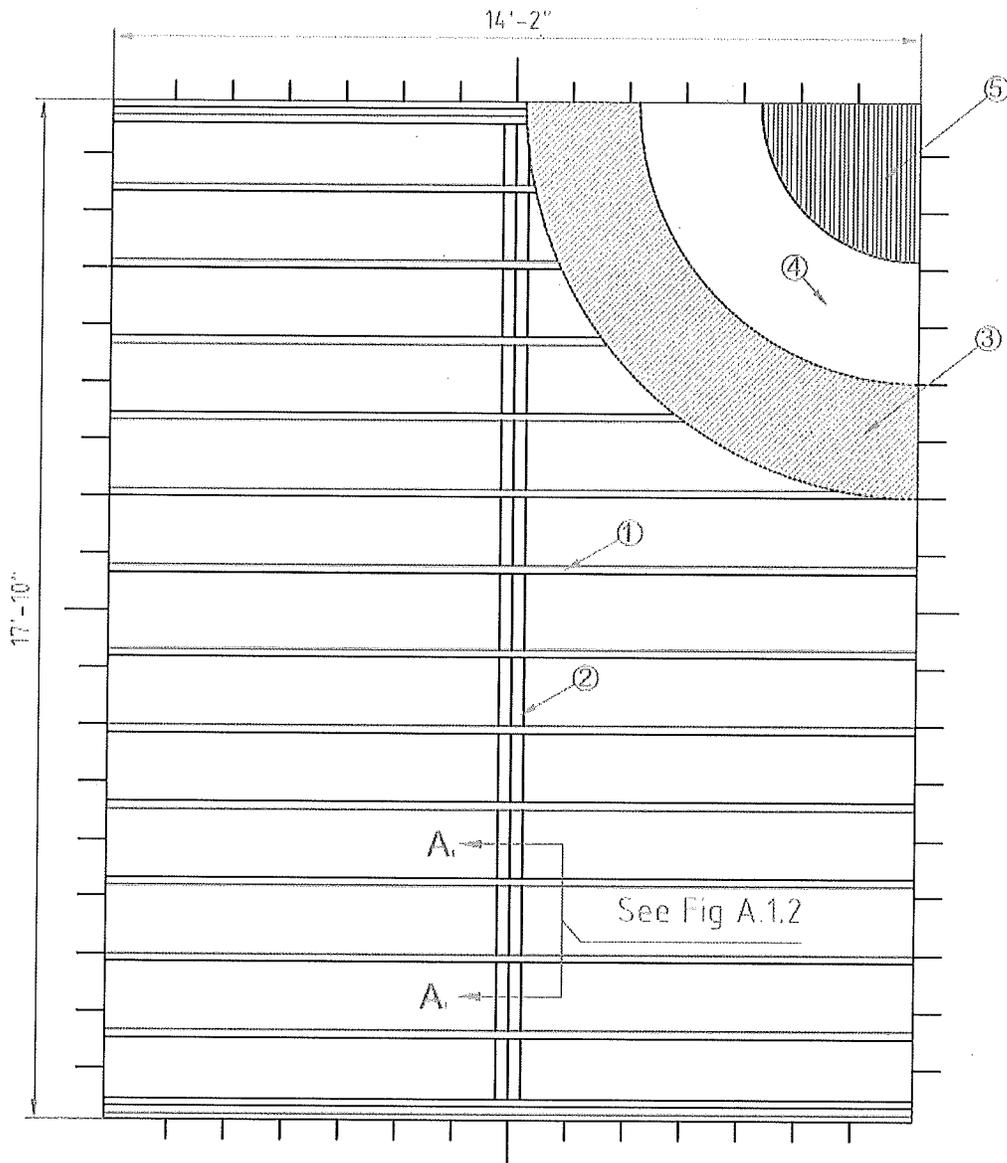
Figure A.1.1 – Construction Layout.

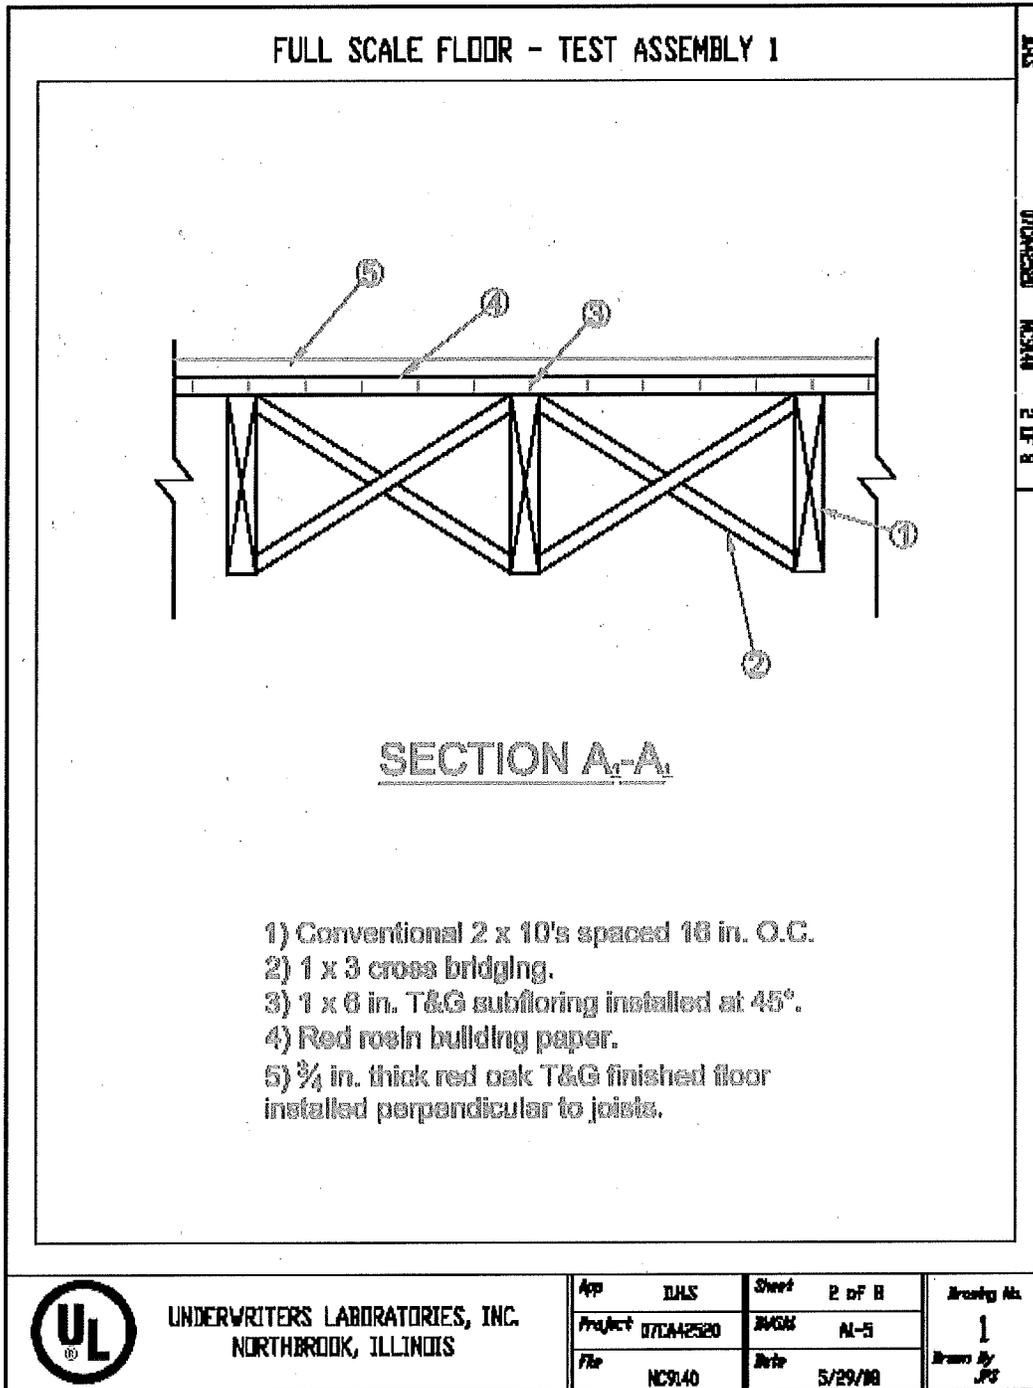
Figure A.1.2 – Construction Layout Section A<sub>1</sub>-A<sub>1</sub>.

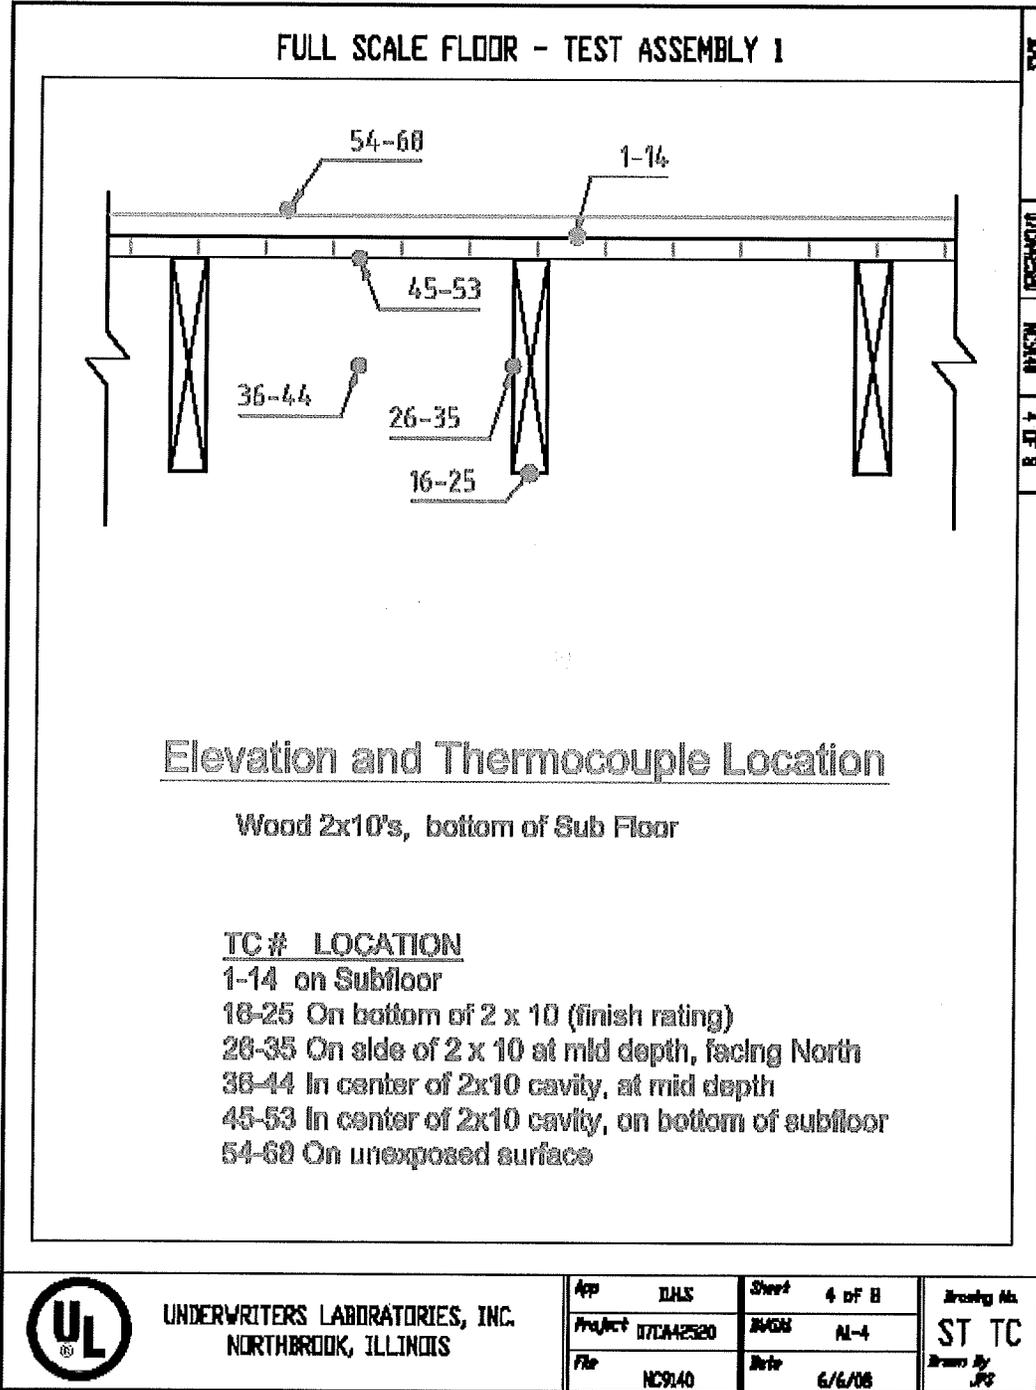
Figure A.1.3 – Thermocouple Locations - Elevation.

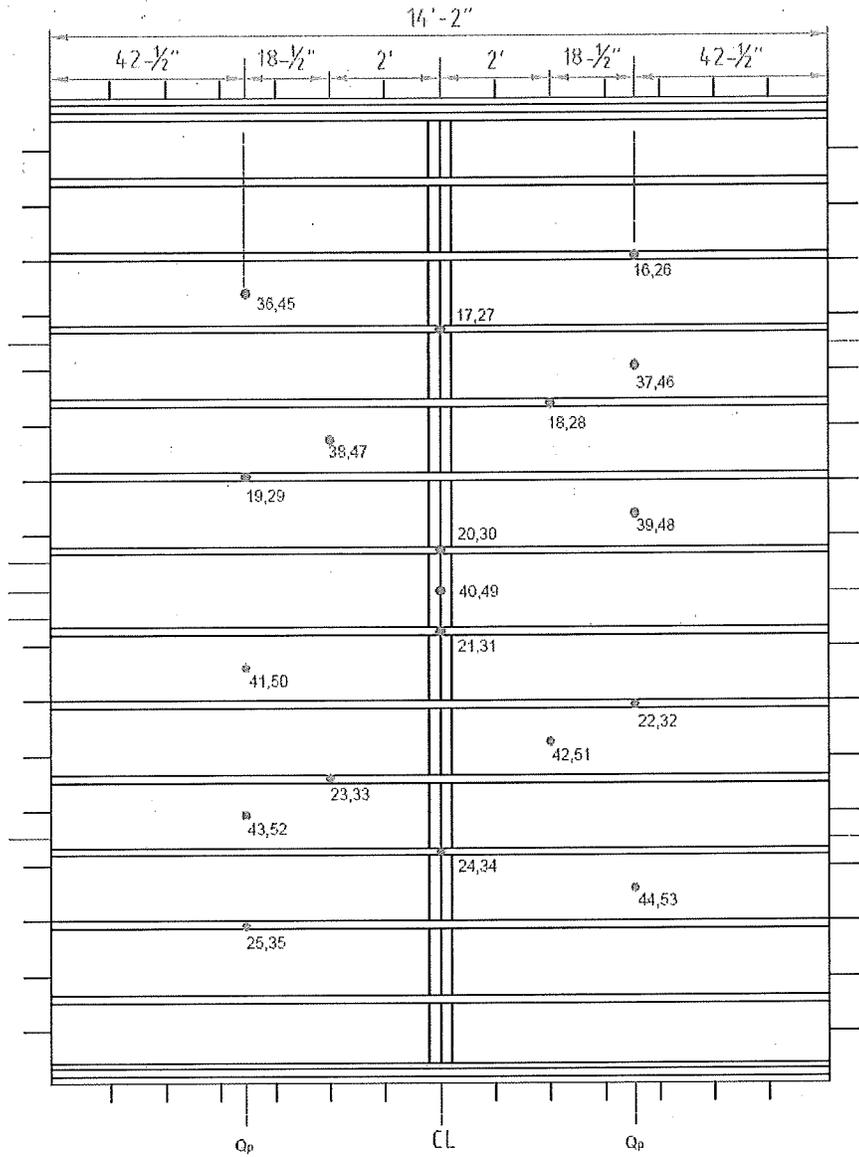
Figure A.1.4 – Thermocouple Locations on Wood Members.

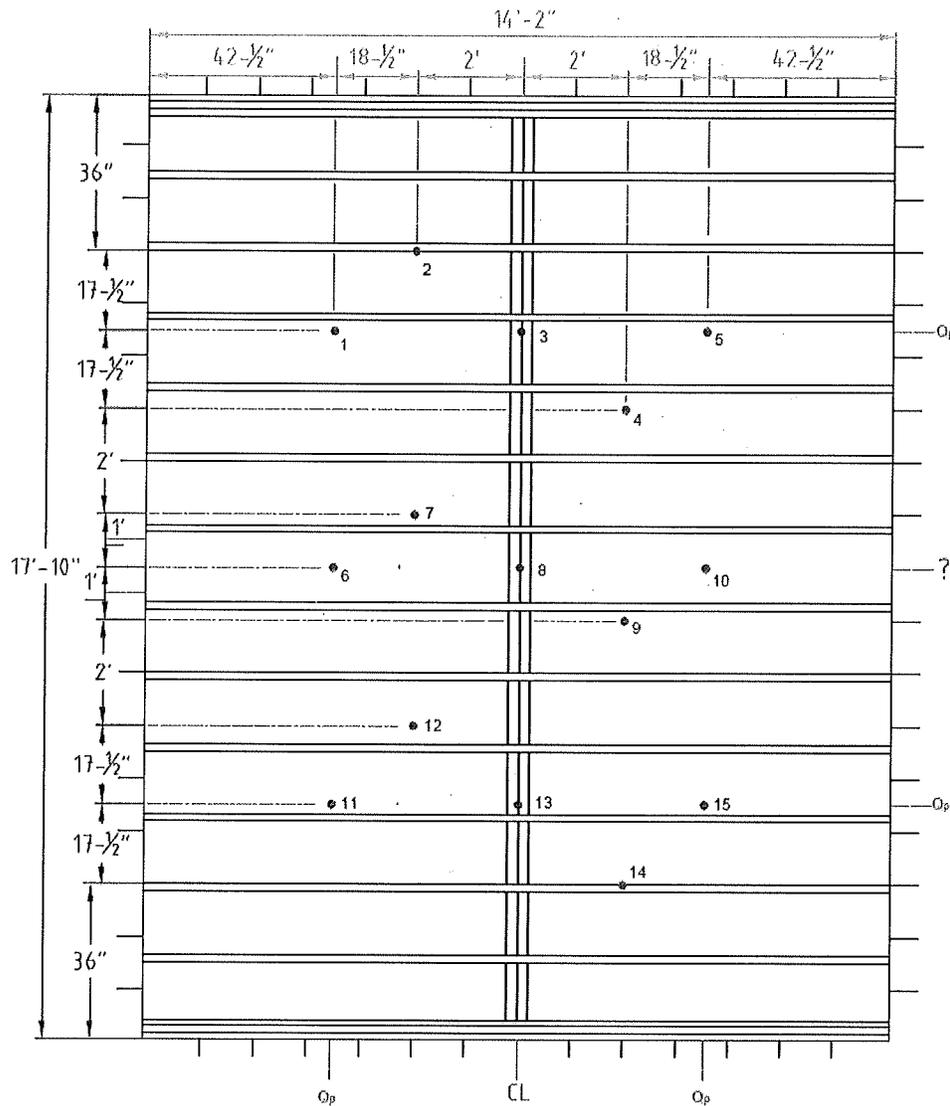
Figure A.1.5 – Thermocouple Locations on Subfloor.

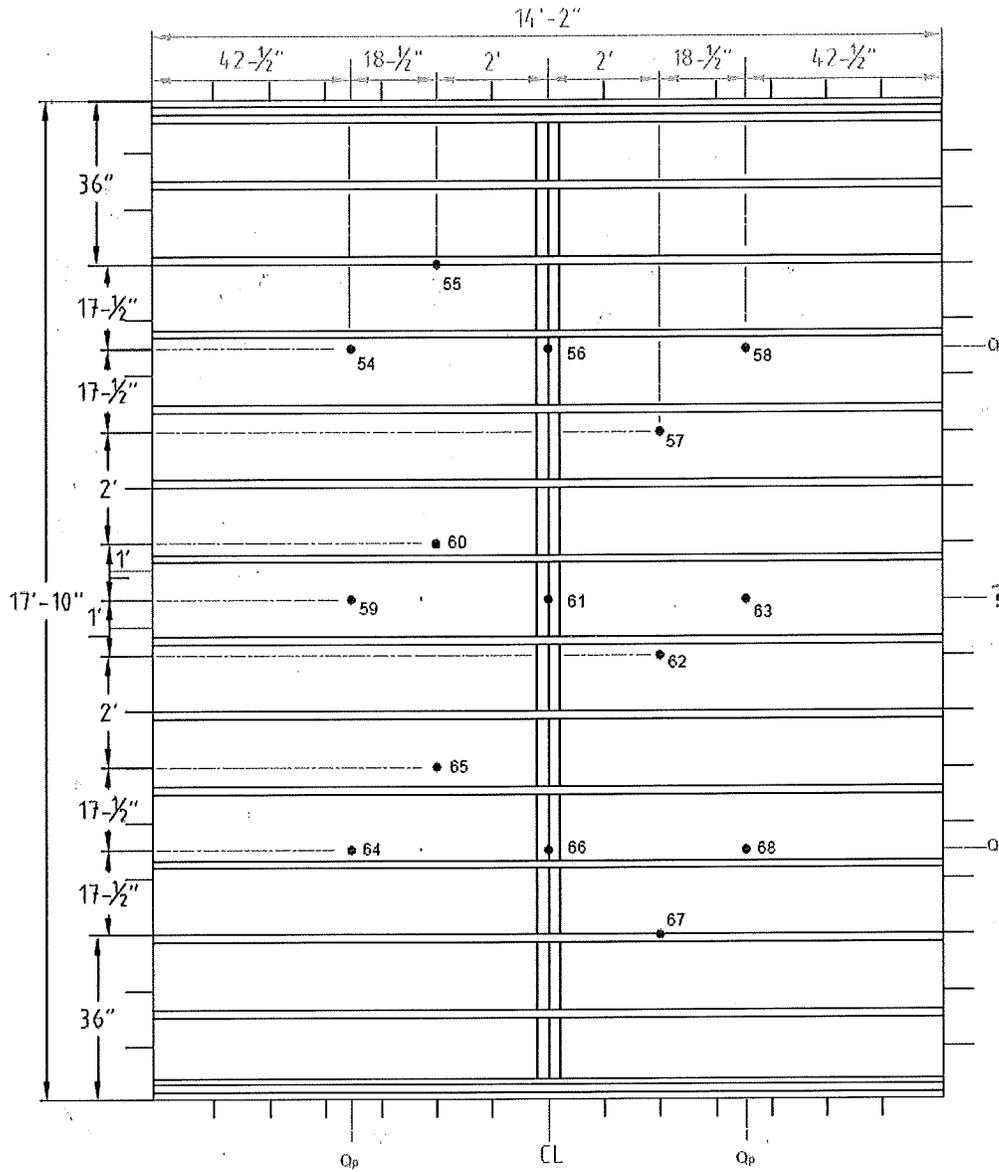
Figure A.1.6 – Thermocouple Locations on Unexposed Surface.
