Underwriters  
Laboratories

**Report  
on  
Structural Stability of Engineered Lumber in Fire Conditions**

**Project Number: 07CA42520**

**September 30, 2008**

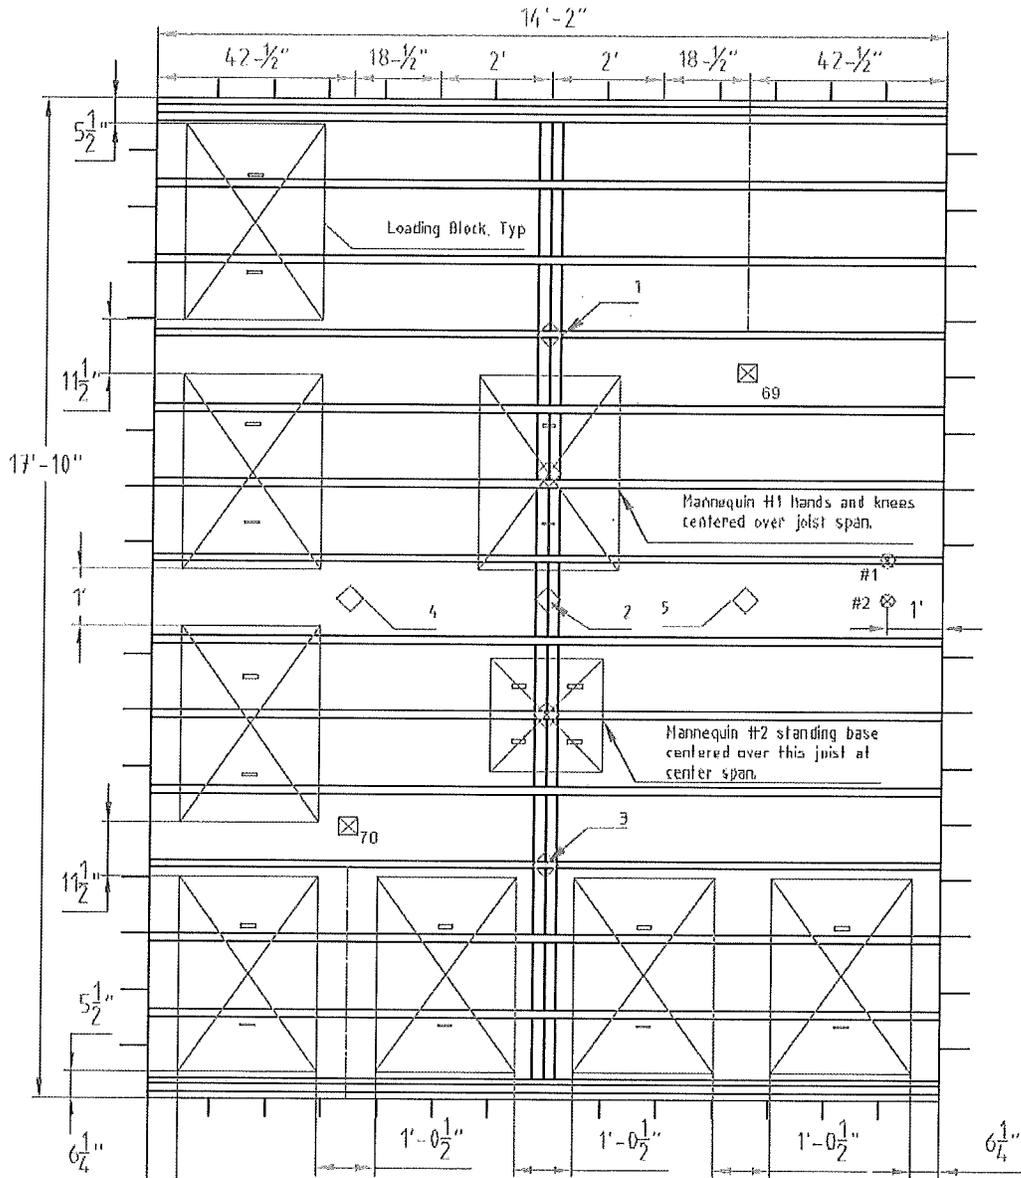
Figure A.1.7 – Loading and Instrumentation Layout (See Figure A.1.8).

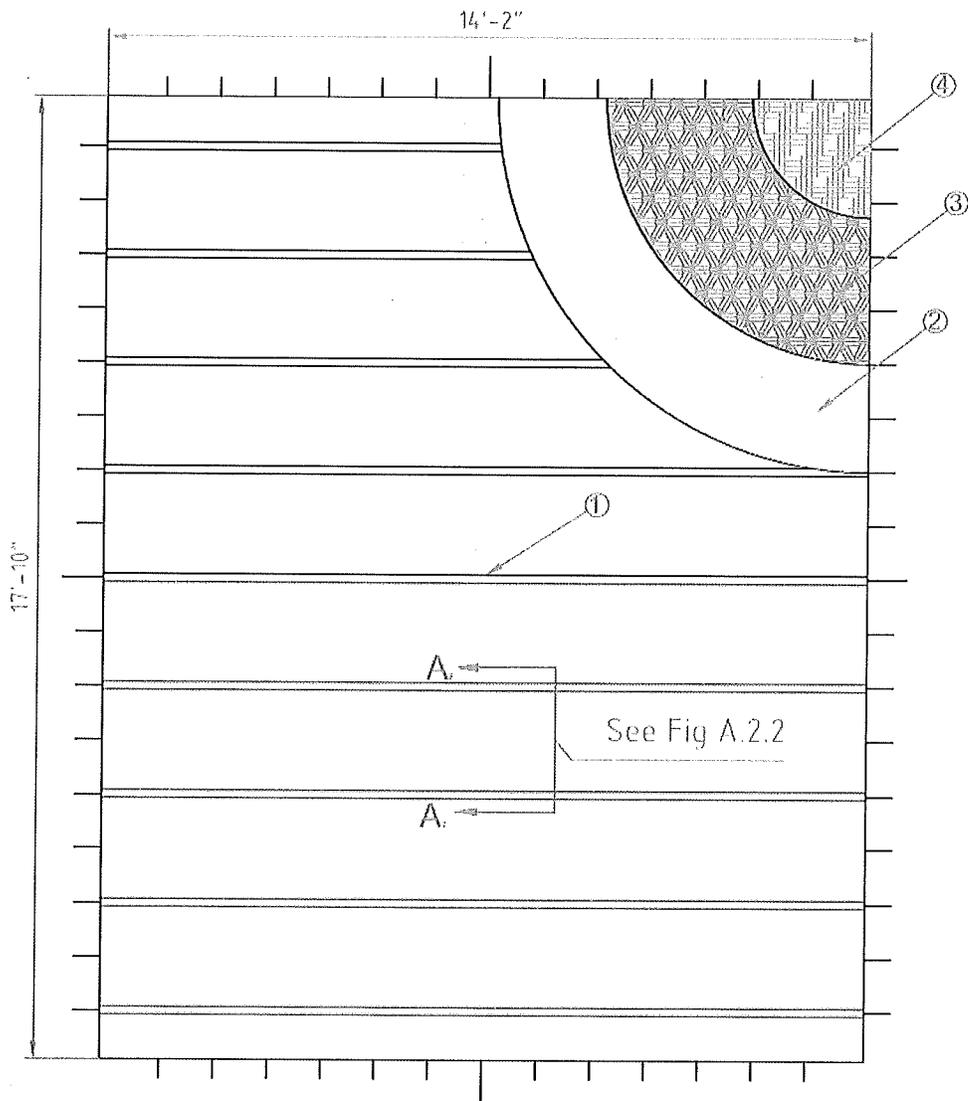
Figure A.2.1 – Construction Layout

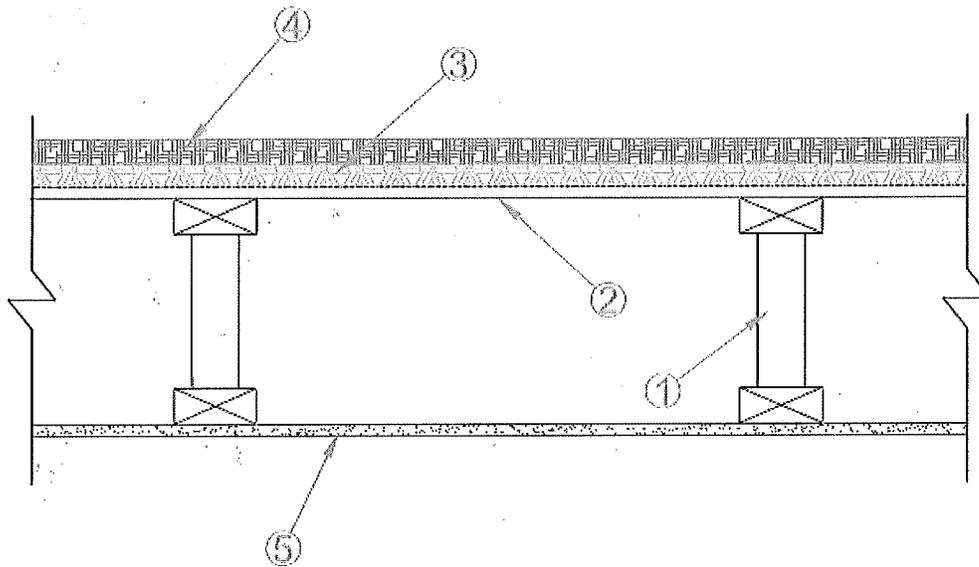
Figure A.6.2 – Construction Layout Section A<sub>6</sub>-A<sub>6</sub>.

- 1) 14 in. Deep wood truss with glued finger joints spaced 24 in. O.C.
- 2) OSB  $2\frac{3}{32}$  in. APA rated sheathing, T&G  $\frac{48}{24}$  span rating.
- 3) Standard carpet padding.
- 4) Standard carpeting.
- 5)  $\frac{1}{2}$  in. thick regular gypsum wallboard.

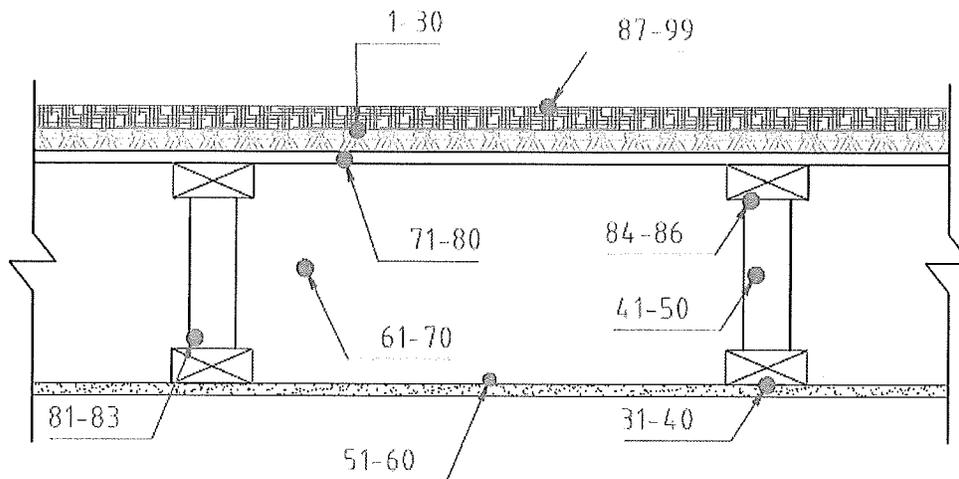
Figure A.6.3 – Thermocouple Locations - Elevation.

Wood truss, Plenum, bottom of Sub Floor

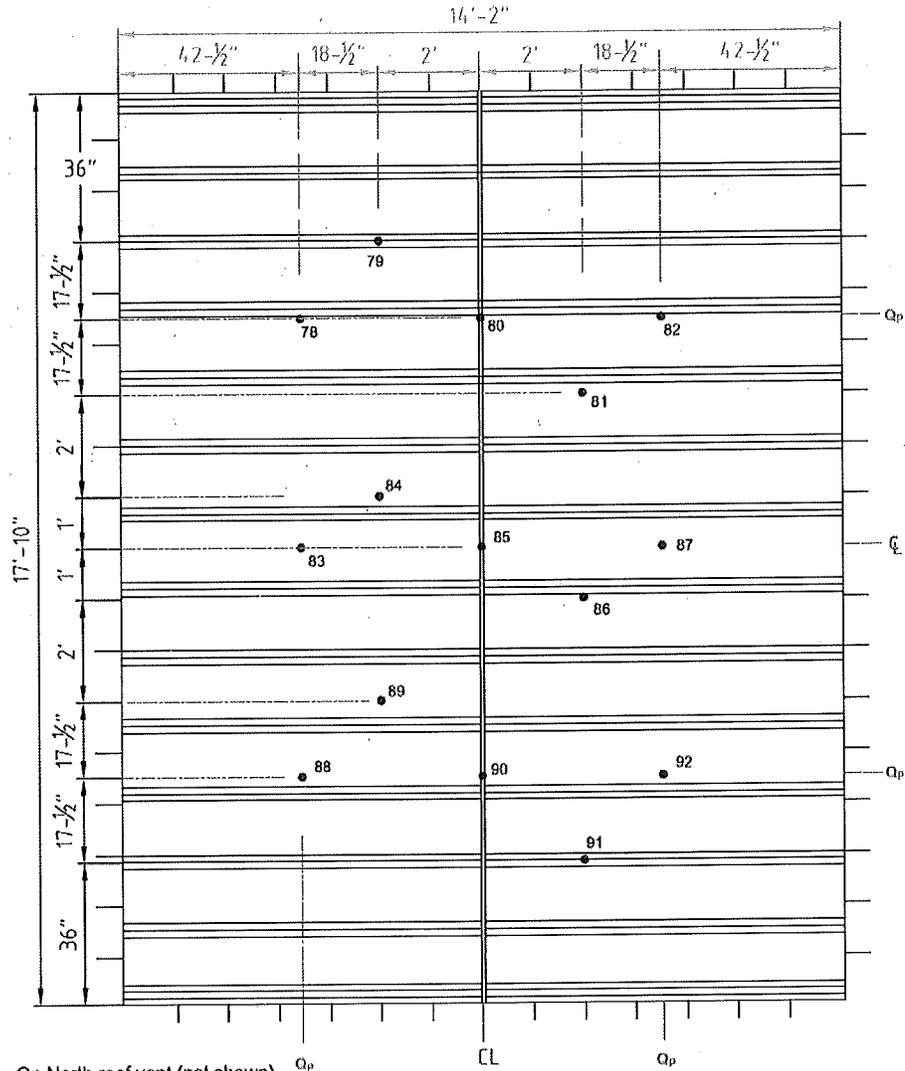
Figure A.7.6 – Thermocouple Locations on Unexposed Surface.

- 93 - On North roof vent (not shown)
- 94 - On Center roof vent (not shown)
- 95 - On South roof vent (not shown)

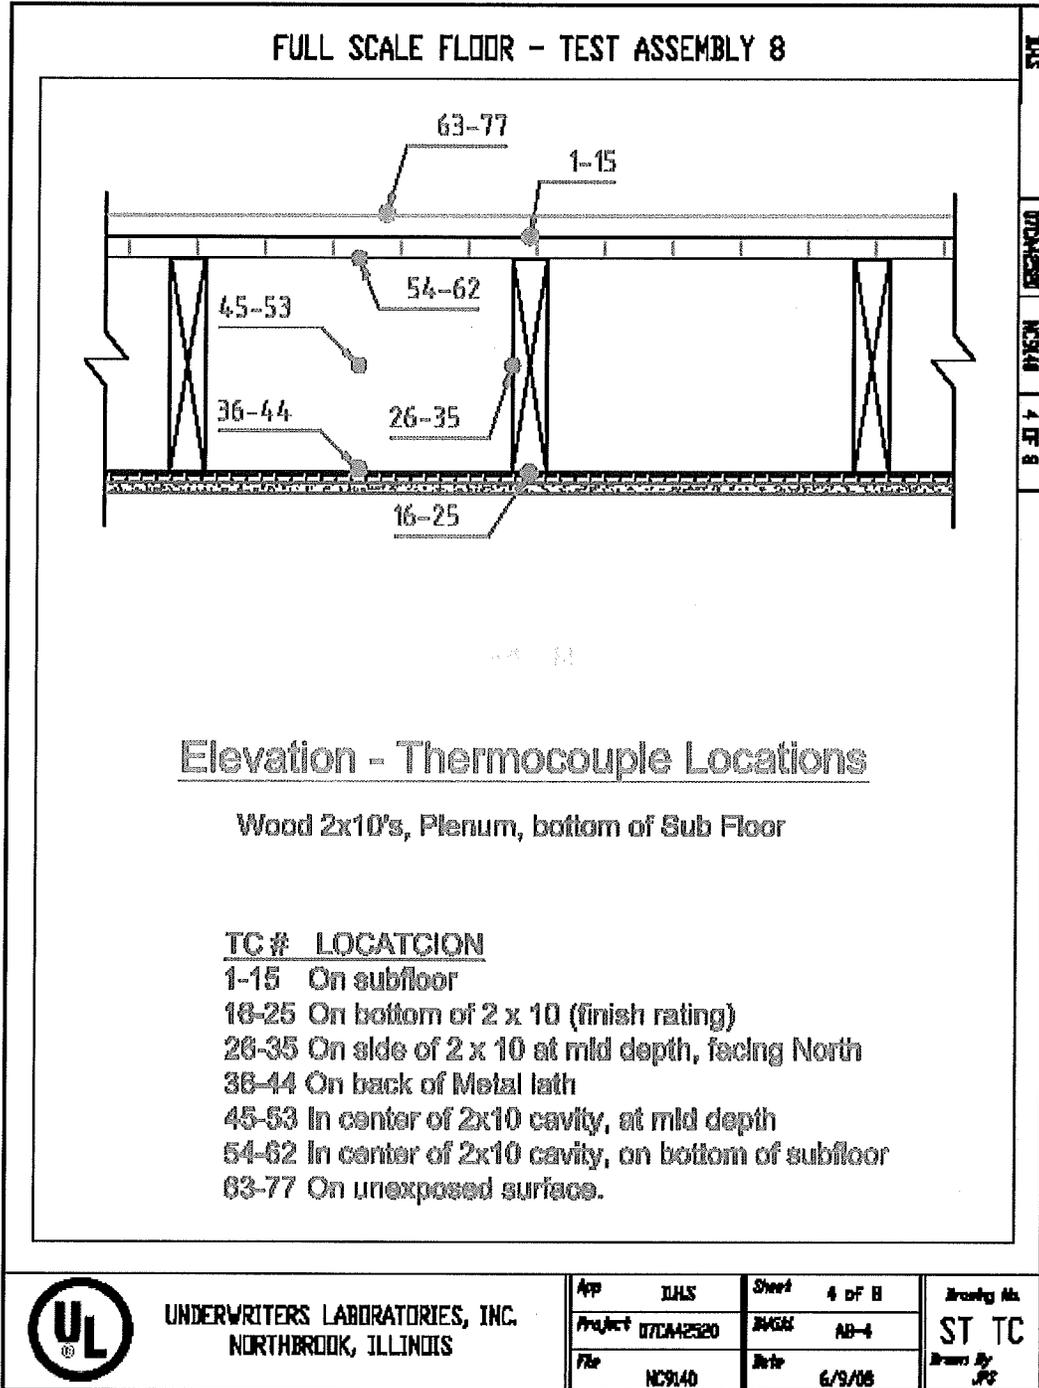
Figure A.8.3 – Thermocouple Locations - Elevation.

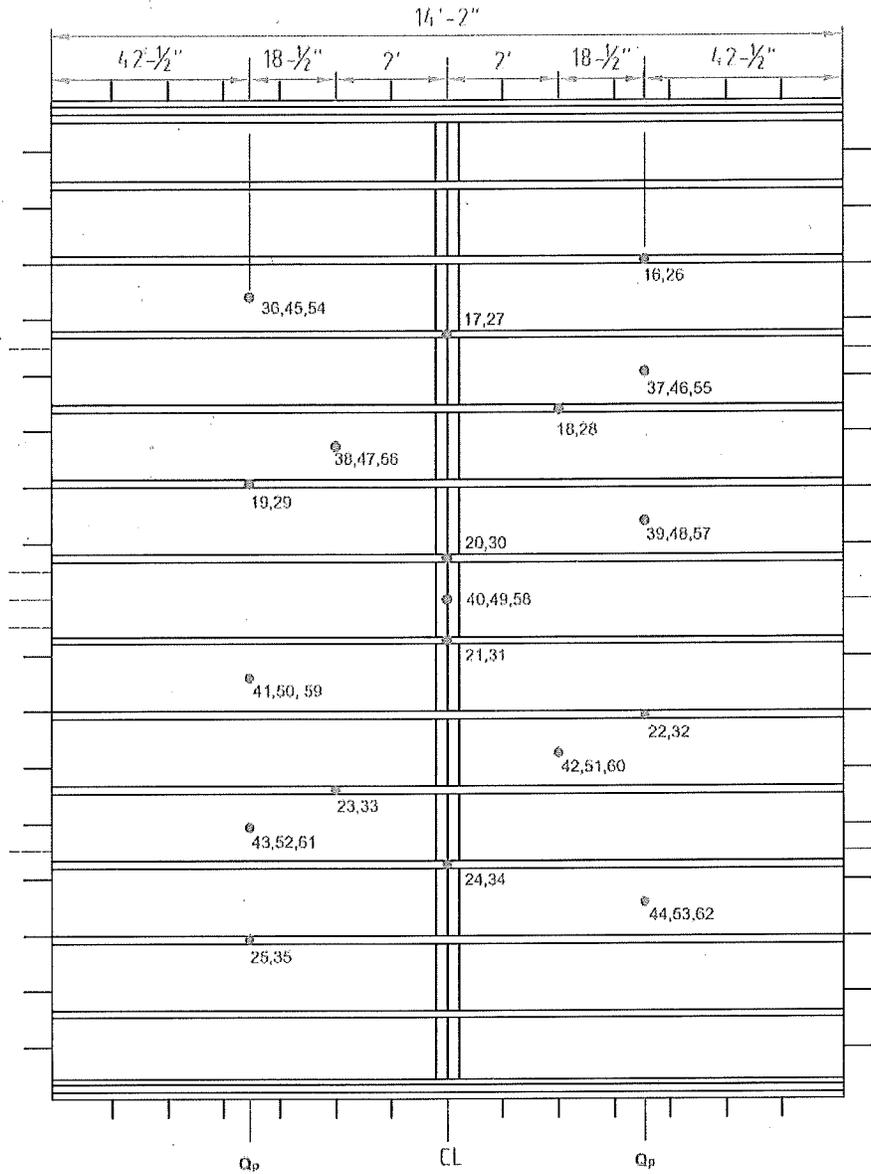
Figure A.8.4 – Thermocouple Locations on Wood Members.

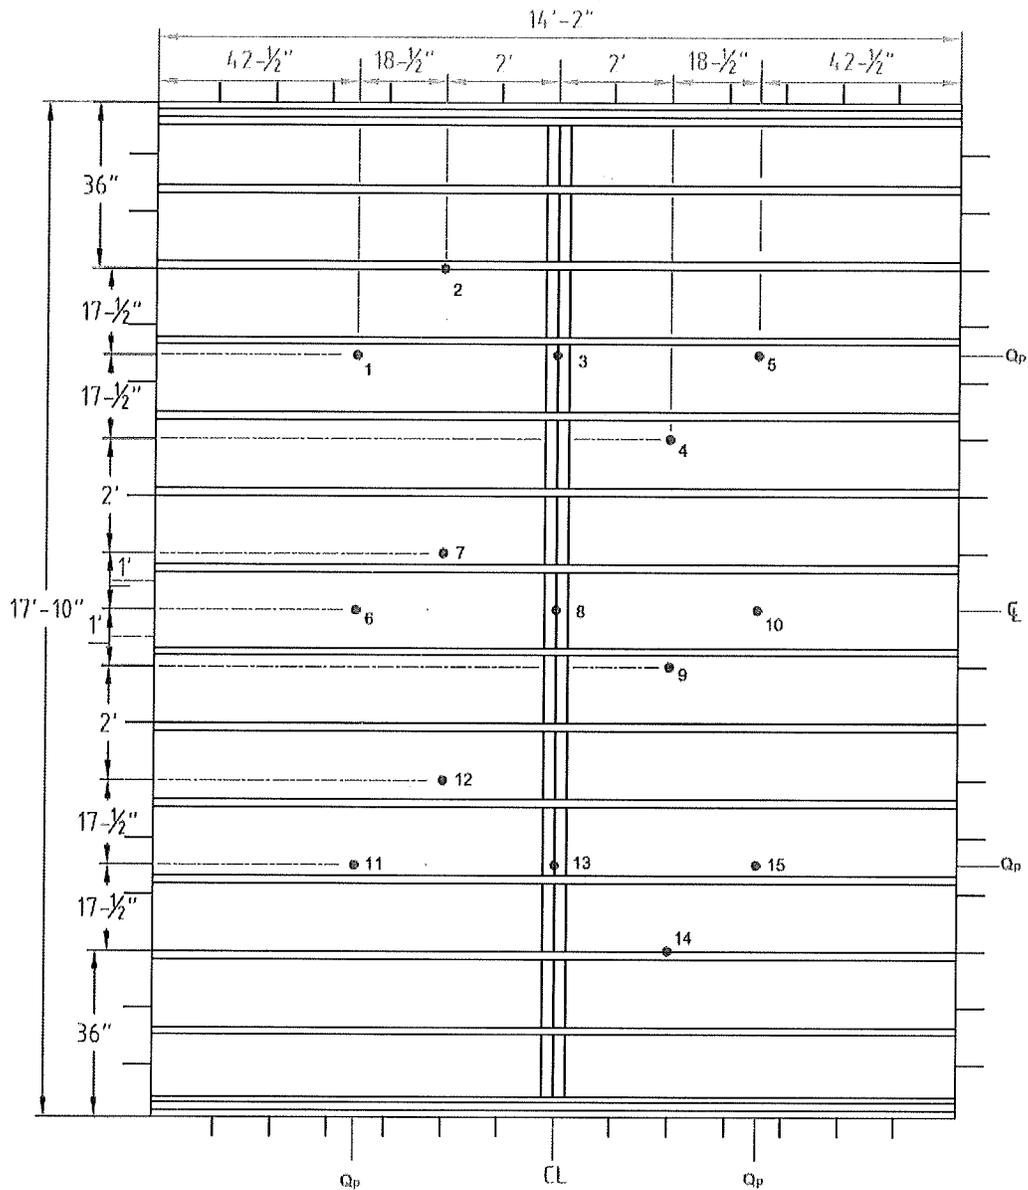
Figure A.8.5 – Thermocouple Locations on Subfloor.

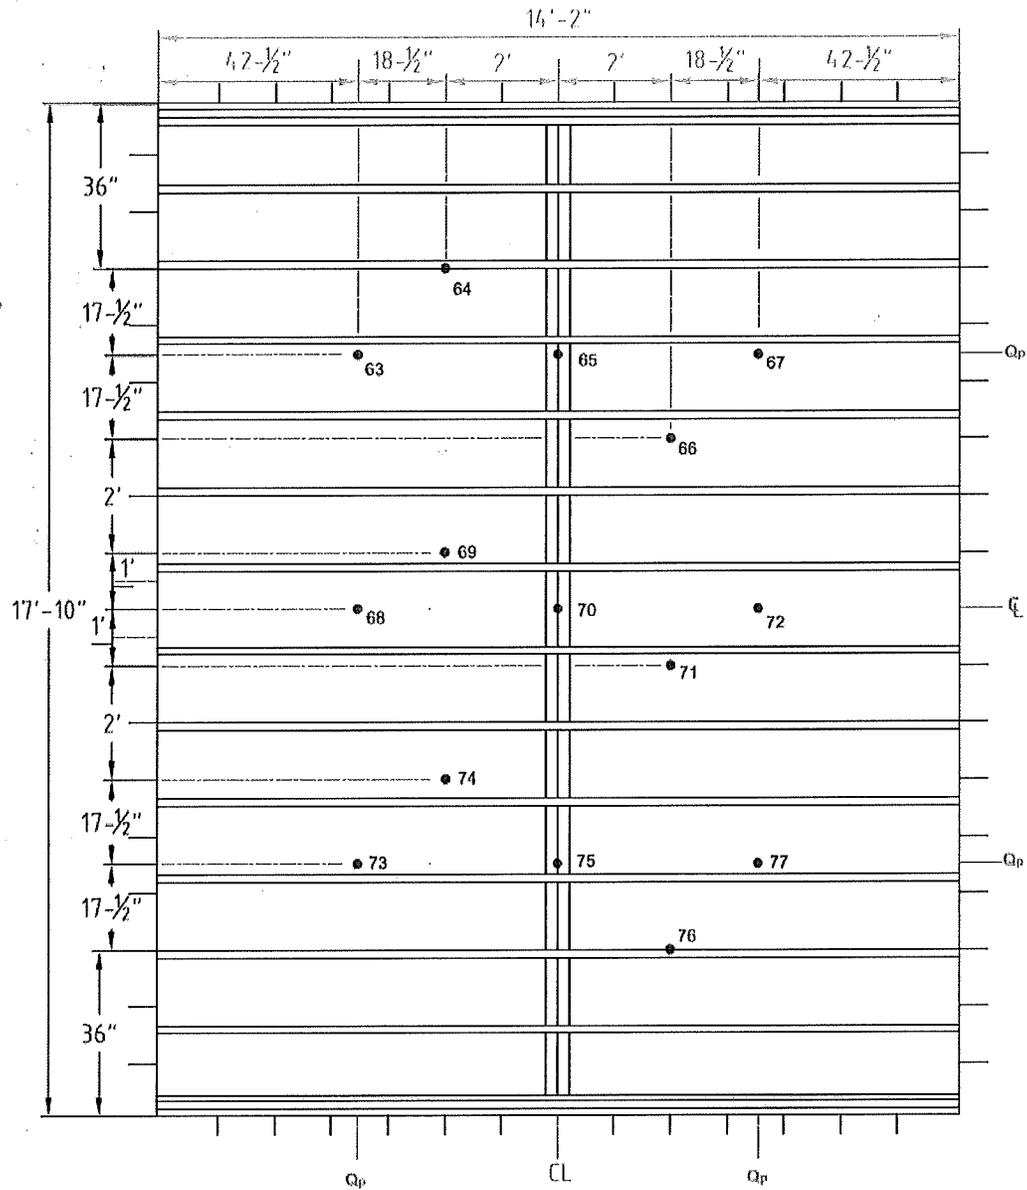
Figure A.8.6 – Thermocouple Locations on Unexposed Surface.

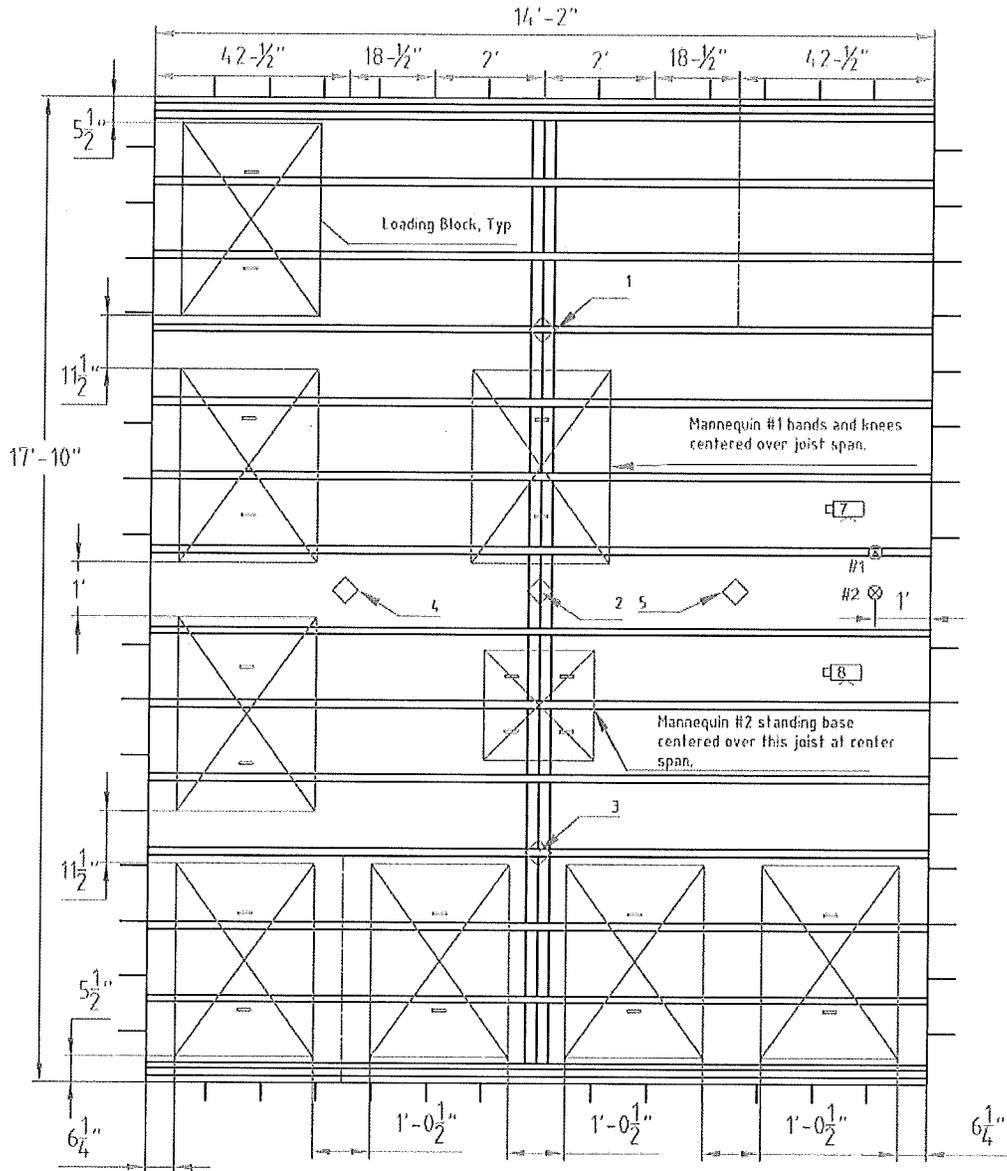
Figure A.8.7 – Loading and Instrumentation Layout (See Figure A.8.8).

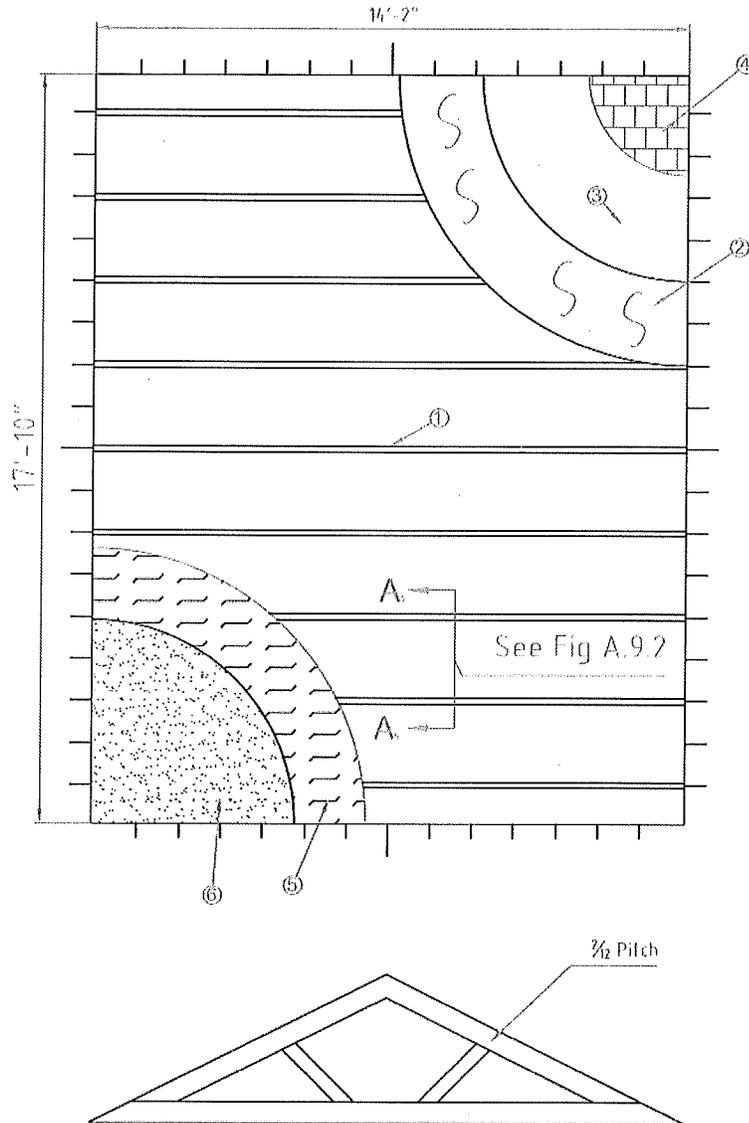
Figure A.9.1 – Construction Layout

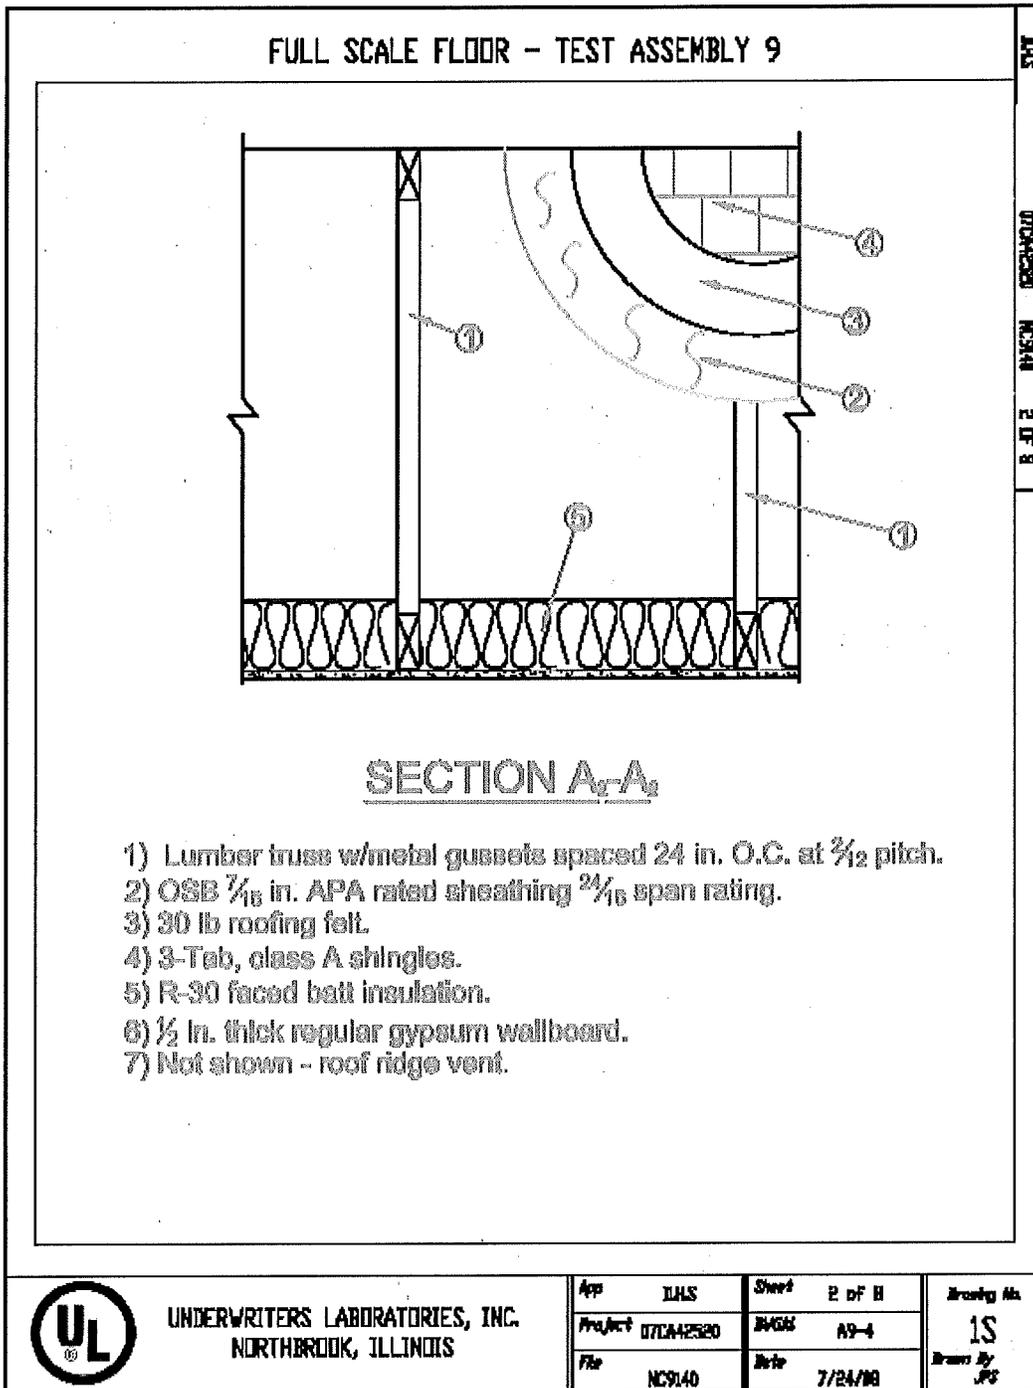
Figure A.9.2 – Construction Layout Section A<sub>9</sub>-A<sub>9</sub>.

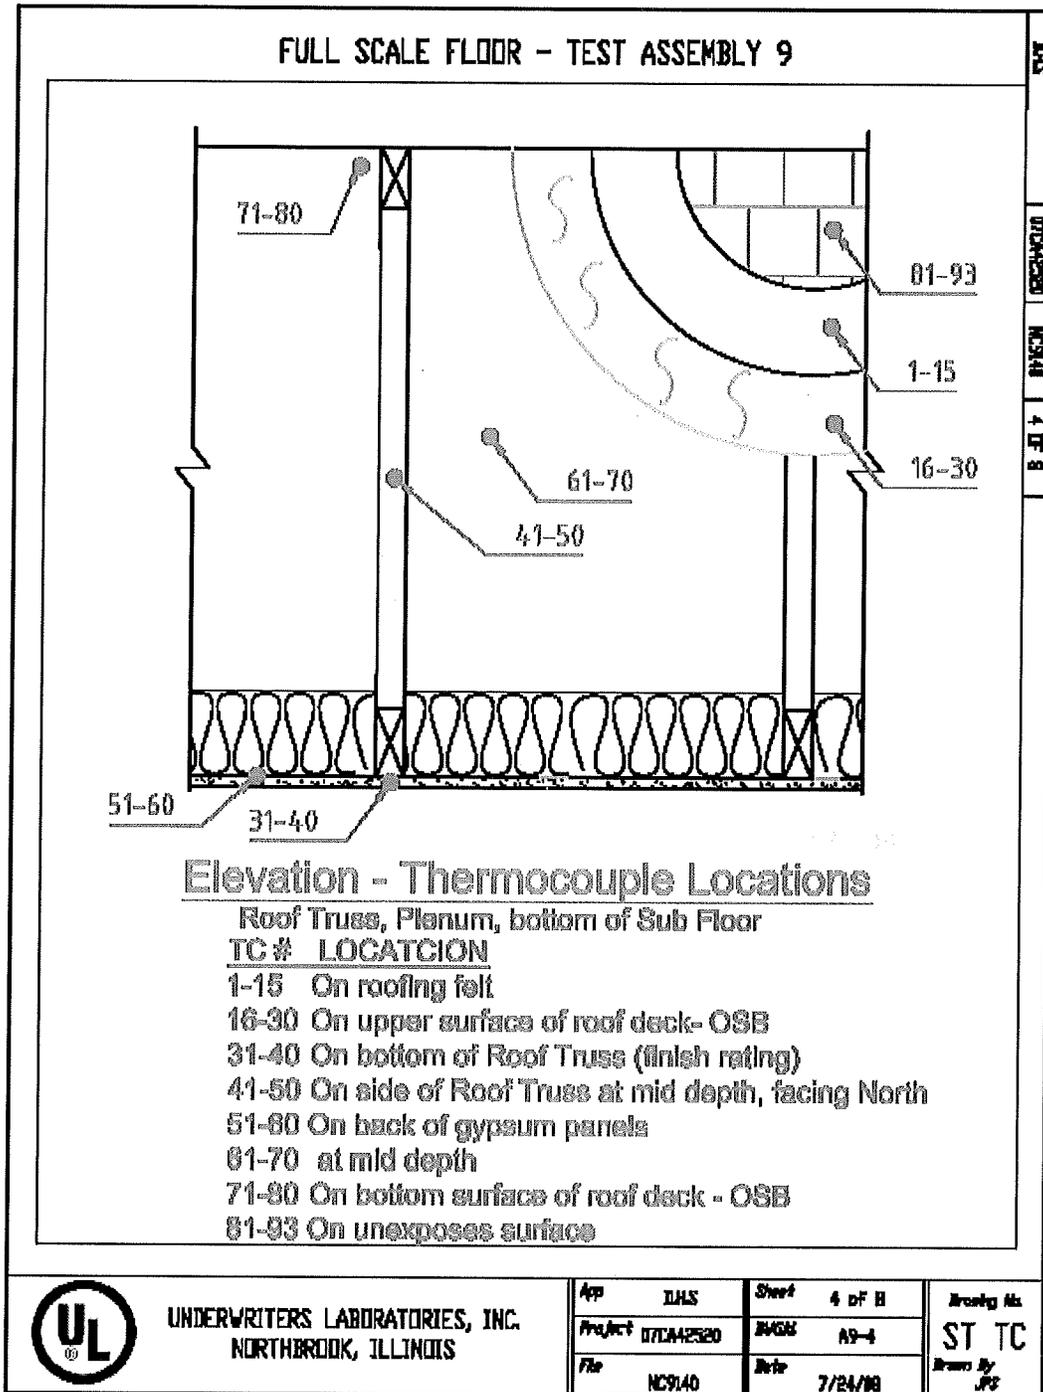
Figure A.9.3 – Thermocouple Locations - Elevation.

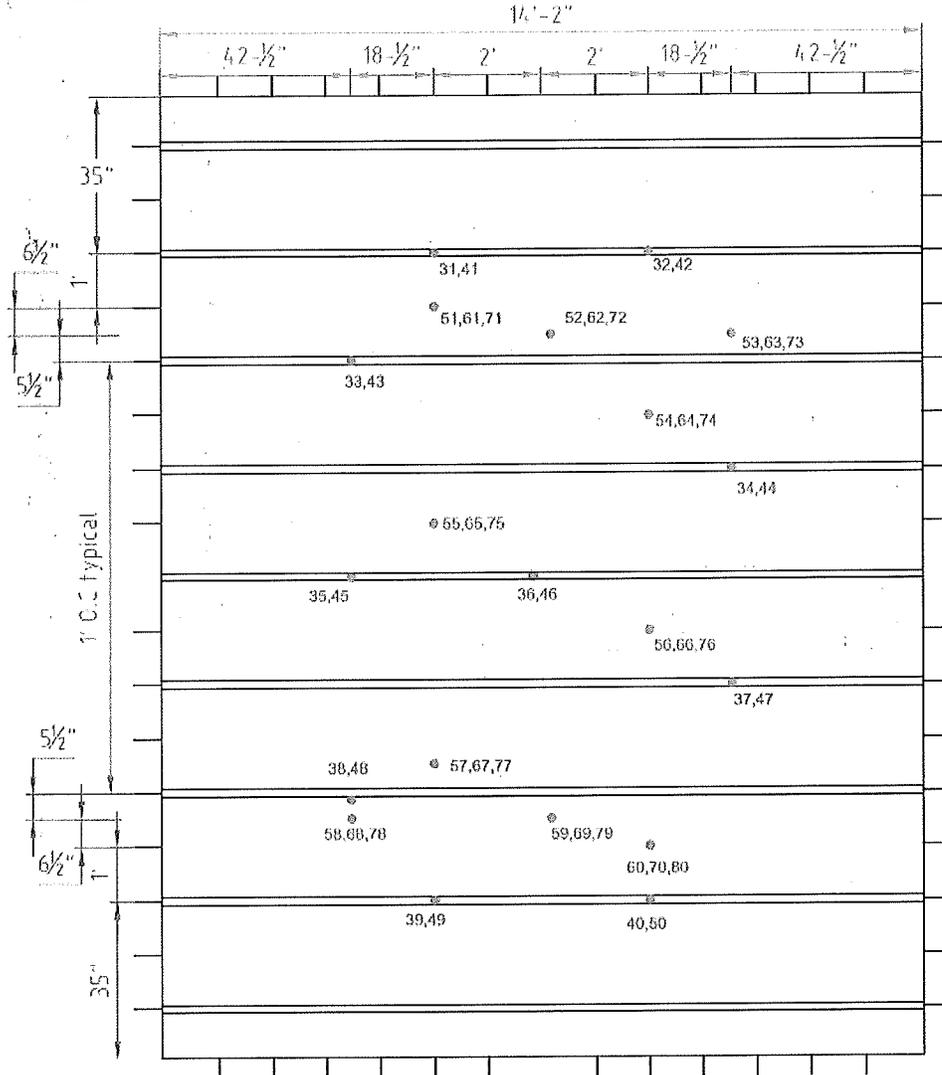
Note:  
T.C.'s 72 & 79 Moved 2 In. West  
due to sheathing cut short from ridge.

Figure A.9.4 – Thermocouple Locations on Wood Members.

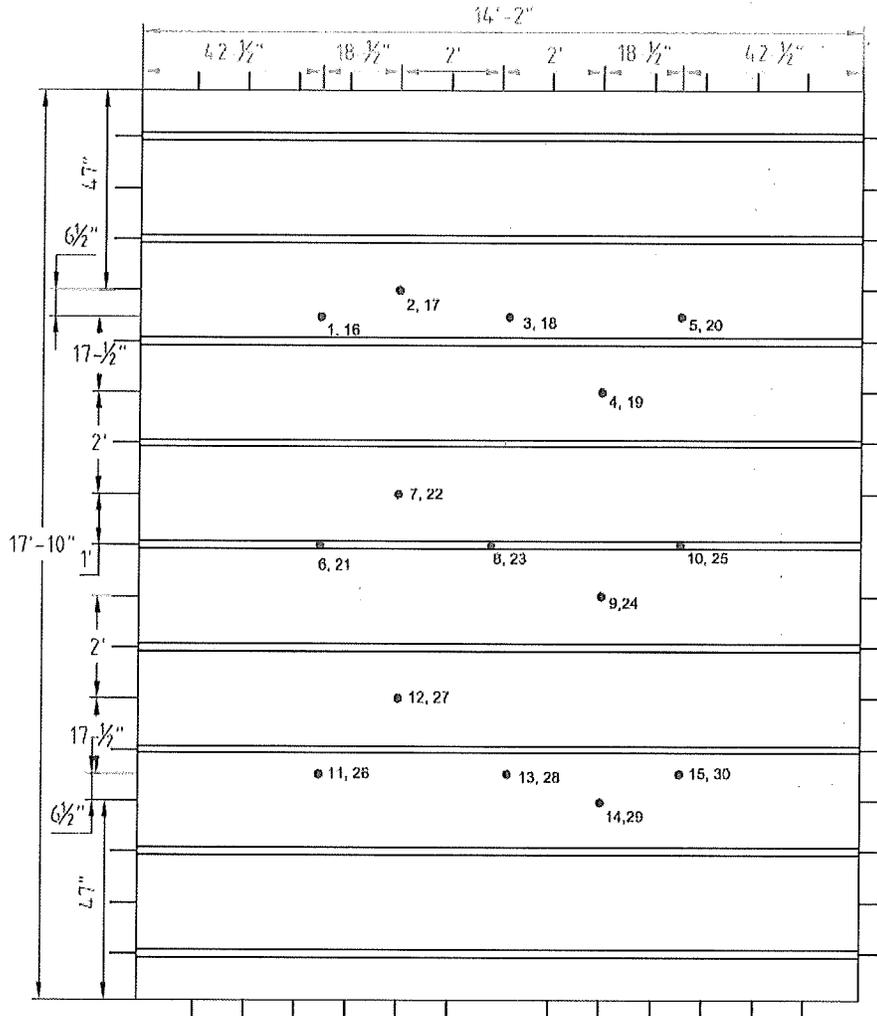
Note:  
 T.C.'s 3,13,18 & 28 moved 2 In. West.  
 T.C.'s 8,23 moved 2 In. East  
 Due to sheathing Being Cut short from  
 ridge.

Figure A.9.5 – Thermocouple Locations on Roof Subfloor and Roof Felt.

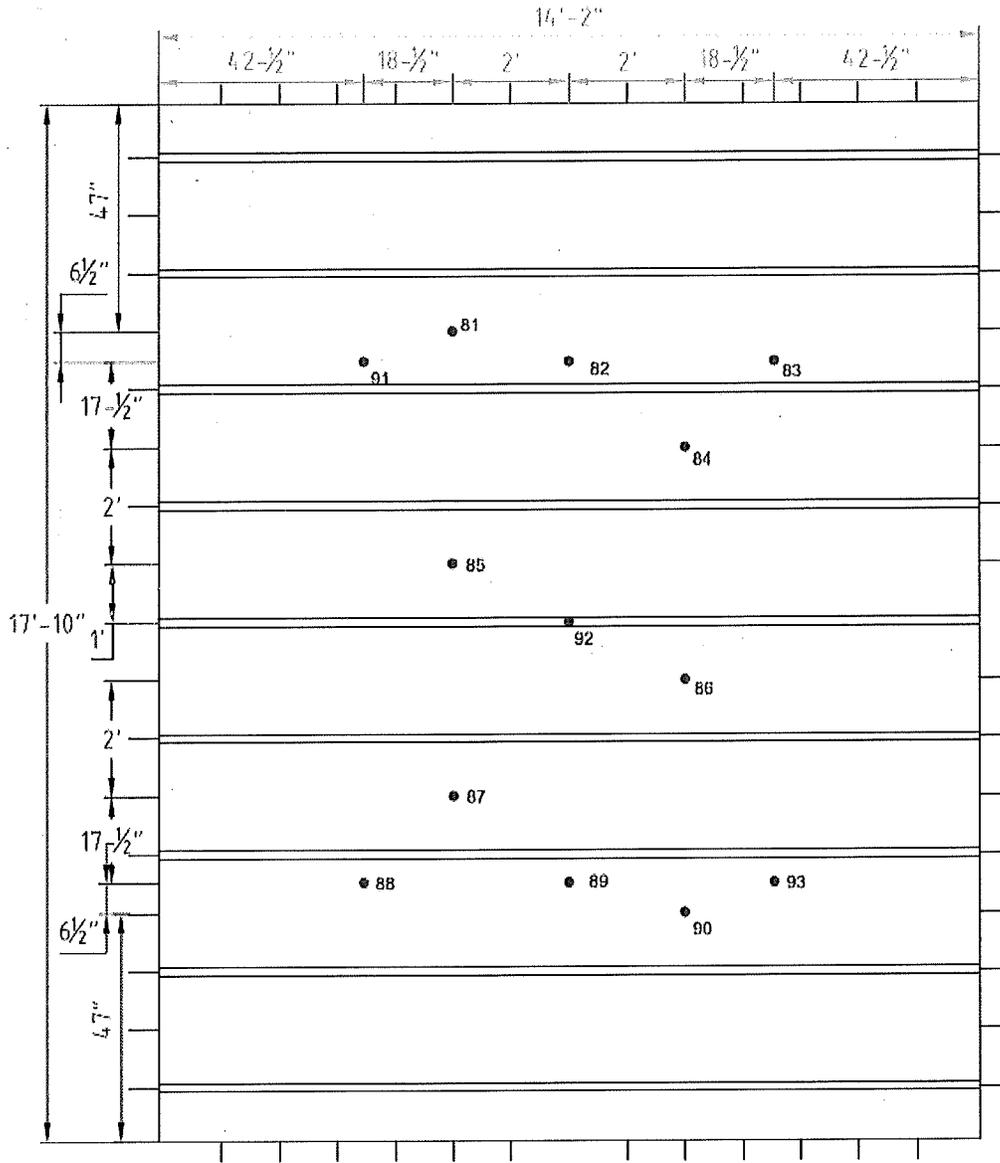
Figure A.9.6 – Thermocouple Locations on Unexposed Surface.

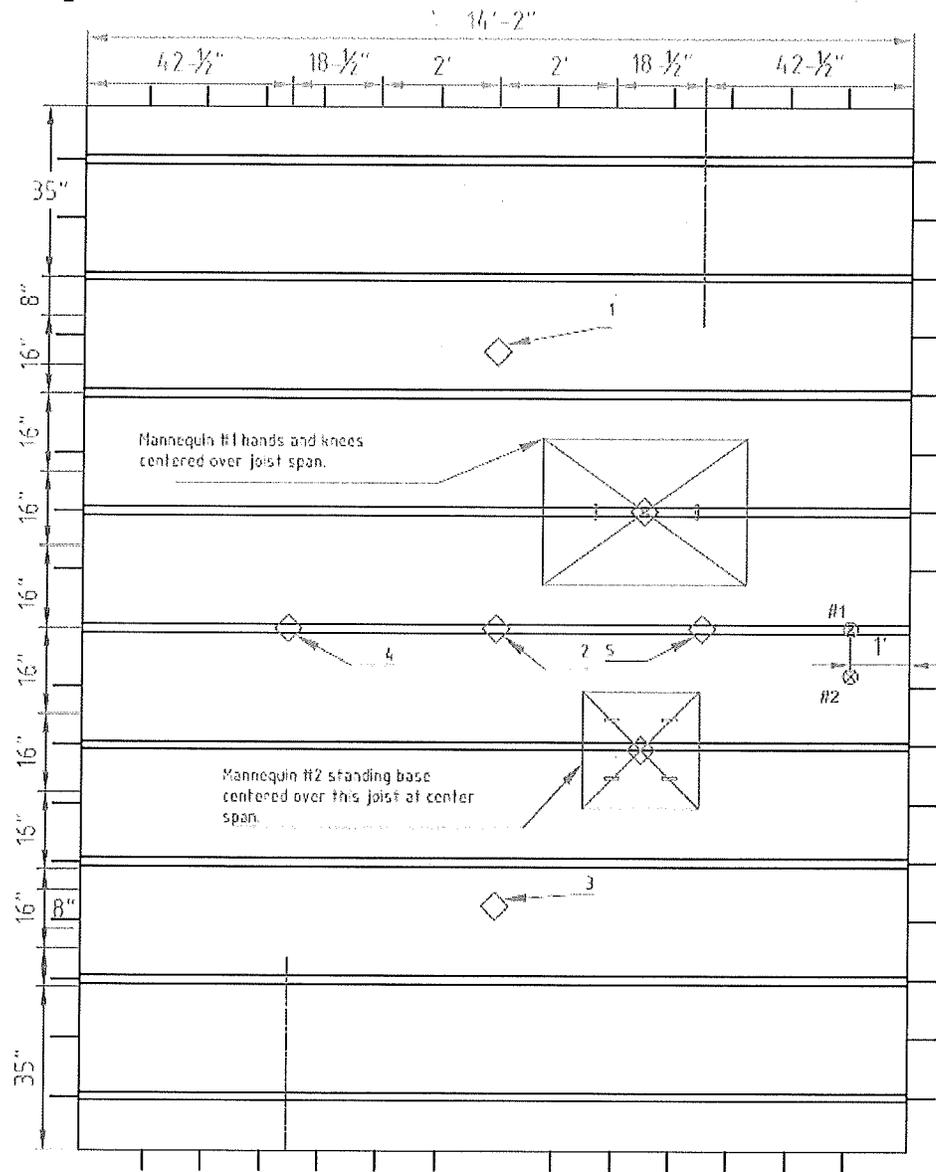
Figure A.9.7 – Loading and Instrumentation Layout (See Figure A.9.8).
