July 31, 2008

Commonwealth of Massachusetts
Department of Public Safety
INCIDENT REPORT

Dominion Energy New England - Salem Harbor Station
Salem, MA
Boiler #3 Failure - November 6, 2007

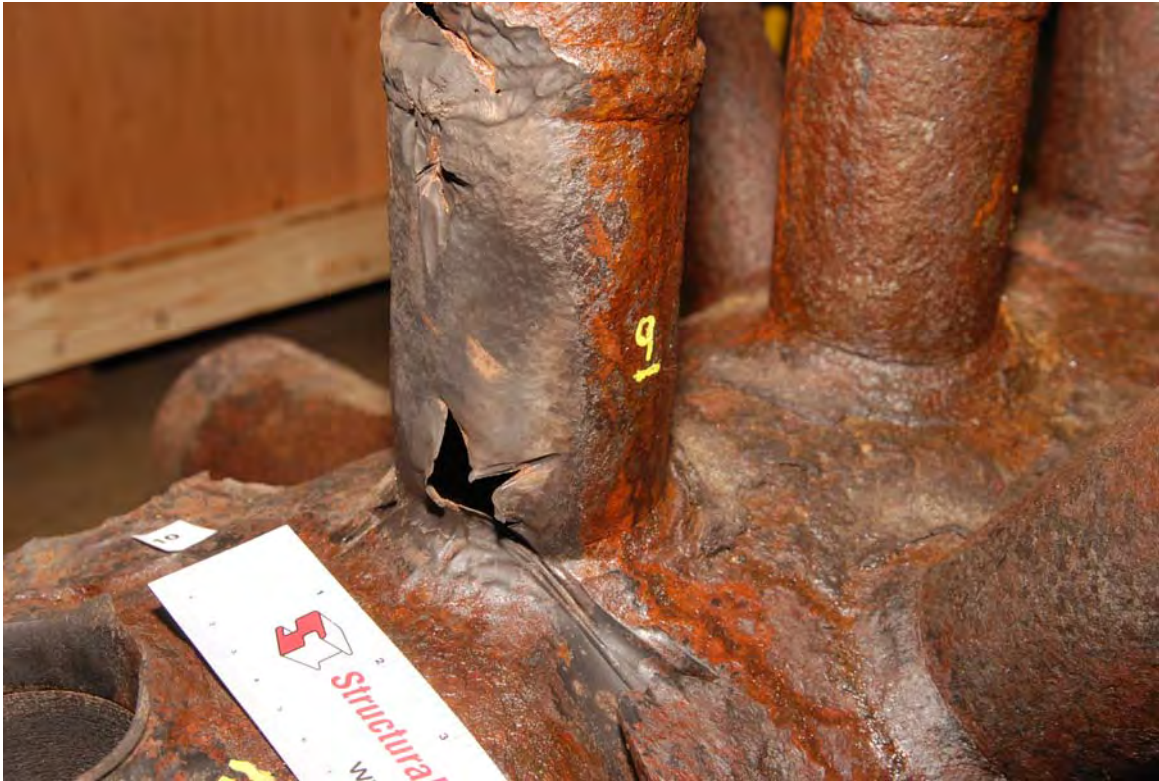
20. Close-up of tube 9

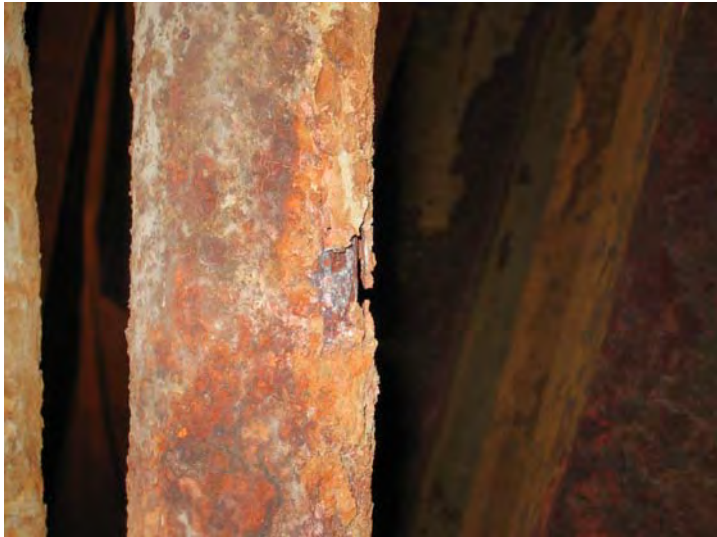
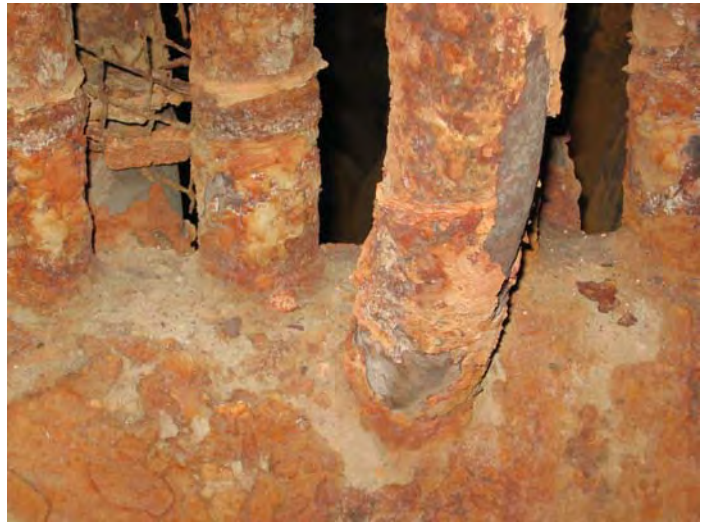
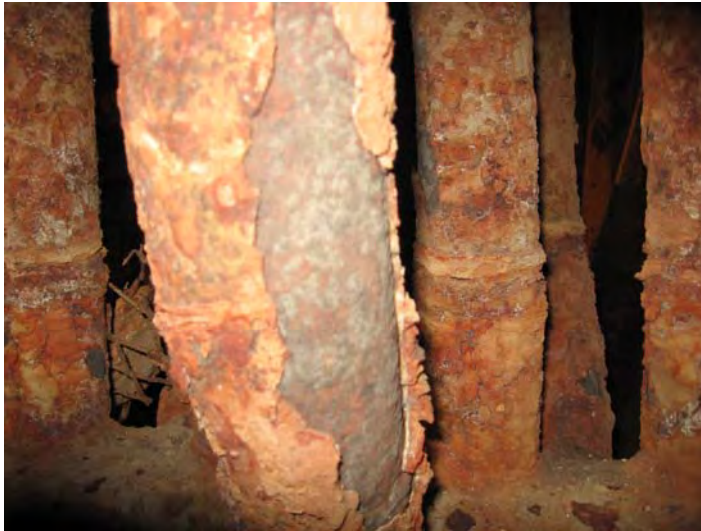
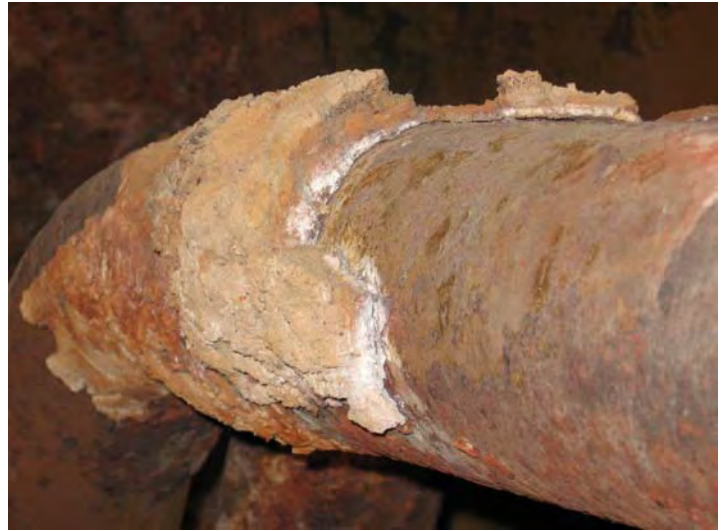
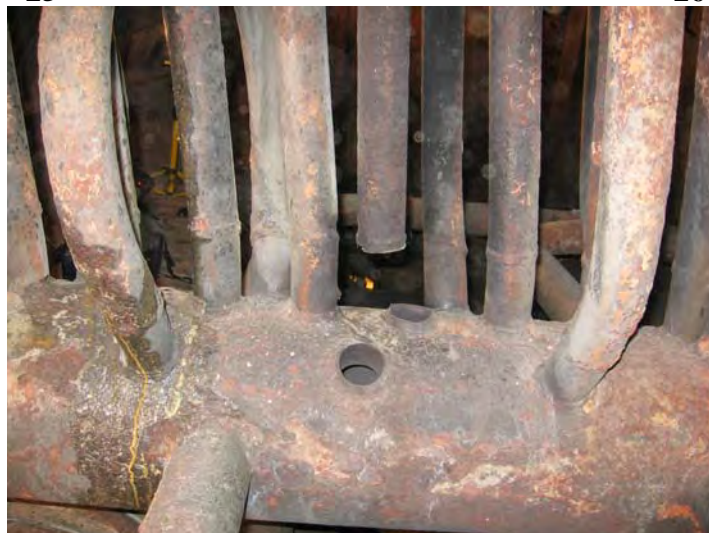
Tube and Header Corrosion Photos (23 – 27)

As part of the investigation, corrosion was considered as a possible cause. Based on witness testimony, it was the common practice to water wash the waterwalls when the unit was taken off line. The water would cascade to the lower section of the boiler including the lower dead air spaces. Water and ash are known to create a highly corrosive environment for boiler components.

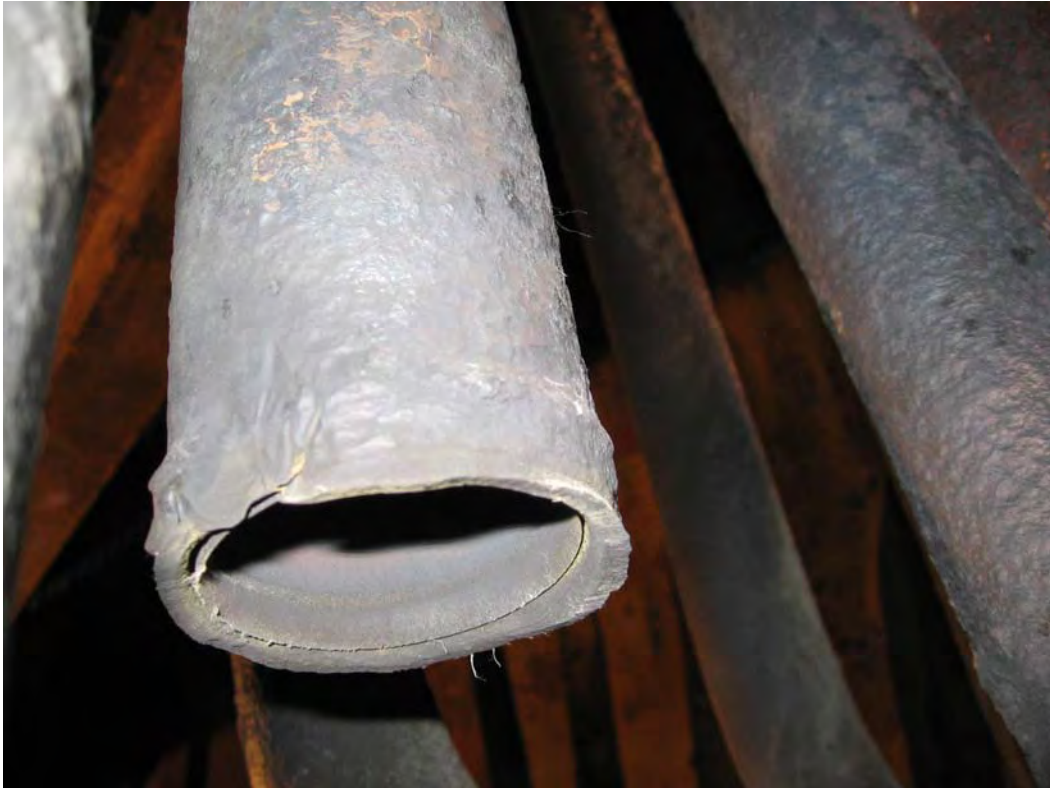
34. Close-up of Tube 11

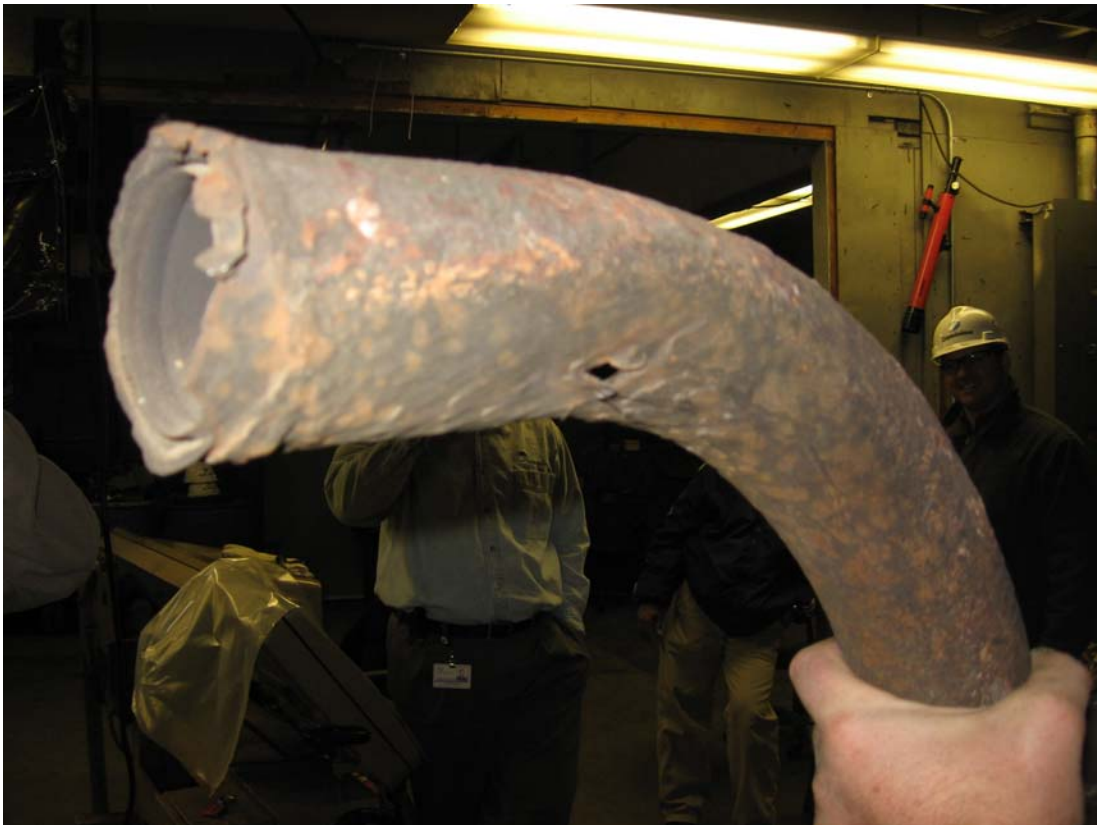
35. Close-up of Tube 10

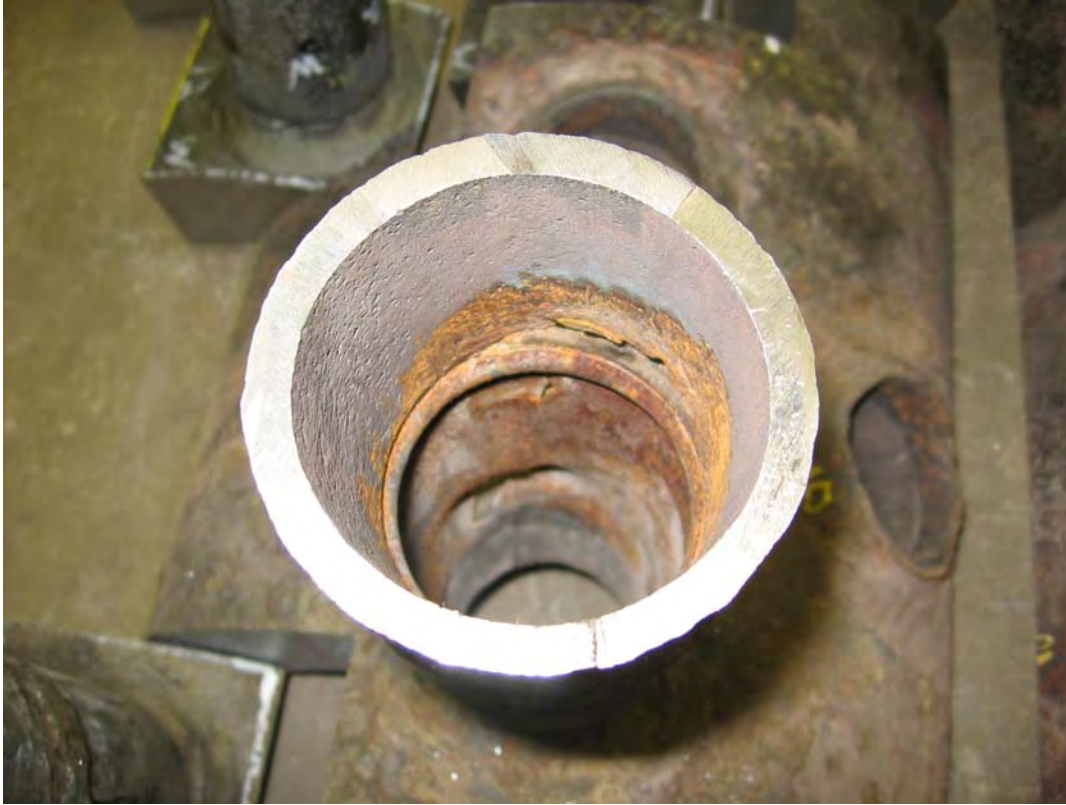
36. Internal view of Tube 9
